Stabilization and Conservation of Minaret Choli in Erbil, Iraq

**presented by Petr Justa
Gema Art Group, Prague, Czech Republic**

- The minaret is situated 900 m west of the southern gate of the Erbil citadel.
- Construction ascribed to the atabeg al-Mudhaffar Din Kokburi (ca. 1190 AD),
- only remaining relic of a large mosque, the earliest phase might be of late Umayyad or early Abbasid period

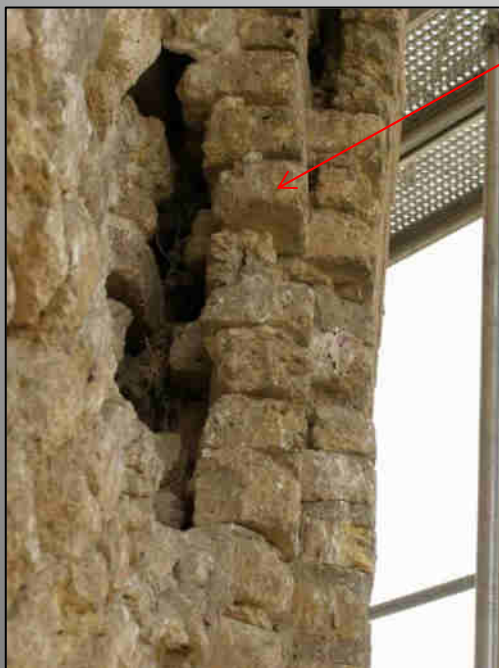
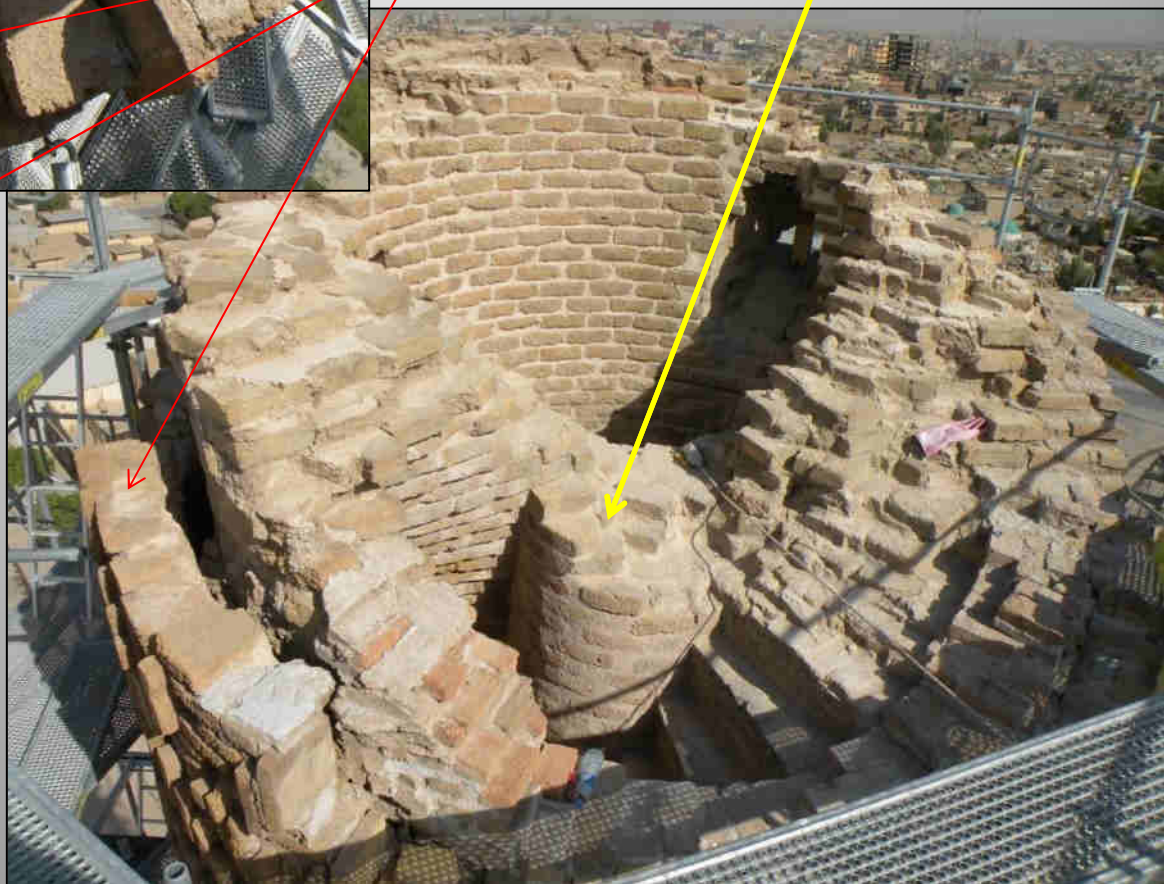
Detachment of the outer wall from the core

**Vertical detachment (window) and
horizontal destruction (wall)
statical cracks highlighted with red arrows**

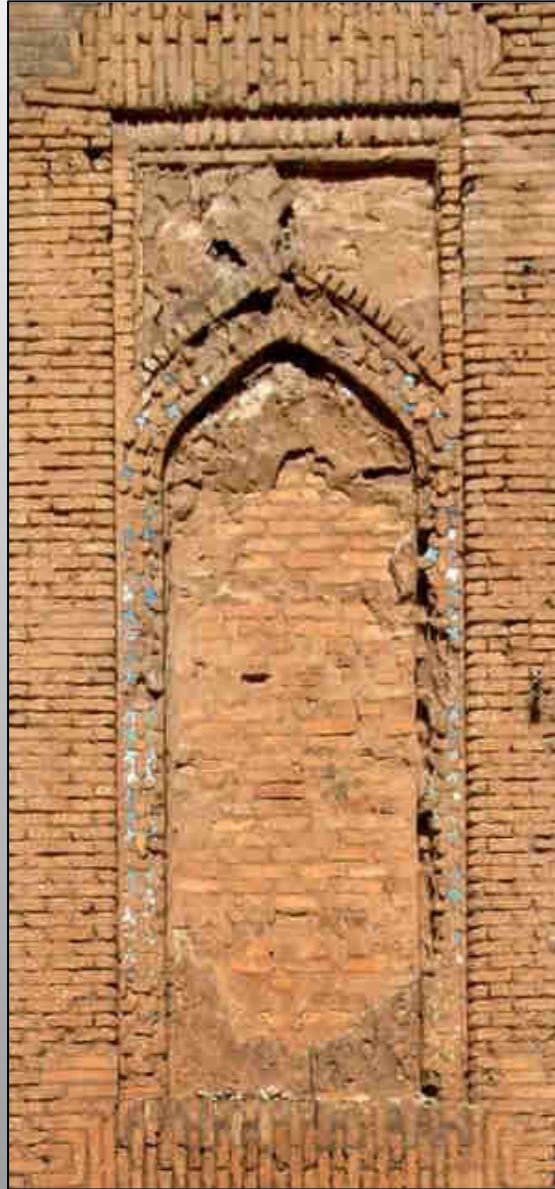
Lower large niches before treatment

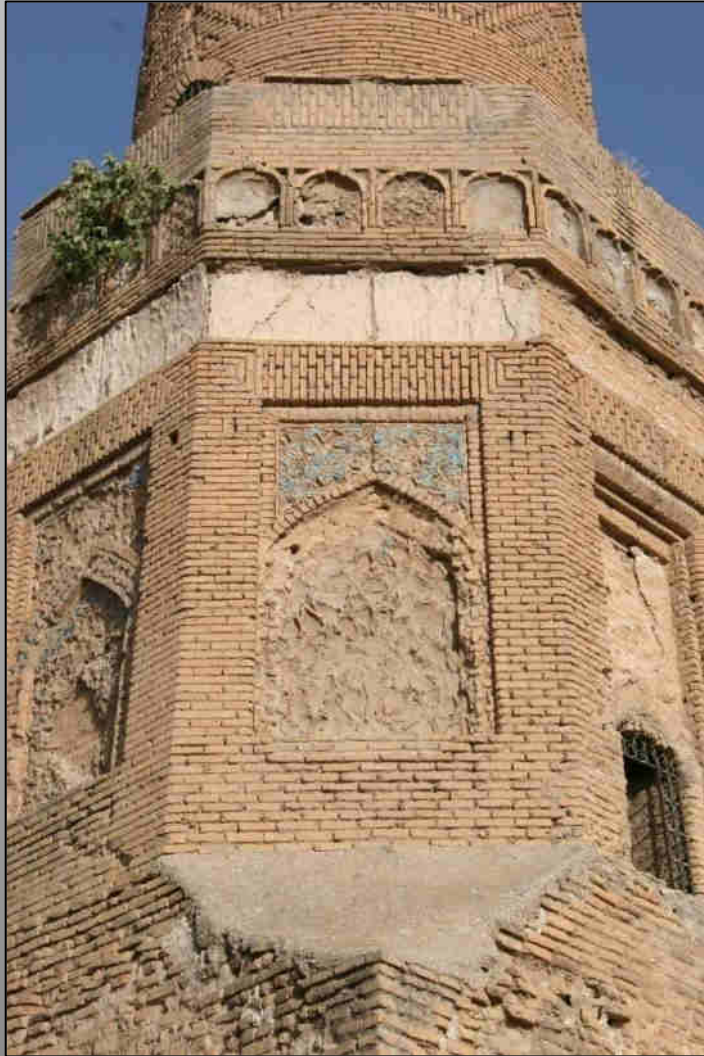
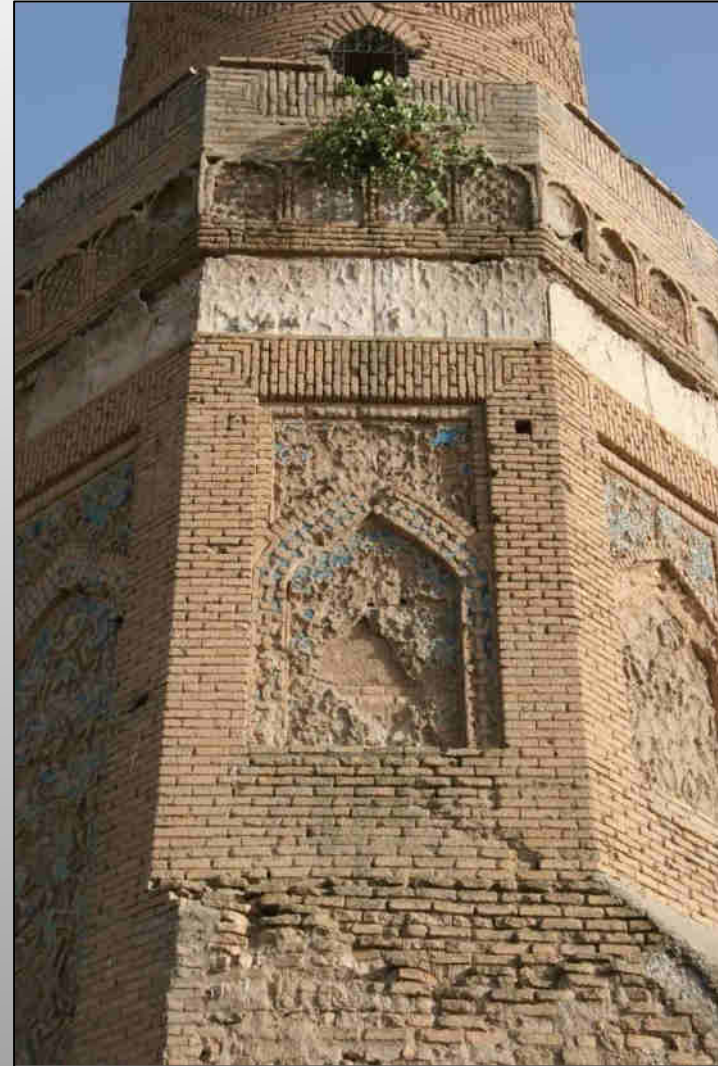
NW small upper niches before intervention
