Conservation of Minaret Choli in Erbil, Iraq

SCIENTIFIC RESEARCH

STABILIZATION AND CONSERVATION

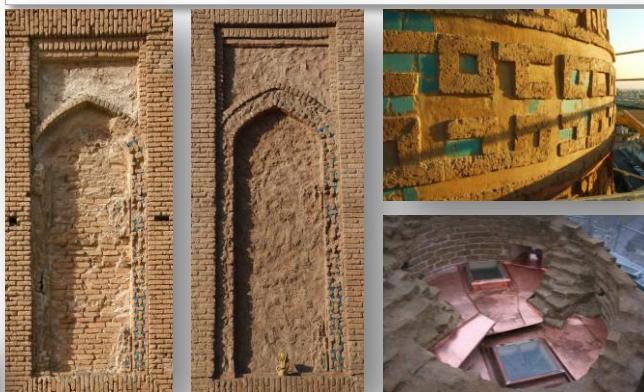
Reconstruction of architectural shape and conservation of wall and original fragments of lower niches

The intervention was kept in terms of pure conservation. The stabilization of the whole structure and conservation treatment of all surfaces was carried out without the tendency of any reconstruction of missing and/or unknown parts of the decoration. The only exception was the inner area of all niches where pure conservation would be confusing from the architectural point of view. The inside area of all niches has been covered by mortar imitating the underlayer for ceramic tiles. All remaining original parts were carefully consolidated, retouched and incorporated into the system. The inner vaults of niches were reconstructed to its original shape (see below) to make the architectural frame better identified.
