## A NEW LOOK AT THE ST. WENCESLAS SCULPTURE IN ST. VITUS CATHEDRAL IN PRAGUE

Petr Justa<sup>1</sup>, Tatjana Bayerová<sup>2</sup> and Karol Bayer<sup>1</sup>

<sup>1</sup> University of Pardubice, Faculty of Restoration

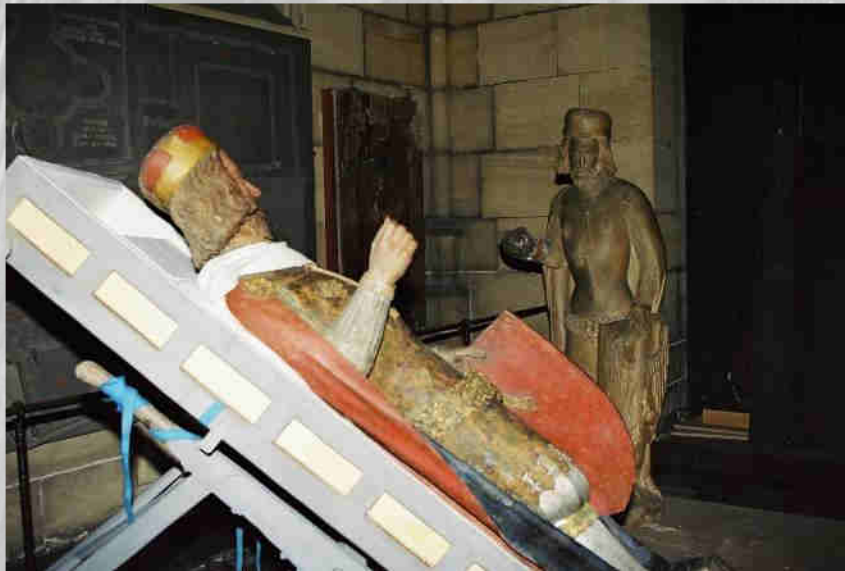
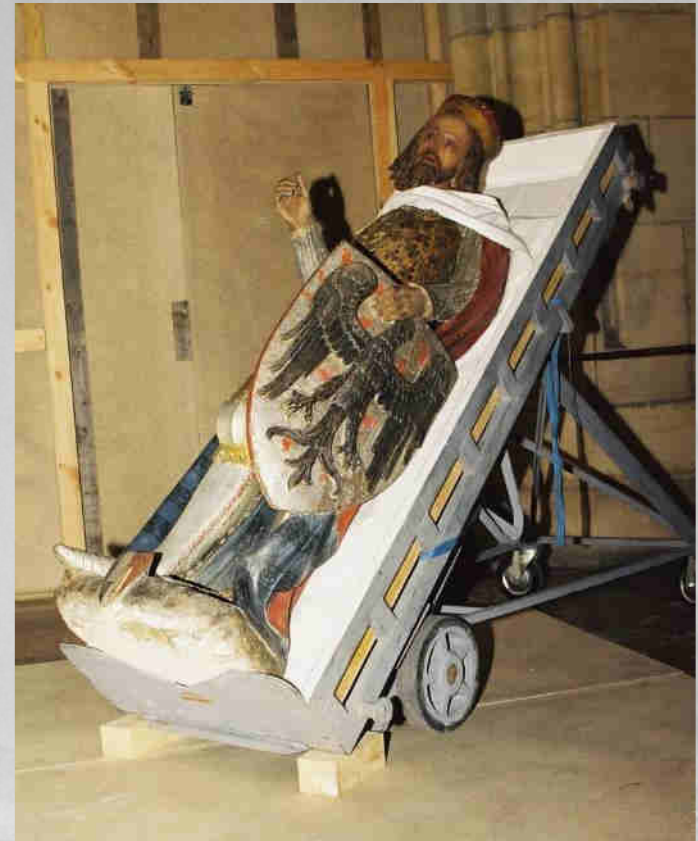
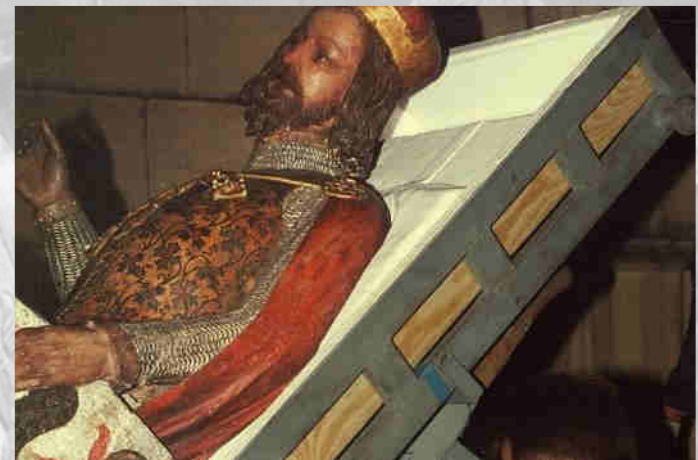
For the transport procedure, the carriage and bedding was designed and tested with the cast gypsum copy

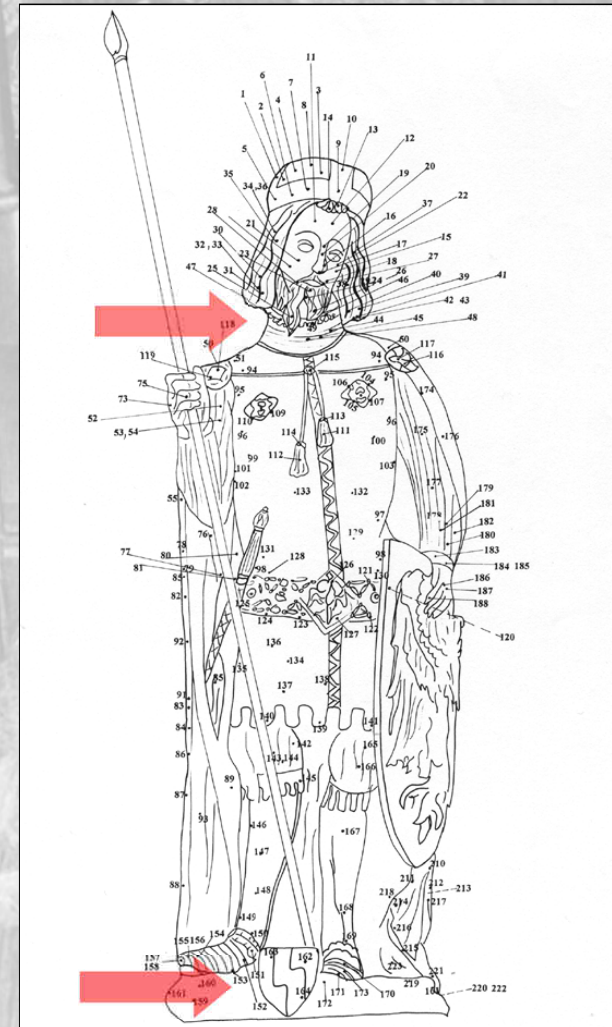
- transmission mode, measuring frequency 250 kHz
- 223 measuring points in different directions
- interpretation based on the ultrasonic velocity values, evaluation of the amplitude and shape of the ultrasonic signal during the single measurements directions

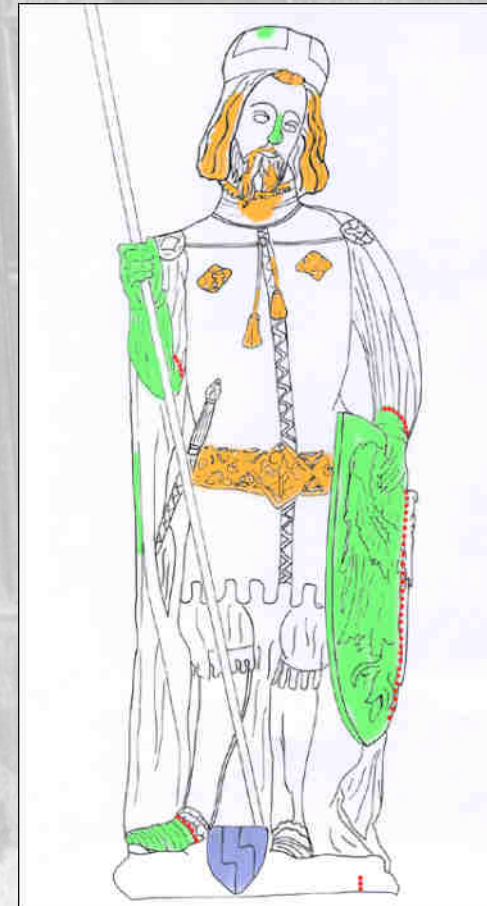
- the general condition of the stone (statue) was evaluated as sufficiently good
- the body and the head were cut from a single block of stone
- the Parler's stone mark was made from a more dense type of stone than the stone of the statue
- local damages and minor cracks only in joints
- secondary stone fillings – right hand, part of right foot and part of the shield
- partly areas with repair mortars – head, belt, chest

Stone fillings - different stone variety
-

Stone mark on the plinth
-

Areas with repair mortars
-

Cracks or damaged joints

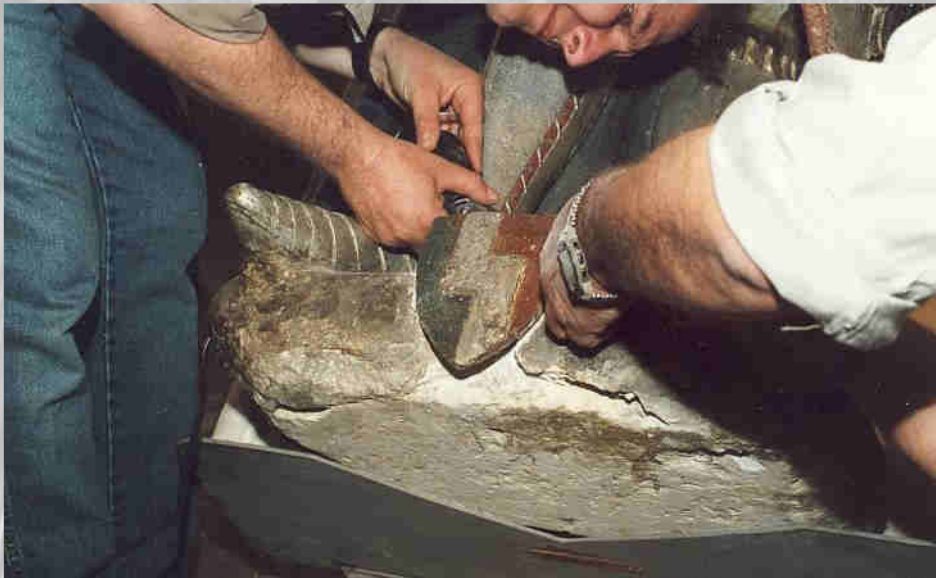
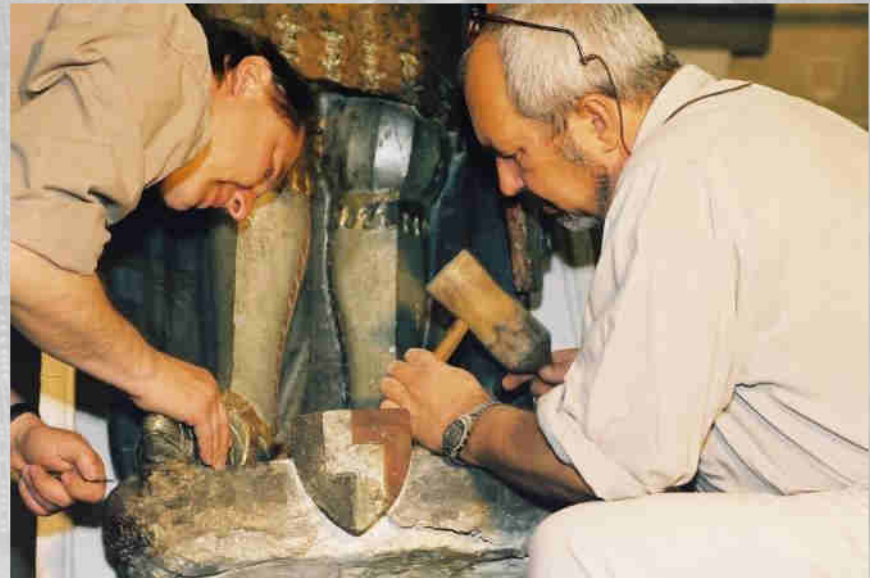
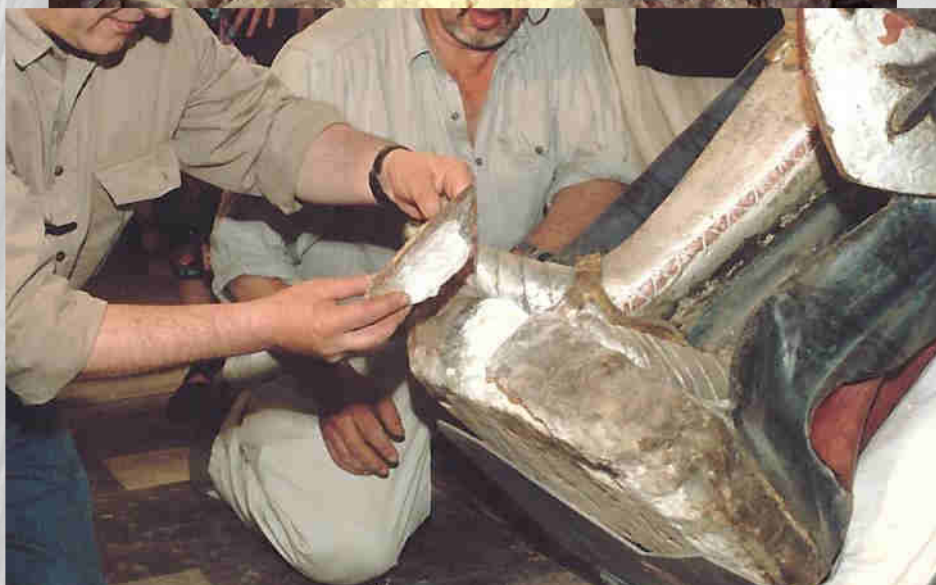
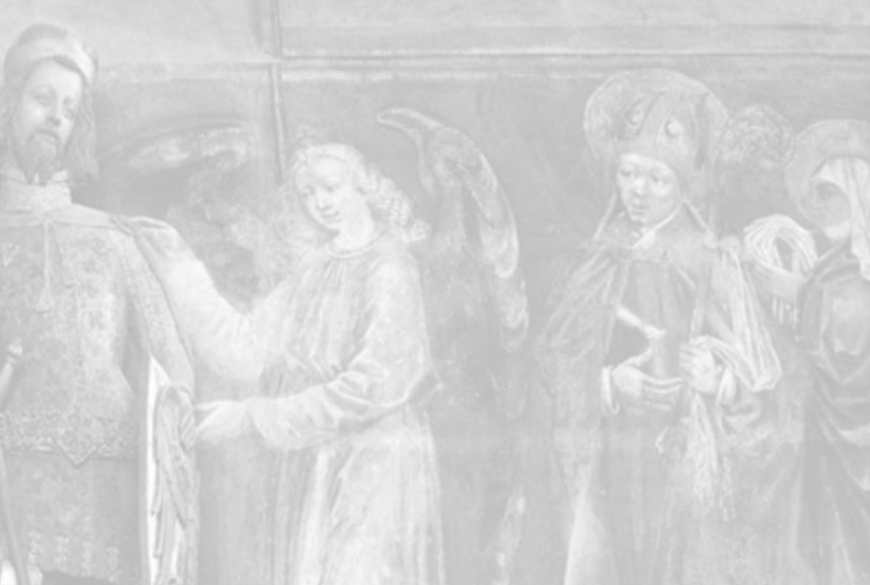
## Dismantling of the Parler's stone mark

- significantly different from the stone of the sculpture in both structure and composition.
- The more dense structure and considerably higher calcite content shift this stone closer to a silty carbonate.

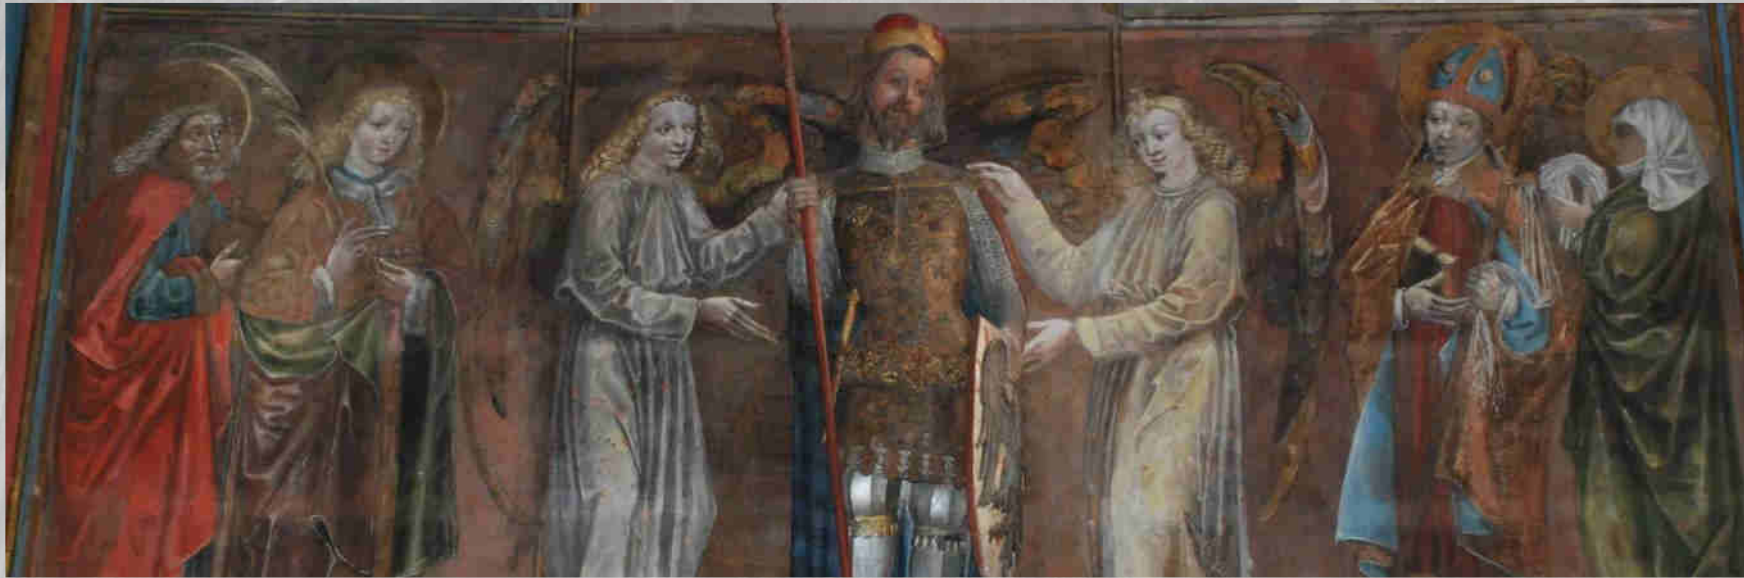
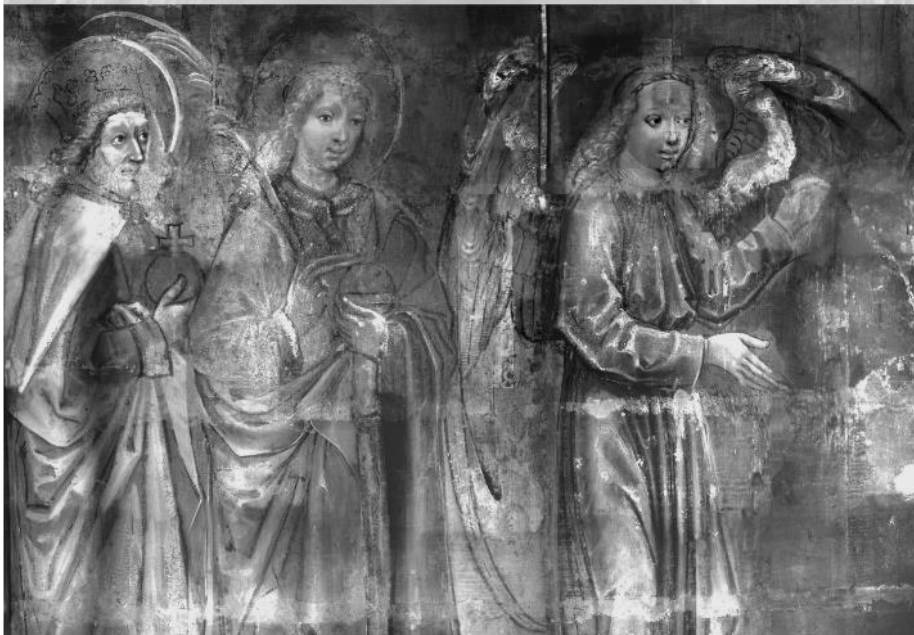
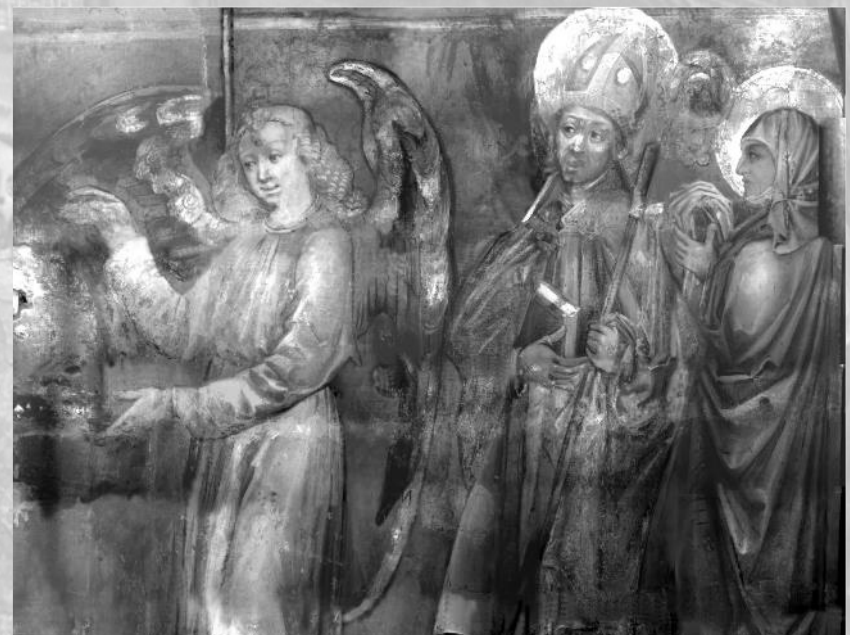
**Comparison of IR images with authentic murals  
both layers are in accordance**

Murder of St. Wenceslas by his brother Boleslaw  
Considerably changed composition between 1st and 2nd layer

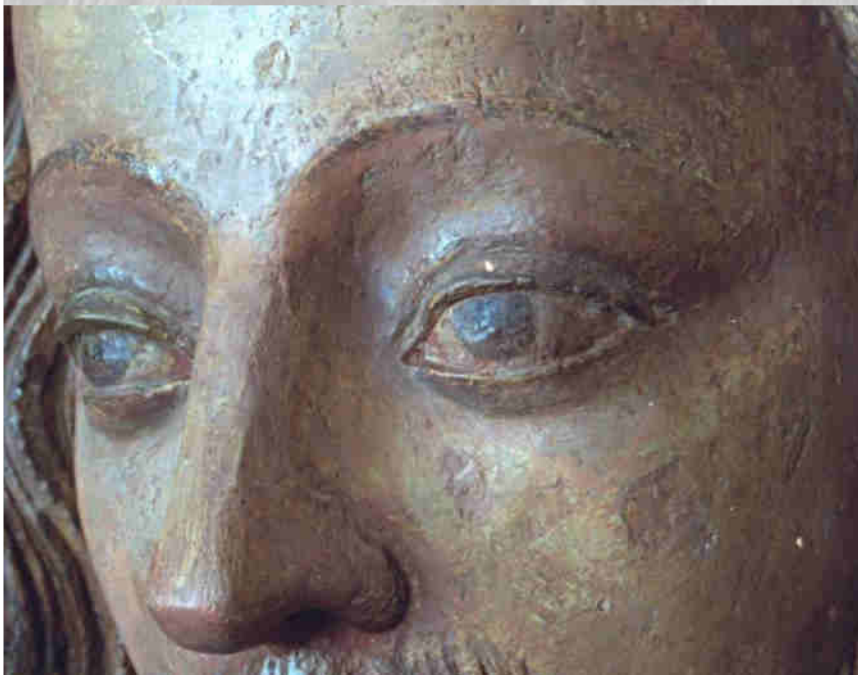
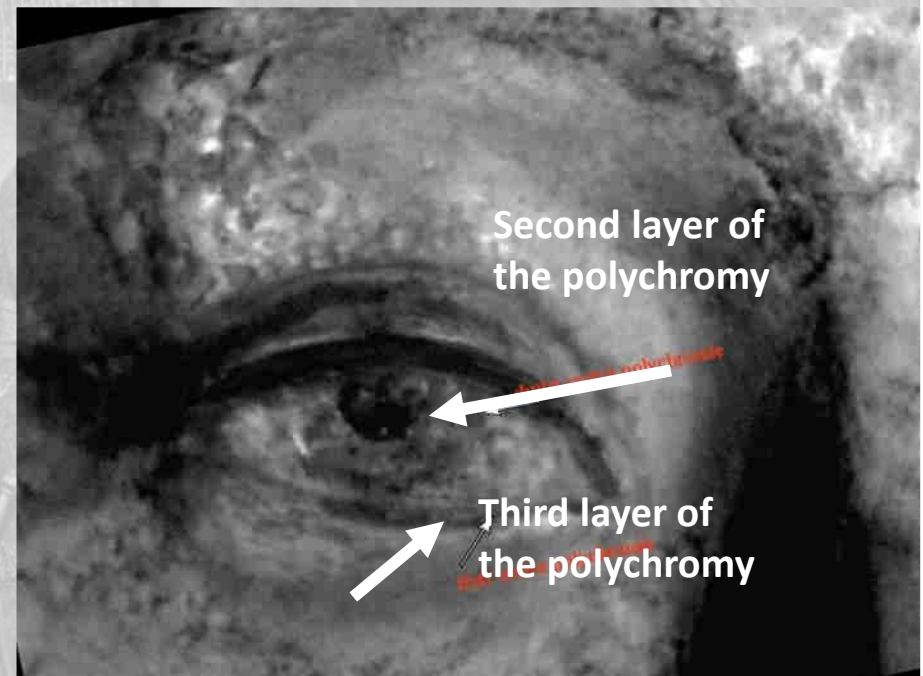
- The considerable change in the direction of the figure's gaze (eye fillets)
- Confirmation of the presence of the older polychromy in fragments

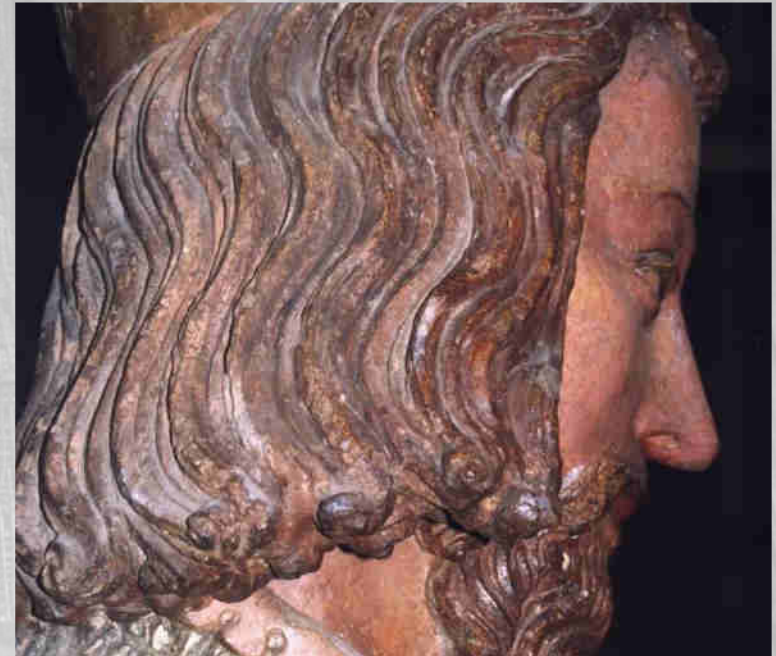
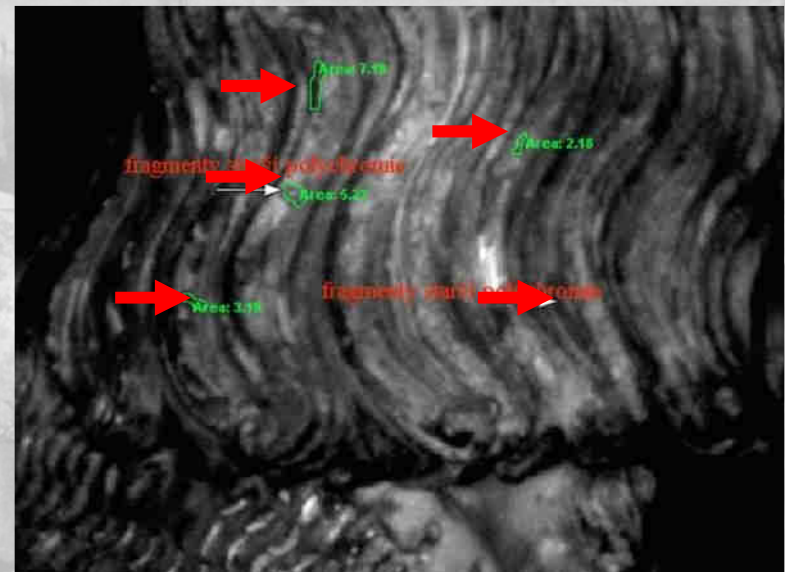
IRR revealed only minor fragments of older (original) polychromy - marked with arrows

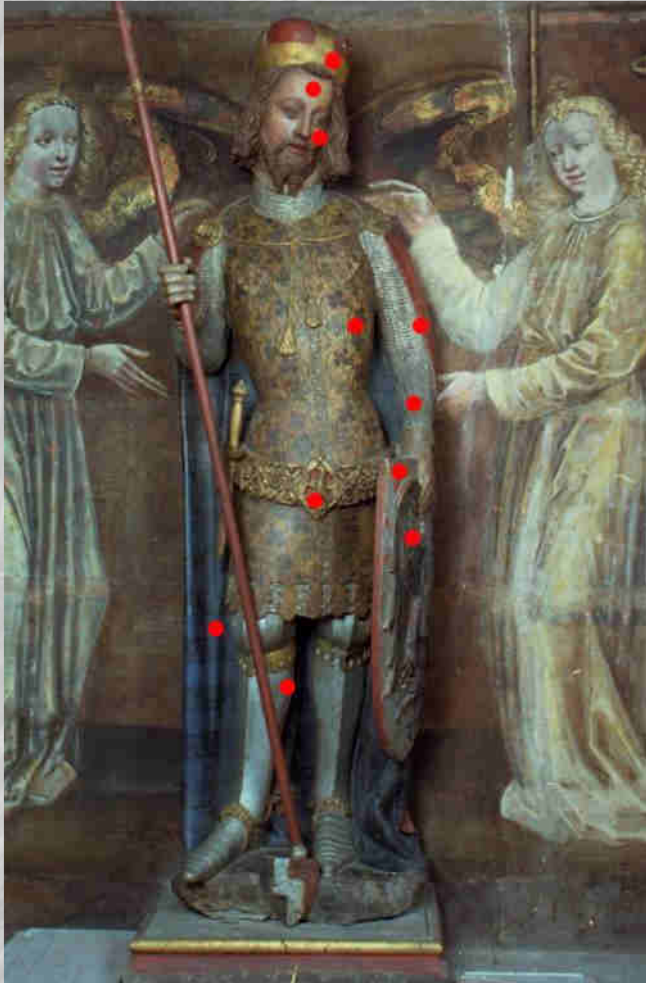
Measured areas

The detection of zinc, chromium, and strontium in all points

→ secondary paint layers from the nineteenth century at the earliest.

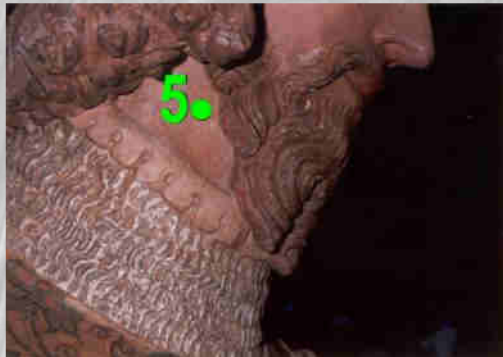
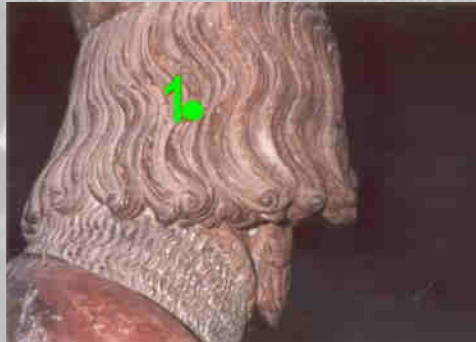
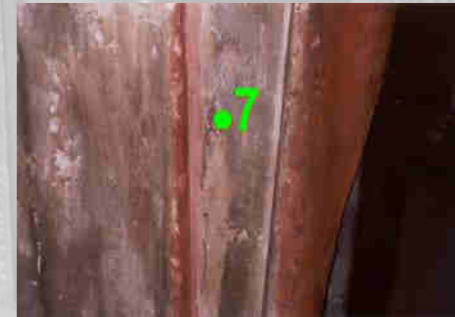
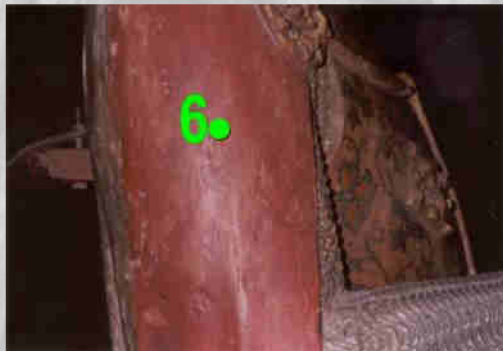
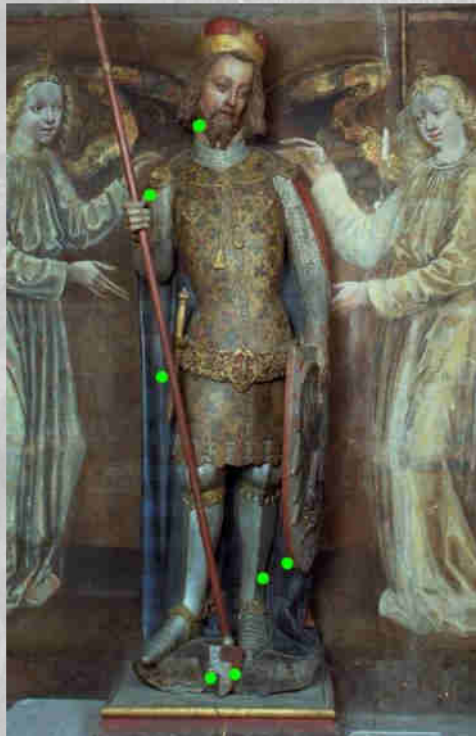
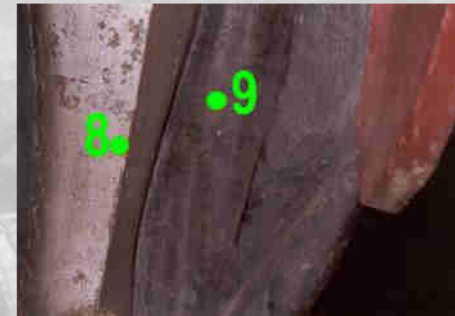
Nine sampling places

Older layers not found in 2, 7, 8, 9

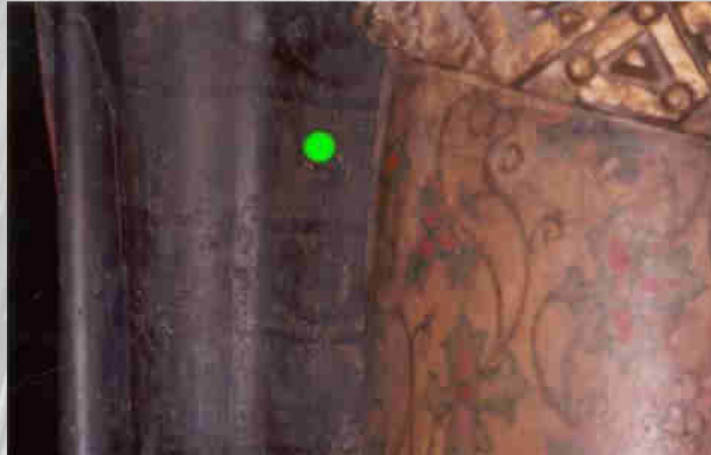
### S4, coat lining

Cross-section A

The description from 1858:  
'...the coat was red with green lining ...'

- 5- dark green glaze
- 4- silver foil
- 3- orange-brown  
(preparation for Ag)
- 2- orange-brown gr.
- 1- ochre-yellow gr.

**Silver foil with green glaze**  
(copper-resinate and egg tempera)

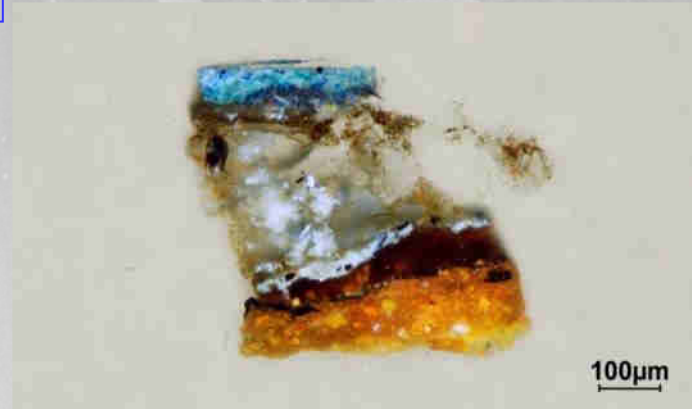
- 7- light brown  
(secondary)
- ?? ??
- 4- silver foil
- 3- orange-brown  
(preparation for Ag)
- 2- orange-brown gr.
- 1- ochre-yellow gr.
- 0- stone fragment

- secondary light brown layer – discoloured blue pigment smalt

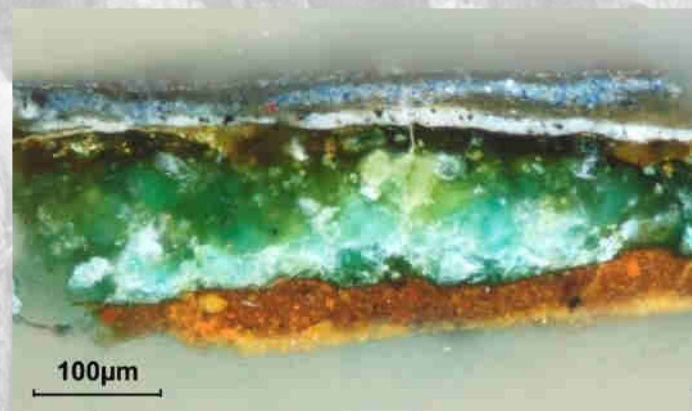
Cross-section C

- copper resinate (peaks at 1716 and 1612  $\text{cm}^{-1}$ )
- protein (amide II peak at 1560  $\text{cm}^{-1}$ )

- drying oil (high amounts of glycerol, fatty acids, and azelaic acid) and egg (13 aminoacids, hydroxyproline absent)

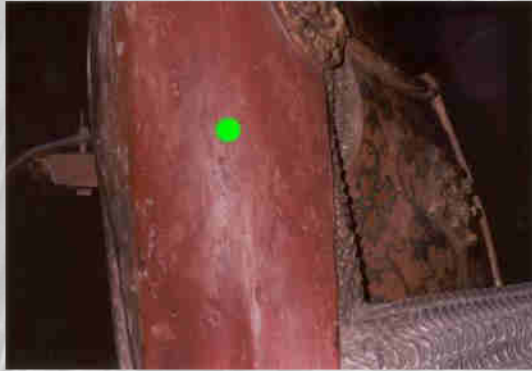
### S6, outer coat

**Not preserved silver foil?**

The preparation layer (?) and the similarity with the layers from the coat lining and from the Parler's stone mark indicates that the metal foil could be original.

4- red, in two layers

3- orange-brown  
(preparatory layer for  
not preserved foil??)

2- orange-brown ground

1- ochre-yellow ground

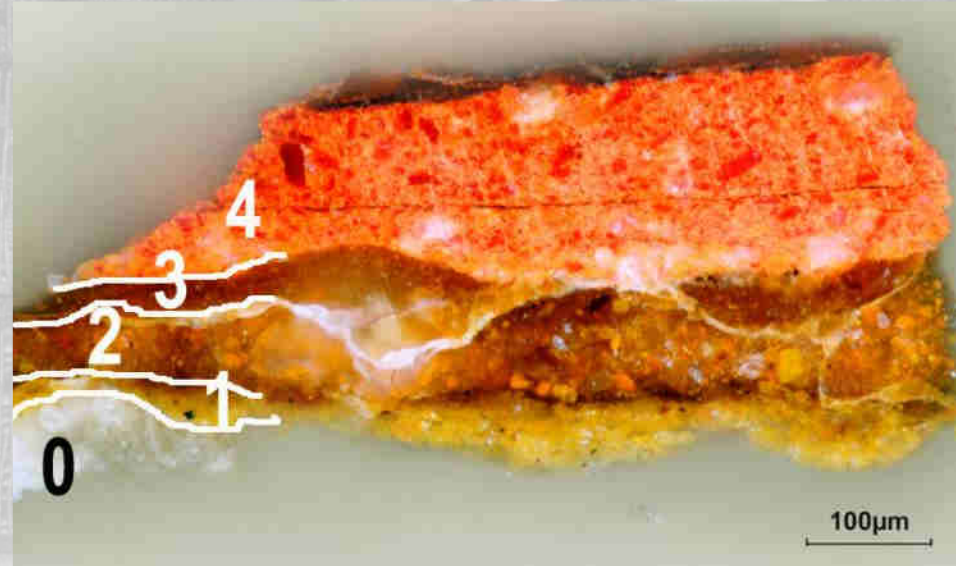
0- stone fragment

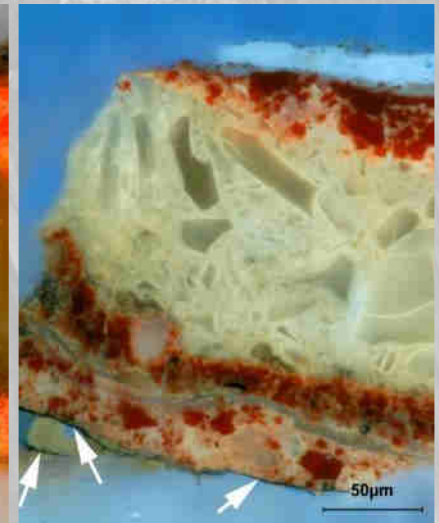
#### Original decoration

- a **double silver foil** over the preparatory layer
- no evidence of any glaze or varnish for the tarnishing prevention
- either the glaze or varnish is not preserved or
- a change in the design and the foil was immediately covered by the red layer

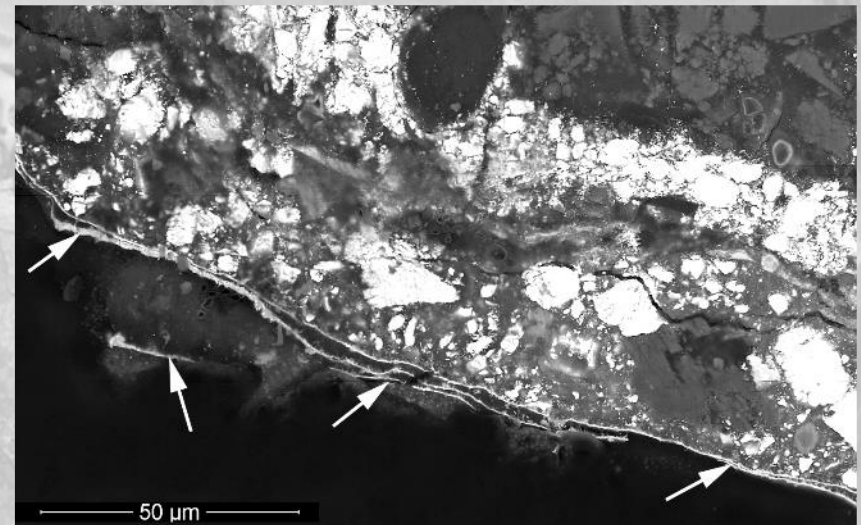
The silver foils marked with arrows

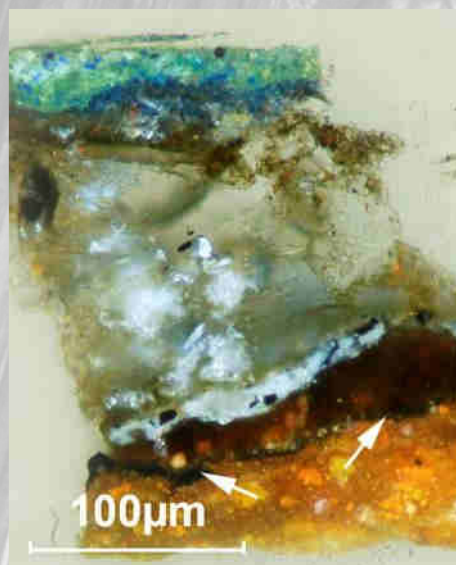
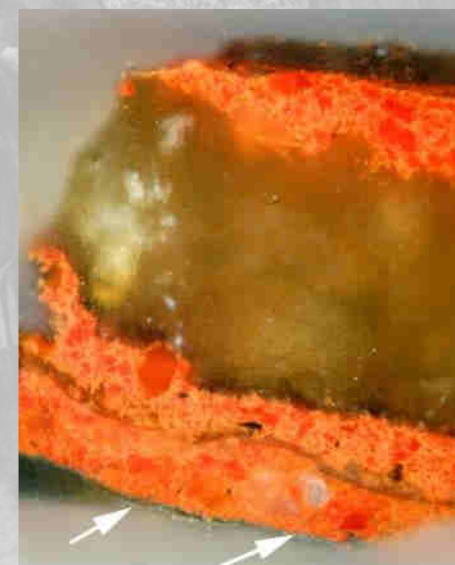
Silver foil with glaze

Silver and glaze missing?

Silver foil  
Glaze missing?

Red cinnabar layer  
over the ground

Red cinnabar layer  
layer over the foil

Secondary discoloured smalt

Polychromy on the stone mark seems to be identical with the polychromy on the statue

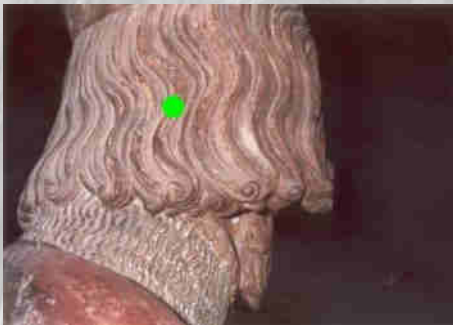
**S1, hair**

### Original layers

- 3- brown layer (ochres)
- 2- orange-brown ground (ochres, red lead)
- 1- ochre-yellow ground (ochres, some red lead)

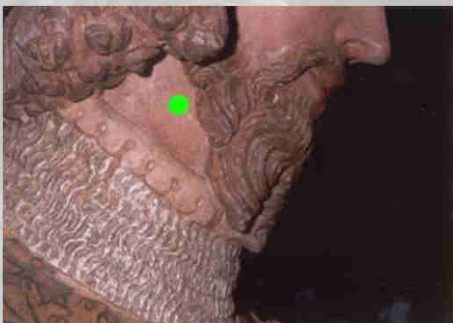
**S5, neck**

- 3- pink layer (fine-grained vermilion, lead white)
- 2- brown-orange ground (ochres, red lead)
- 1- ochre-yellow ground (ochres, some red lead)
- 0- stone fragments

Results in agreement with the description from 1858:  
'...the hair and beard were light brown...'

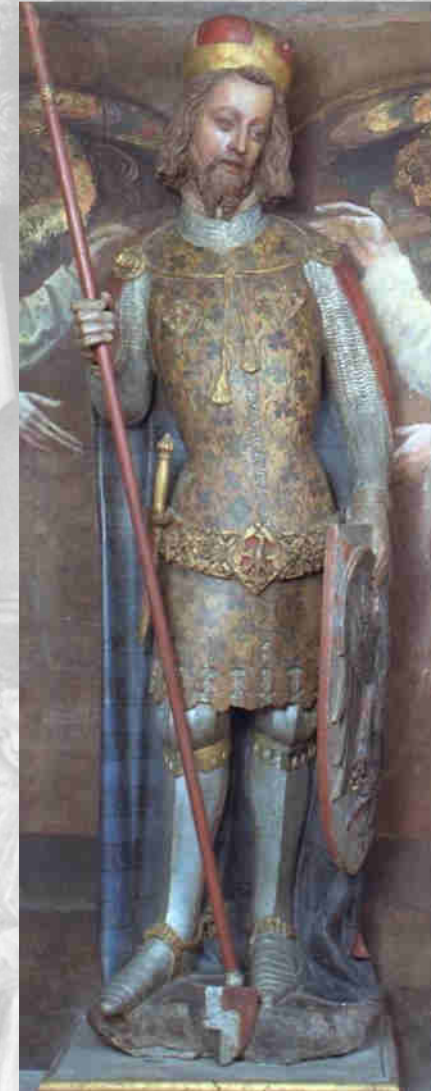
## Conclusions I

- Original appearance – according to original polychromy
- The coat lining (today blue), was originally decorated with silver foil and green glaze
- Outer coat (today red) could also have been decorated with silver foil, and hypothetically with a red glaze
- The colour of the hair was originally brown ochre
- The red field of the stone mark was initially decorated with silver foil, but it is not clear whether the foil was glazed or immediately repainted in the red colour.
- Examination of the polychromy newly defined the extent of original polychromy and clarified and enhanced its first description from 1858 .

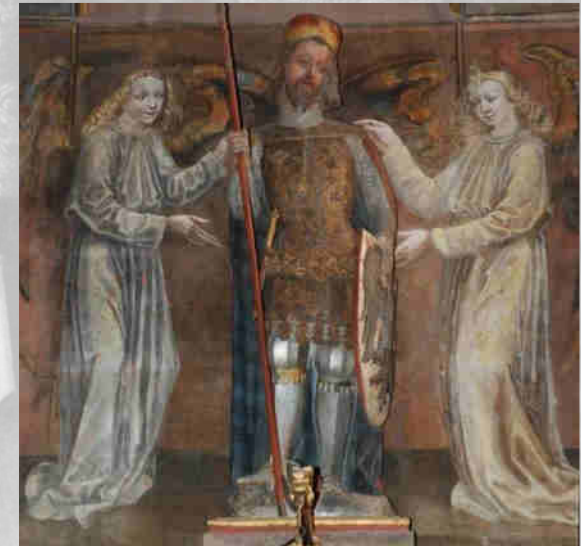
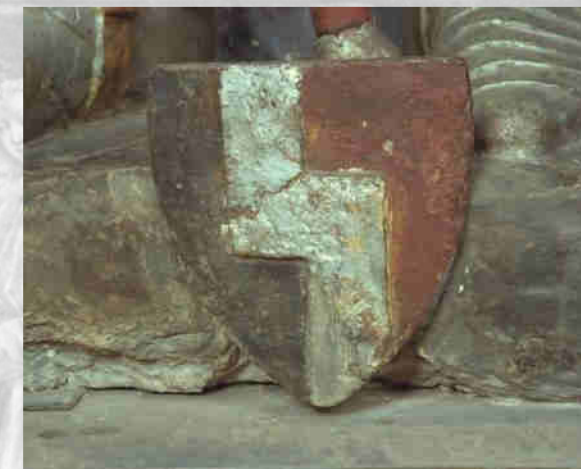
## Conclusions II

- **Authenticity** : the head and body are from the same piece of stone , the originality of the head was confirmed
- **Comparison of mural paintings surrounding the statue** confirmed the location at the cornice in times of the first decoration of the Chapel by Master Oswald
- It was also confirmed that the statue was very probably originally designed for a higher position - tabernacle above the chapel
- The stone of the sculpture is a biomicritic carbonate siltite, that for the mark is a silty carbonate
- **Authenticity of the stone mark**: despite different varieties of stone for the figure and the mark, the polychromy comes from the same period of time
- This finding indicates the same date of painting of the mark and does not deny the authorship of Peter Parler
