Nano*for*ArT

WP 6 – Long Term Behavior Update and future steps

Gema Art Group, a. s.

Brussels, June 2013

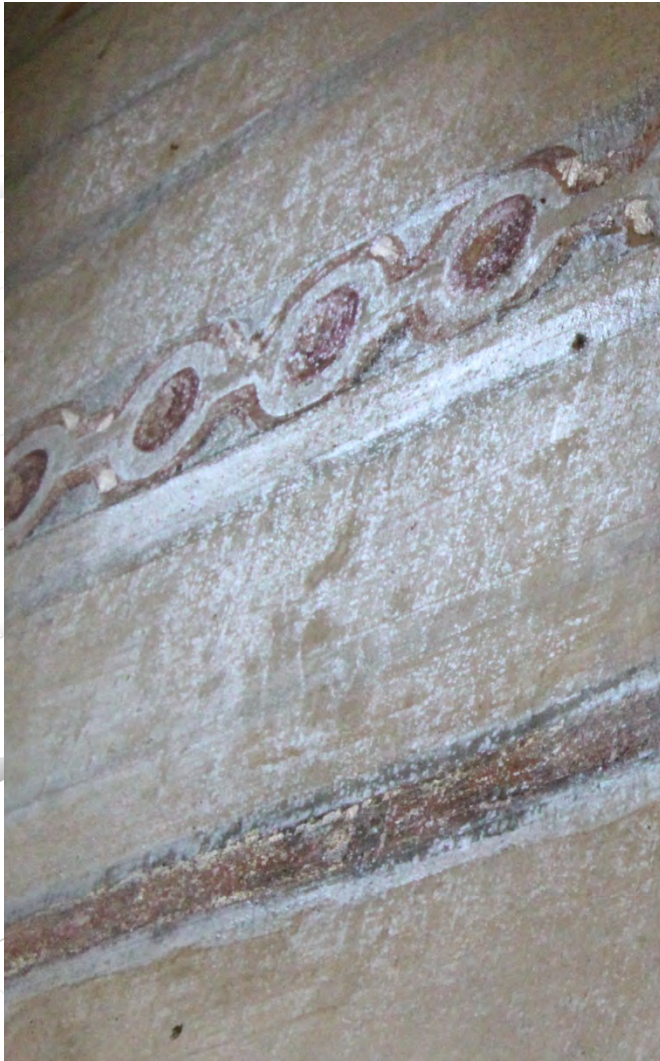
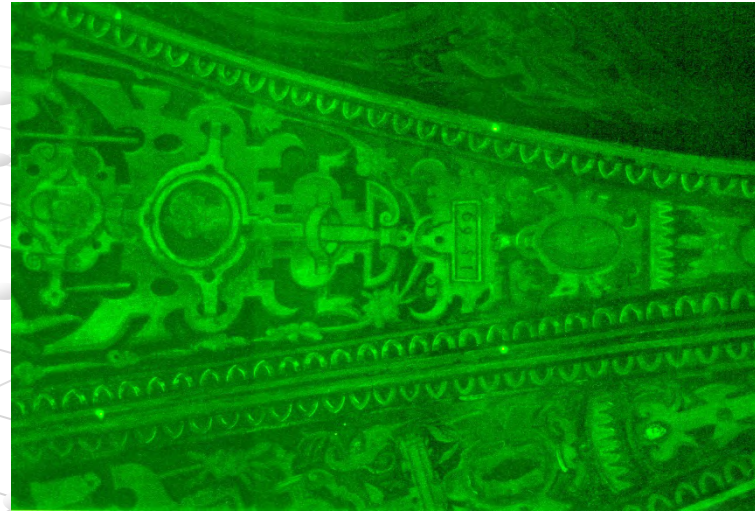
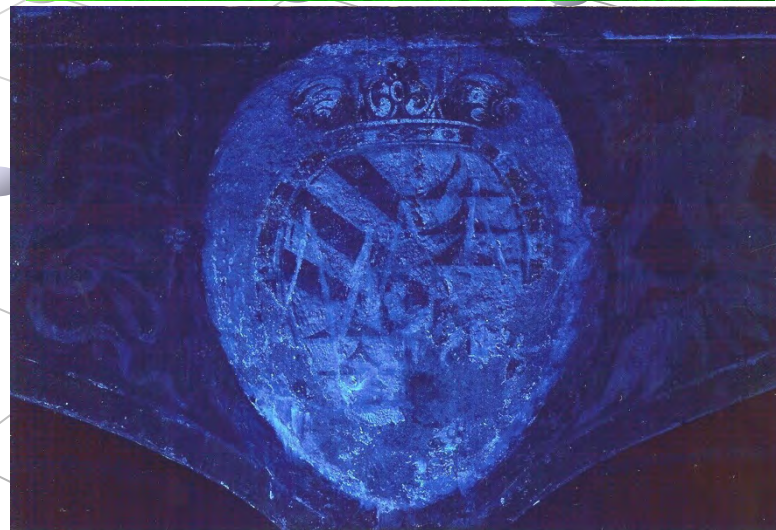
Detail of glossy surface caused by acrylic varnish
Images in UV Light

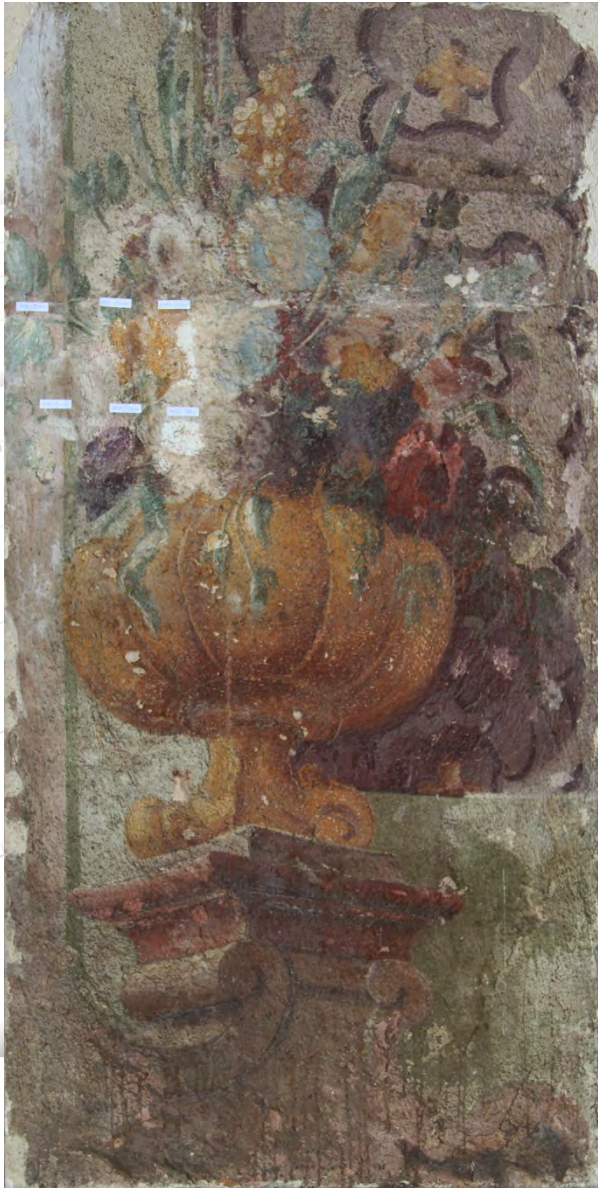
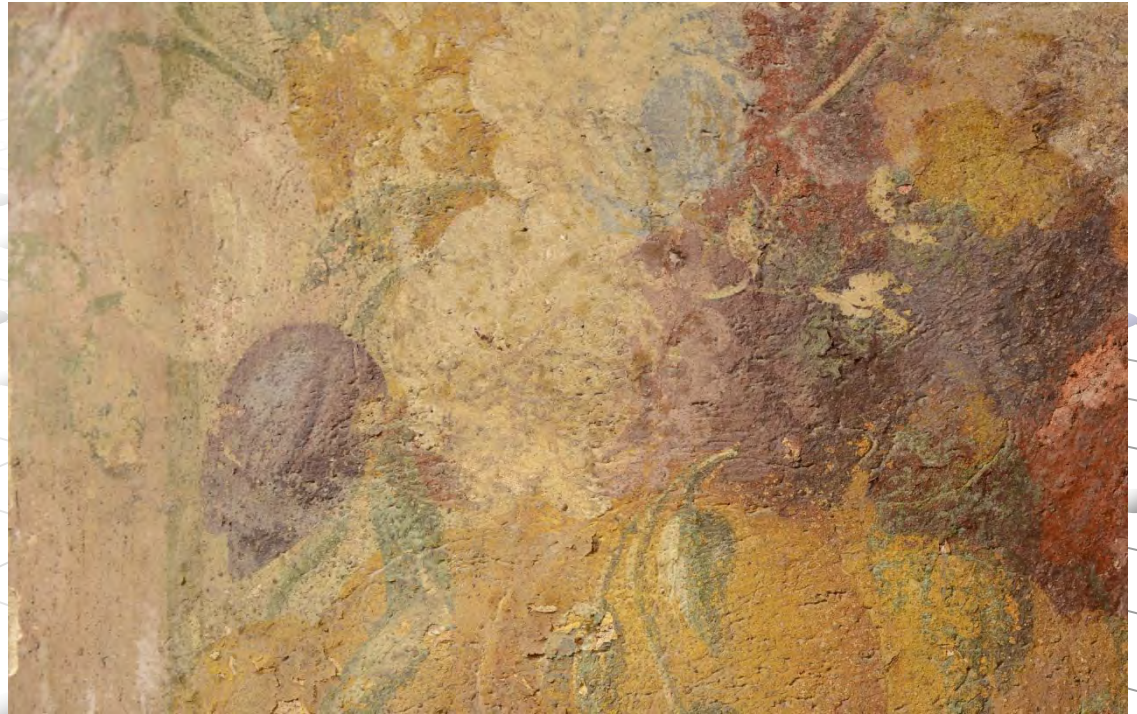
Transfer panel used for experiments

- The designated interior paintings were fixed with Disapol (locally produced acrylic emulsion)
- Subsequently covered by three layers of gauze (light fabric with the weave of 10 x 10 threads per cm²).
- A mixture of Lovosa (kind of CMC) and Disapol in the ratio of about 10:1 was used as glue

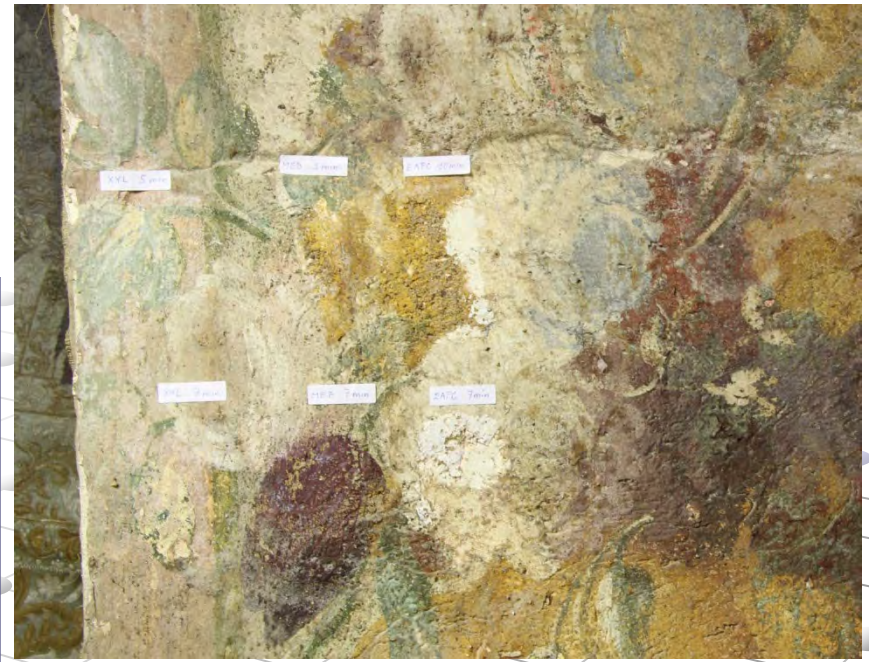
Detail of the application of XYL for a period of 5 minutes. UV light reveals that a thick layer of glue has been removed from ca 95% of the test surface. Color layer locally came off, but due to the fact that the color layer had not been properly fixed prior to the application of the glue. This I fault is not considered to be related to the used XYL microemulsions.

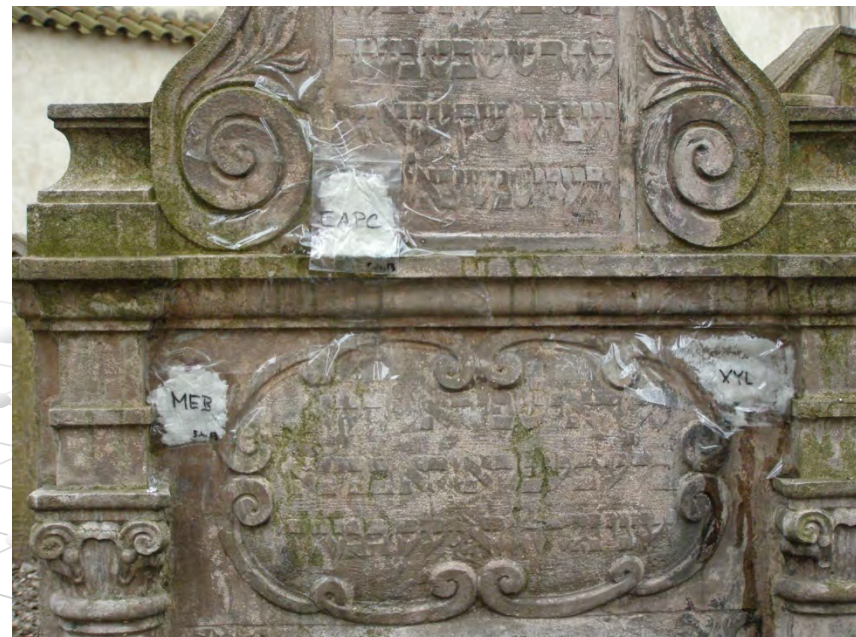
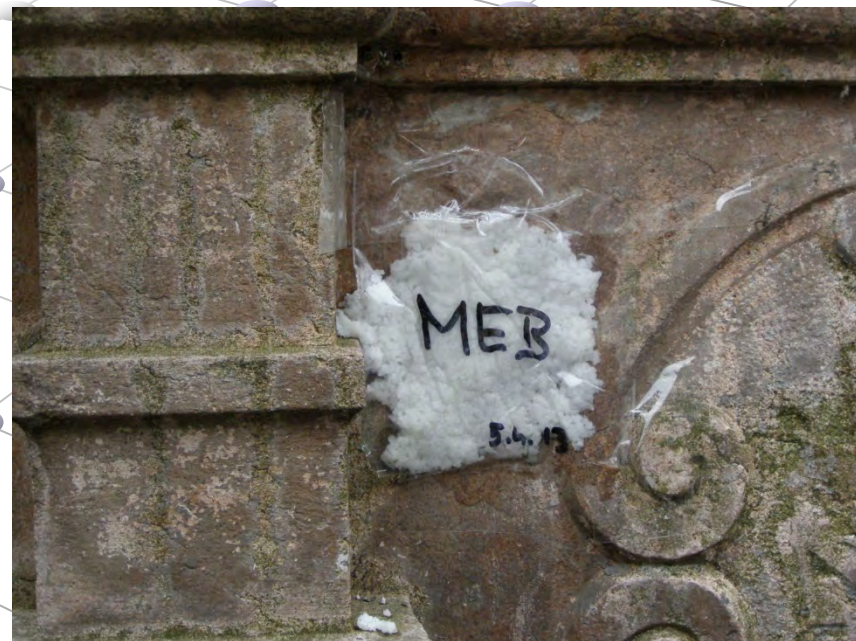
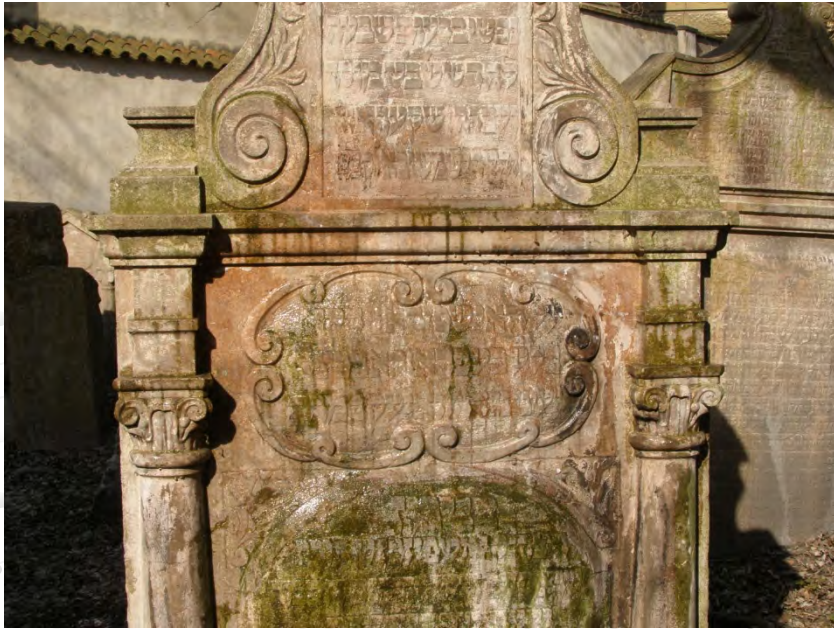
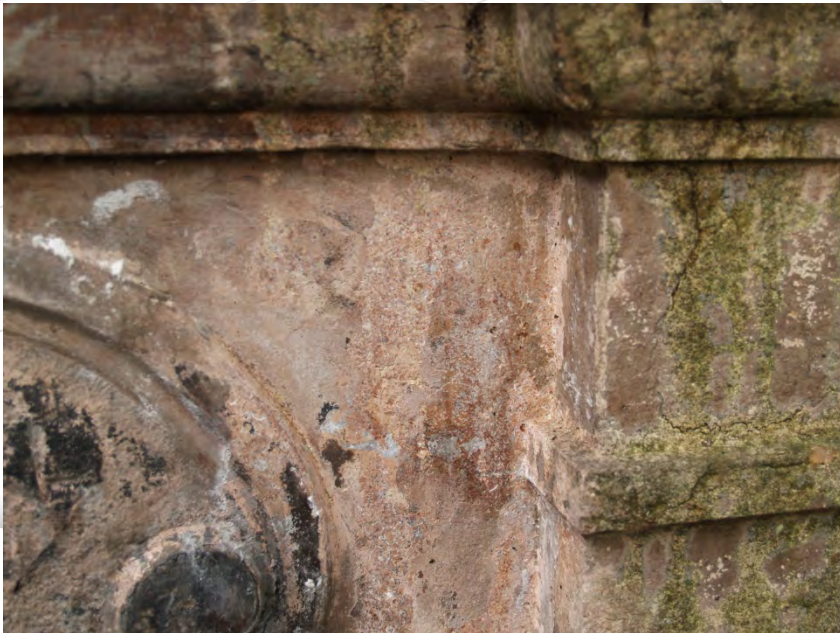
- Pulp (Arbocel) saturated with micro-emulsion applied directly on the stone surface and upon Japanese paper covering of stone surface
- Covered by plastic sheet to reduce evaporation of solvents (in both cases)
- Weather condition: cold rainy day and sunny warm day

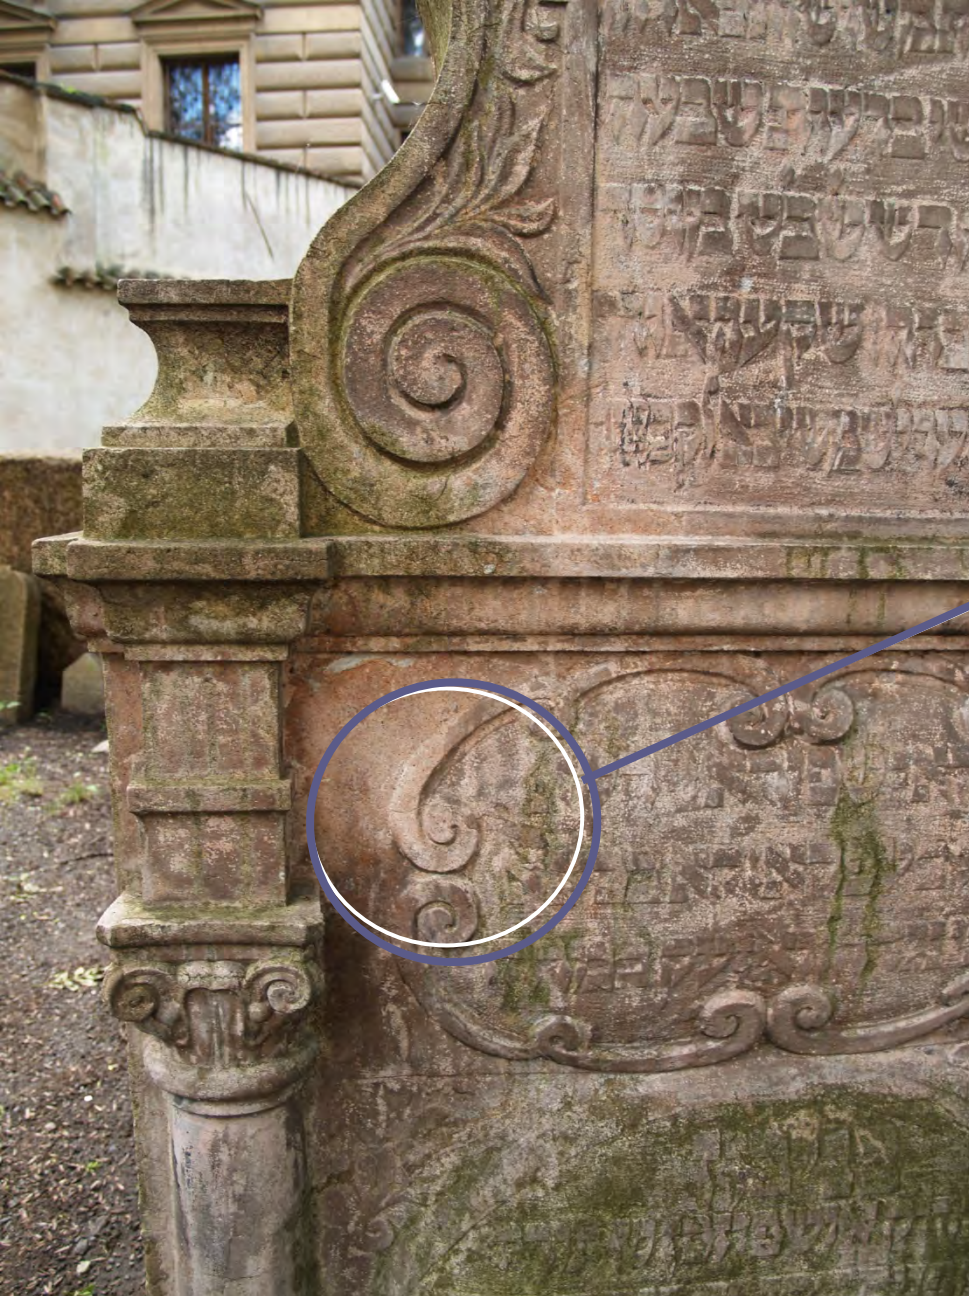
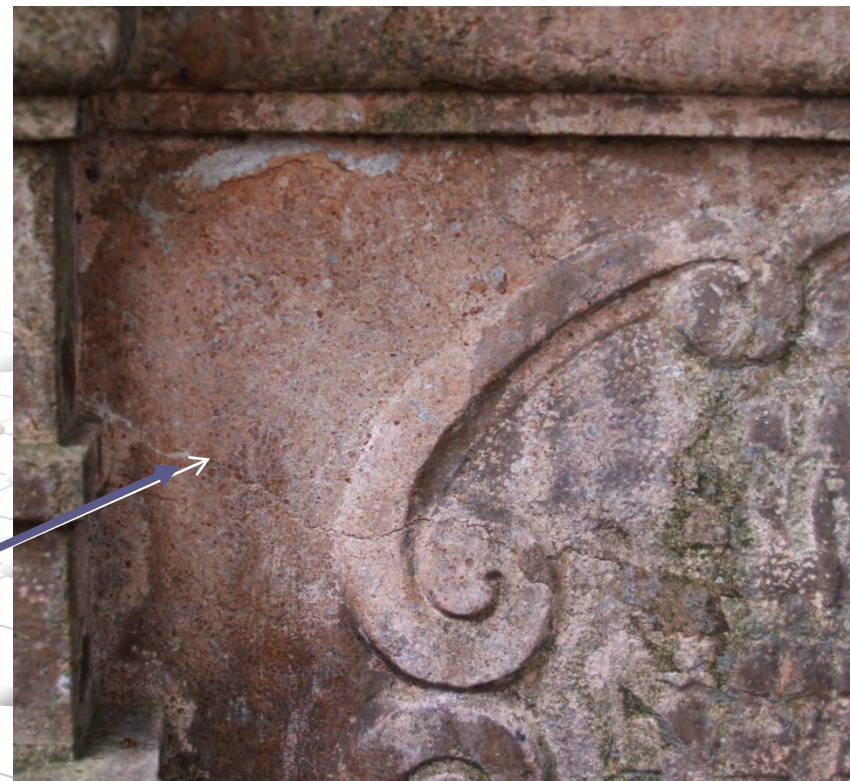
- Surface was cleaned by excess of water and brushed after removal of compress

- Cleaning process was successful for all three types of micro emulsions with favourable visual effect
- Possible alteration of stone surface is still under inspection

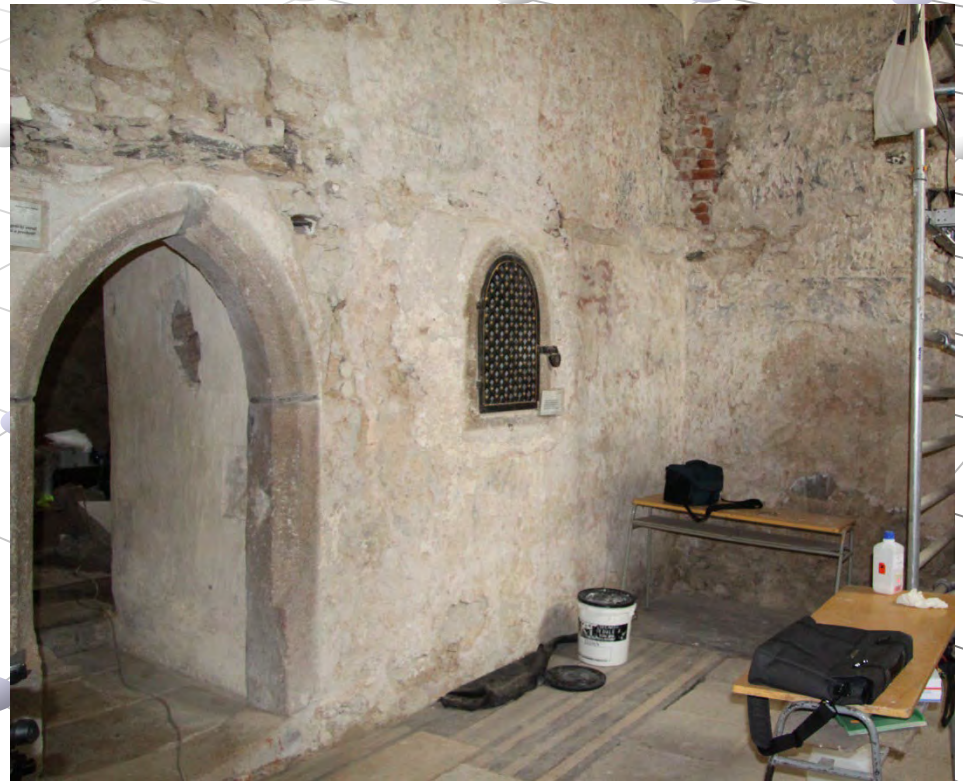
Designated testing area marked with white square,
Way of application: by brushing

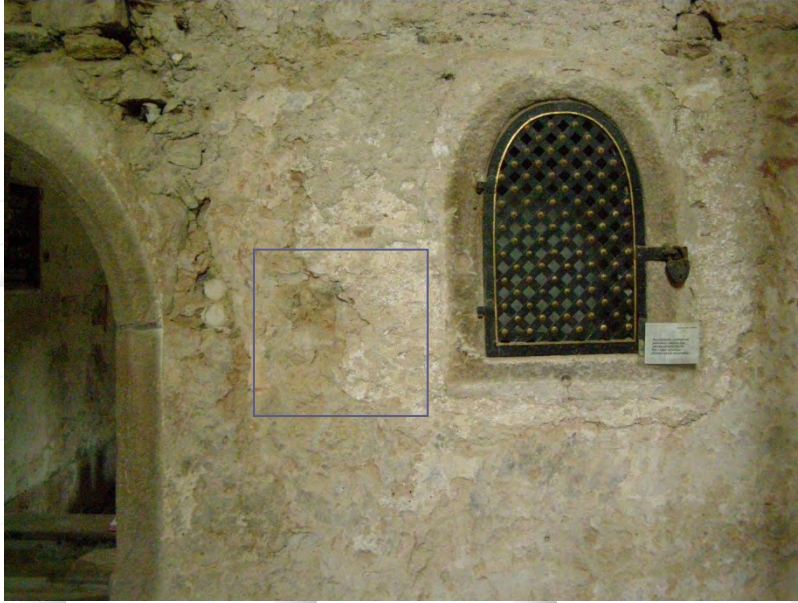
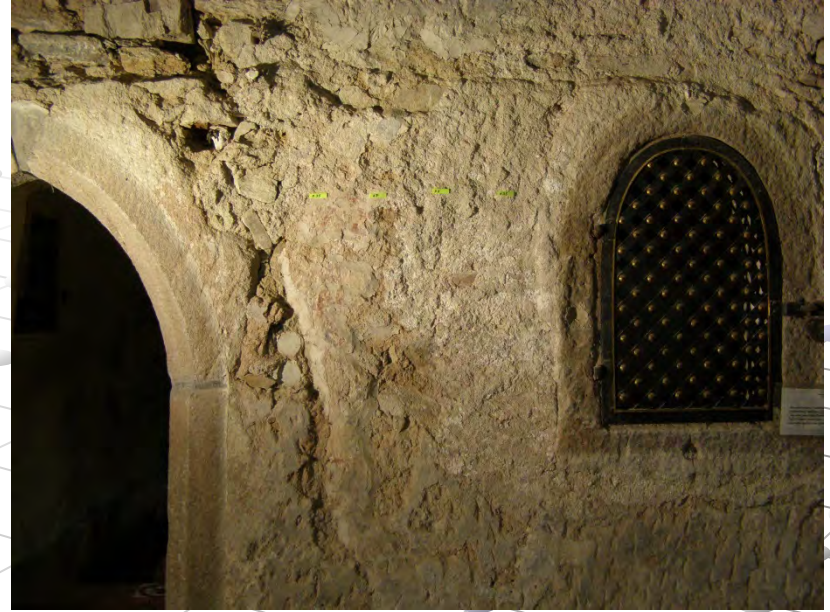
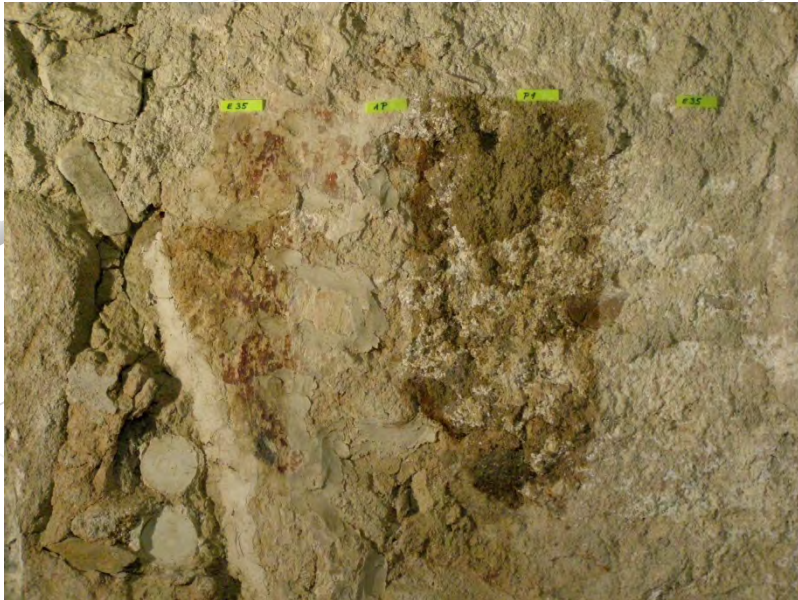
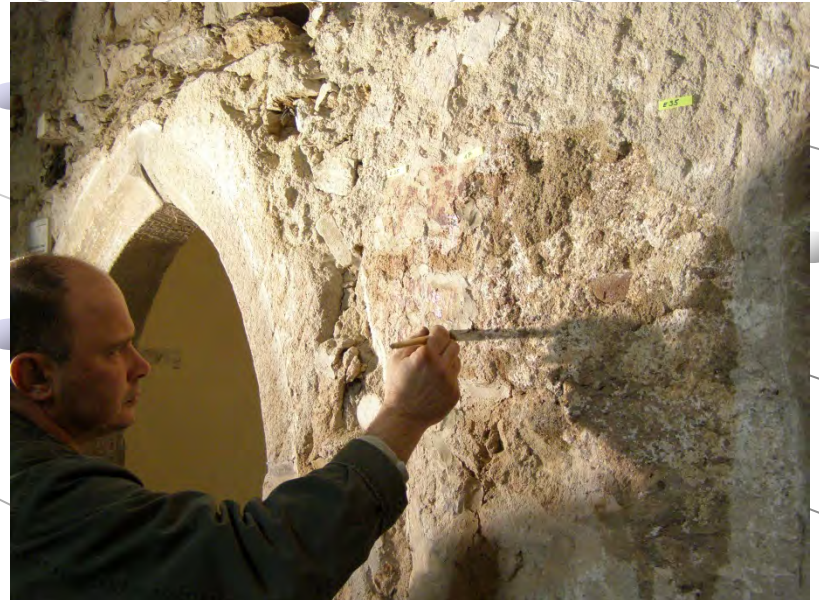
Consolidation of paint layer (left image and two left stripes)
and lime mortar underlayer (two right stripes)

- White haze identified both after application of 1P (more) and E35 (less)
- No other nanosuspension tested so far
- Murals must be slightly washed after treatment to prevent the creation of white haze
- Re-washing endanger unstabilized secco layer, traces of released pigment identified
- Facing problems in identification of the depth of penetration

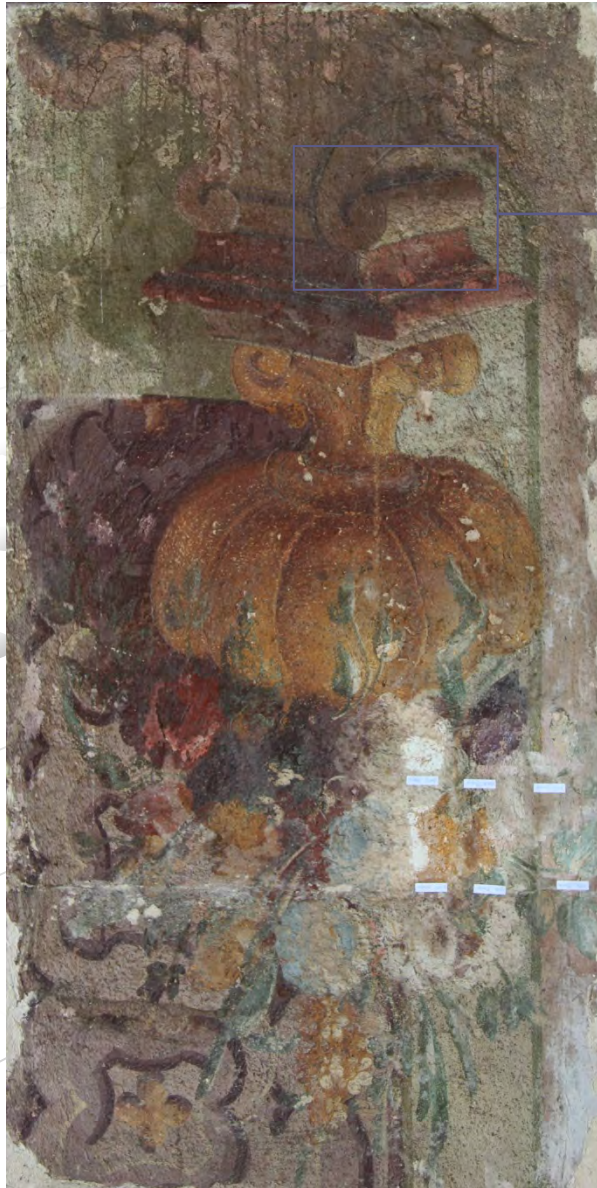
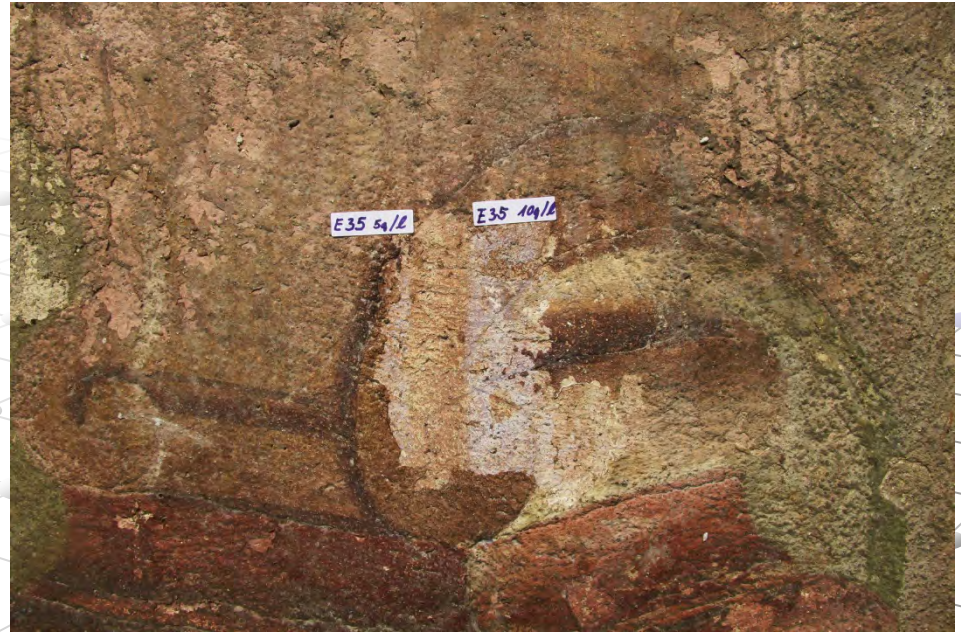
Transfer panel used for consolidation test

Application proceeded
on the fresco layer after
cleaning

Application by brushing
1 varnish – left
2 varnishes –right

Difficult to penetrate

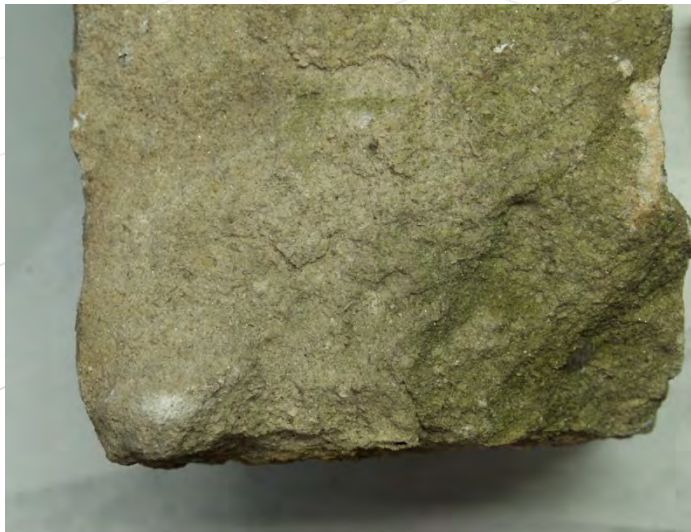
Evaluation of depth of penetration: Coloring of cross section by phenolphthalein in ethanol

Depth of penetration: very little penetration of nanosuspensions observed in both cases

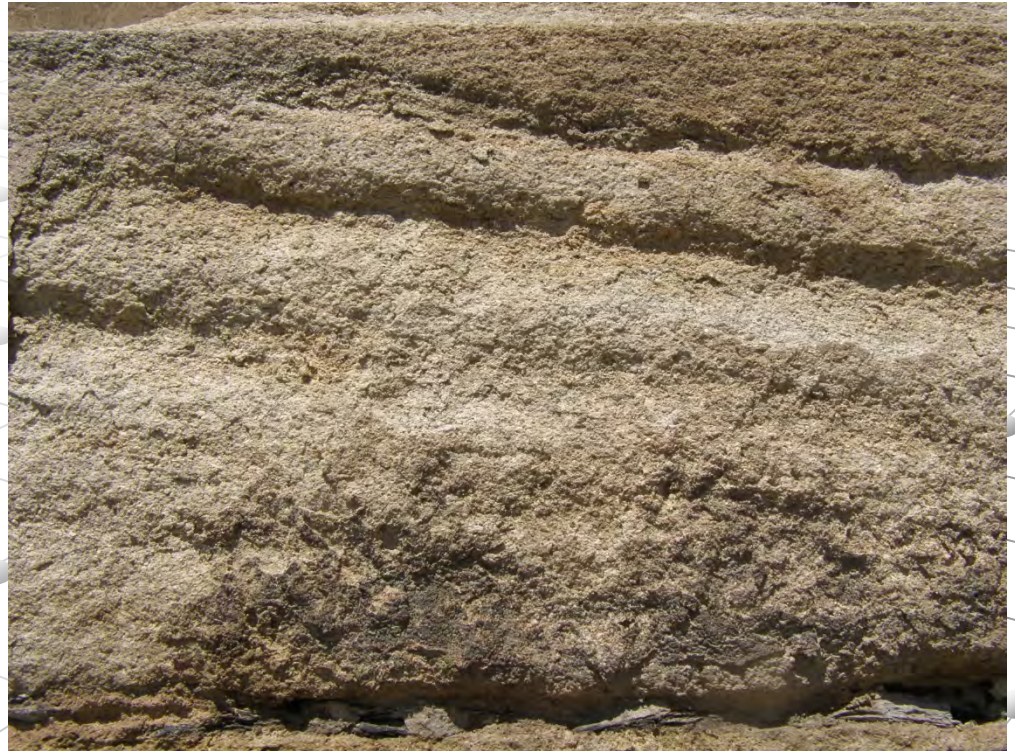
Test 1: homogeneous stone ashlar

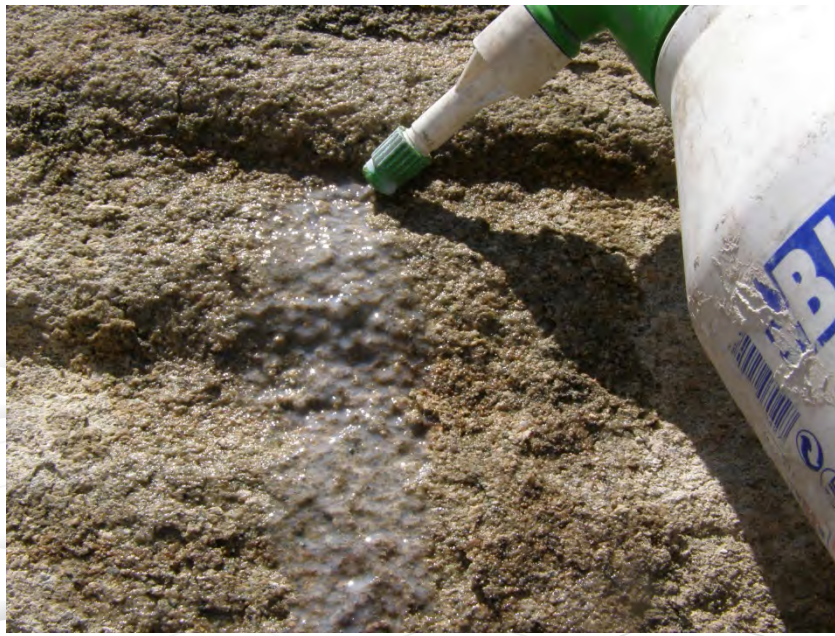
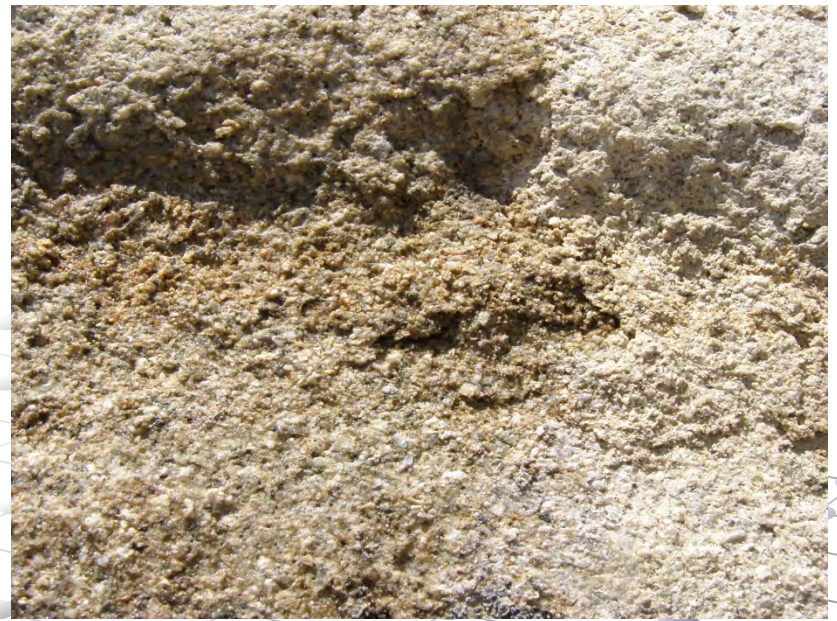
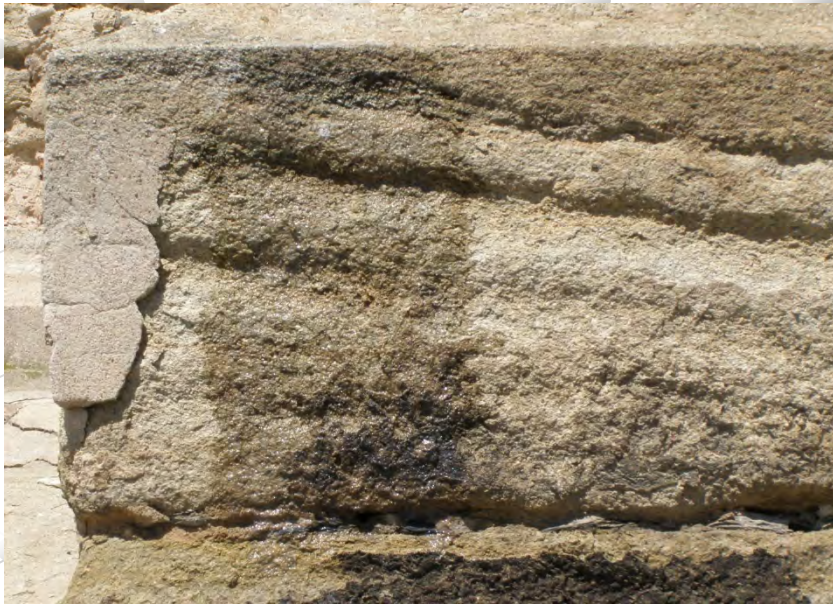
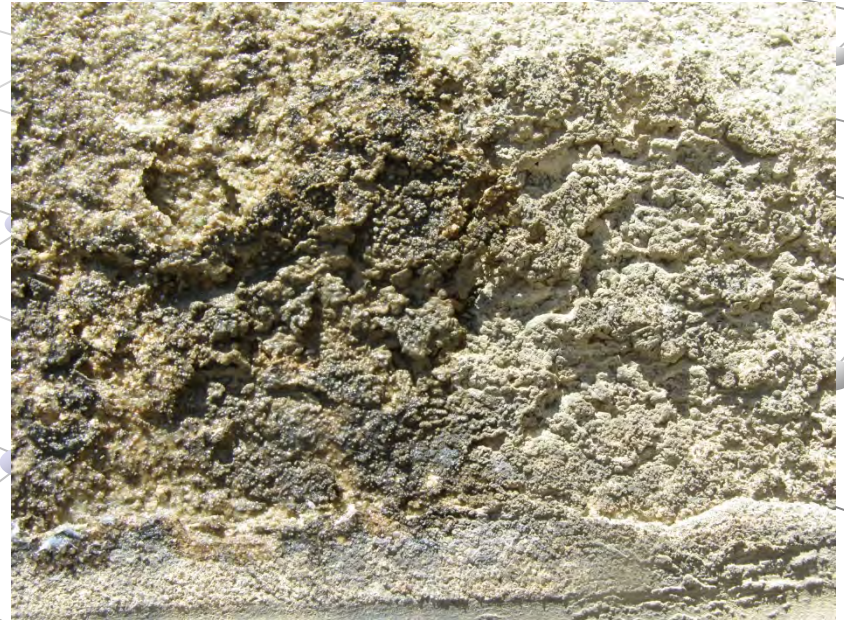
Test 2 : stone ashlar with weathered sedimentary layers

Way of application in all cases: continuous pouring till the substrate accepts consolidant

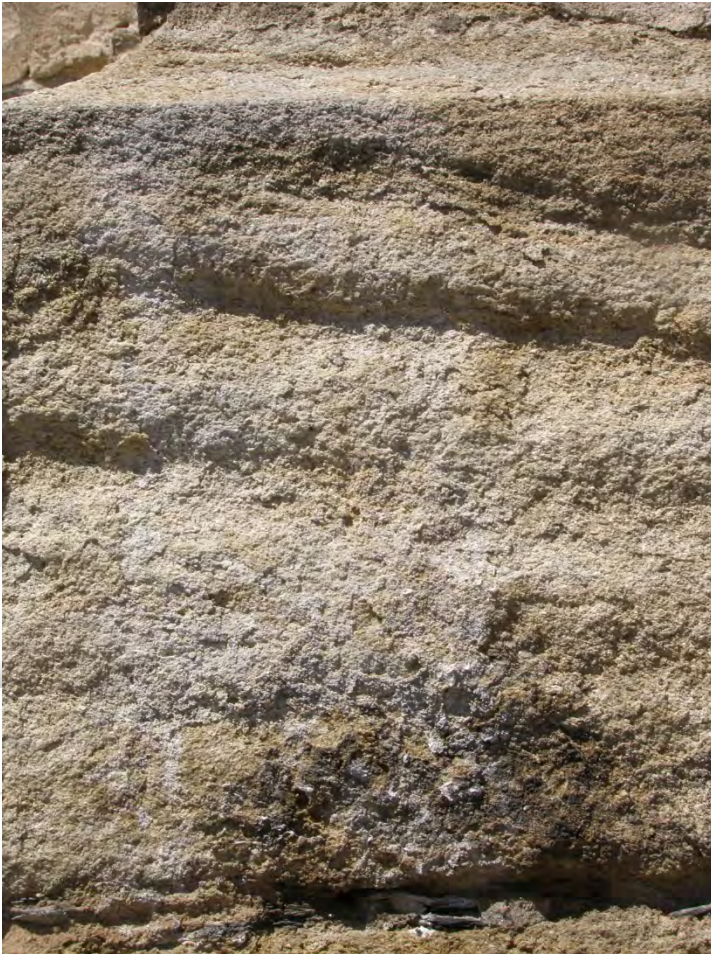
P1

Testing areas after drying
