# WP 3 – Applicability assessment WP 6 – Long Term Behavior

## I. CONSOLIDATION

Gema Art Group, a. s.

VENICE, 27 November 2014

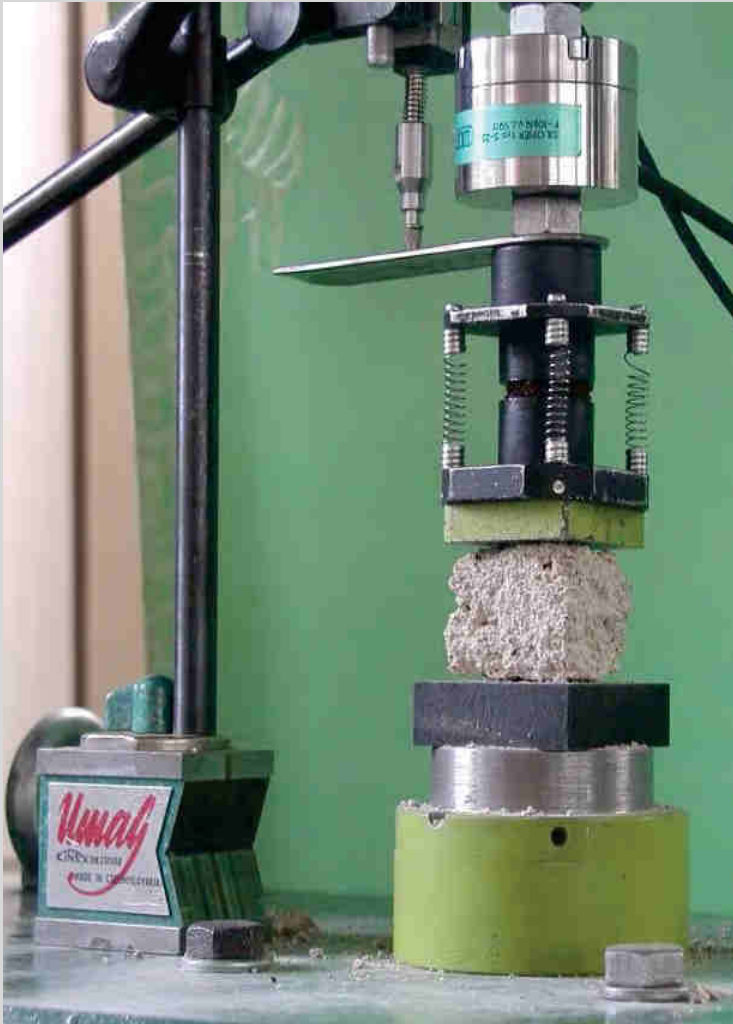
# Compressive strength

Sample	depth a [mm]	width b [mm]	height h [mm]	Maximum power F [N]	Compressive strength $R_e$ [MPa]	Equivalent average cubic strength $R_c$ [MPa]	Increase of strength cons./ref.
K_P1_t1*	28.6	36.5	40.2	1238.50	0.84	0,428	68 % rel.
K_P1_t2	22.6	37.1	42.2	1317.90	0.84		
K_MBN_t1	28.6	36.0	40.4	939.99	0.65	0,428	68 % rel.
K_MBN_t2	27.0	29.0	33.8	495.07	0.51		
K_MBN_t3	30.9	34.3	39.3	702.58	0.52		
K_E35_t1	32.8	28.8	33.4	288.18	0.30	0,389	53 % rel.
K_E35_t2	34.3	35.2	37.9	669.52	0.50		
K_ref_t1	30.6	40.0	44.2	750.10	0.42	0,255

- **Compressive strength** of treated plasters increased by 50-70 % in comparison with the reference and vary between **0,30 - 0,84 MPa**.  
Strength increase:  $E\ 35 > P1 \geq MBN$
- **Flexural strength** of treated plaster increased by up to 300 % **BUT** the total value of flexural strength vary **only around 0,20 MPa**
- **Peeling test** showed good consistency in plaster treated by ZFB , P1 and MBN. Worse results, but still positive reviews, are found if the plaster is treated by E 35
- **Open porosity** of the treated plaster is lower by **8 to 11 % rel.**
- Results of **water absorption** show that the **plaster retains the ability to absorb water after treatment**. Measured rate reduction vary between **4-29 %**.
- Results of **drilling resistance** confirmed the slight consolidation effect already after 5 applications

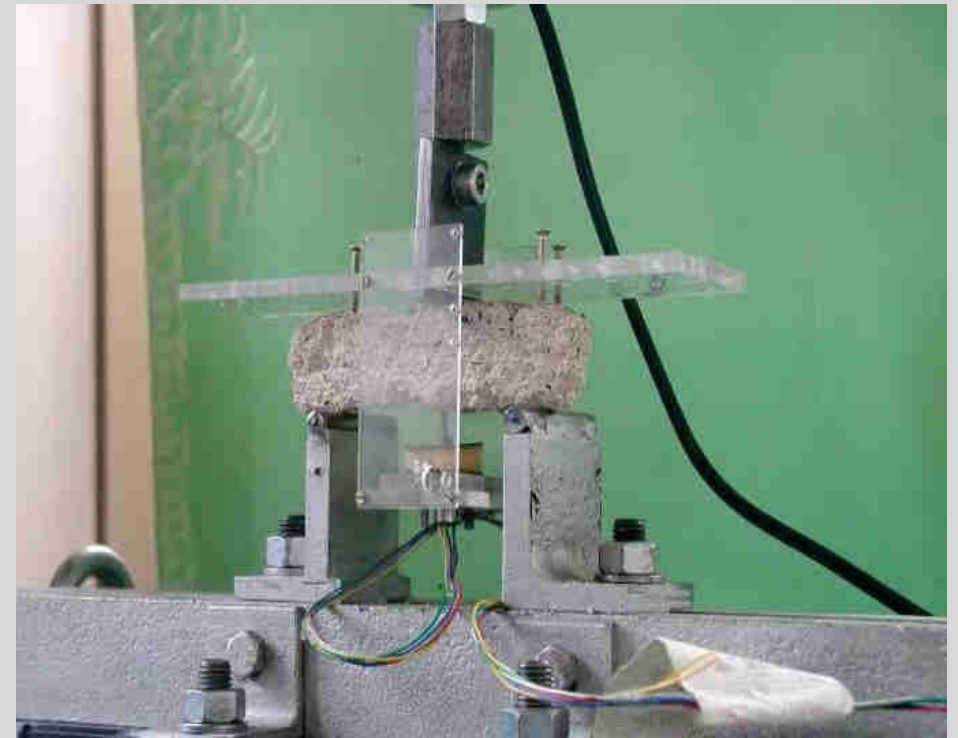
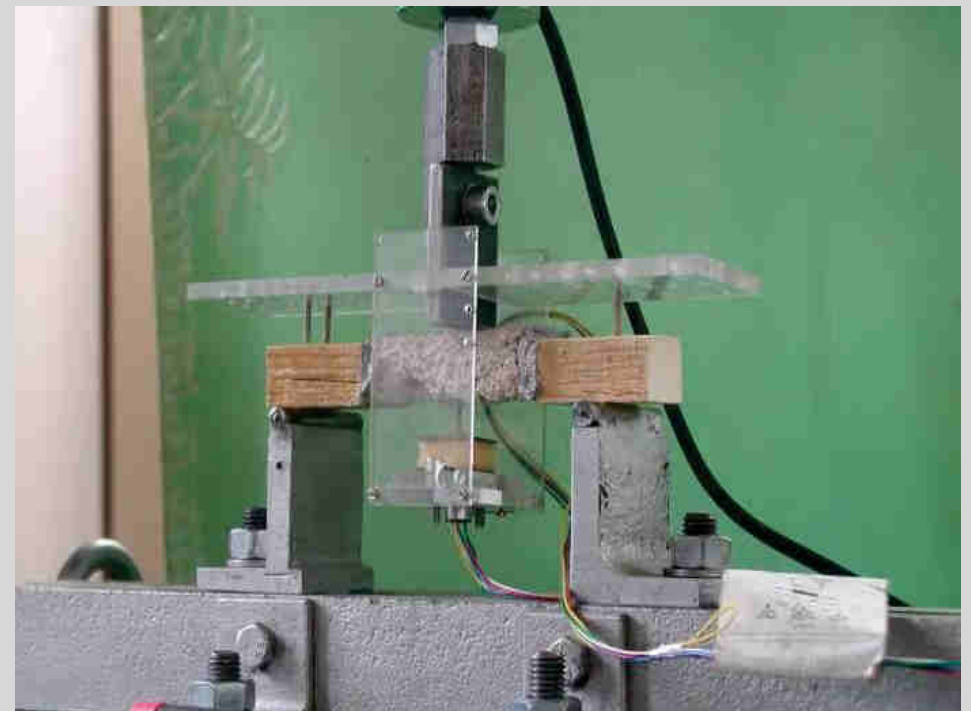
TESTATRON instrument, capacity 100 kN. Loading force measured by force transducer LUKAS with capacity up to 500 N. bending measured with LVDT sensor with susceptibility below 0,00015 mm, range  $\pm 1$  mm. Speed of movement 0,15 mm/min.

Sample with and without prosthesis

Results were calculated according to the formula

$$R_t = \frac{1.5Fl}{bh^2}$$

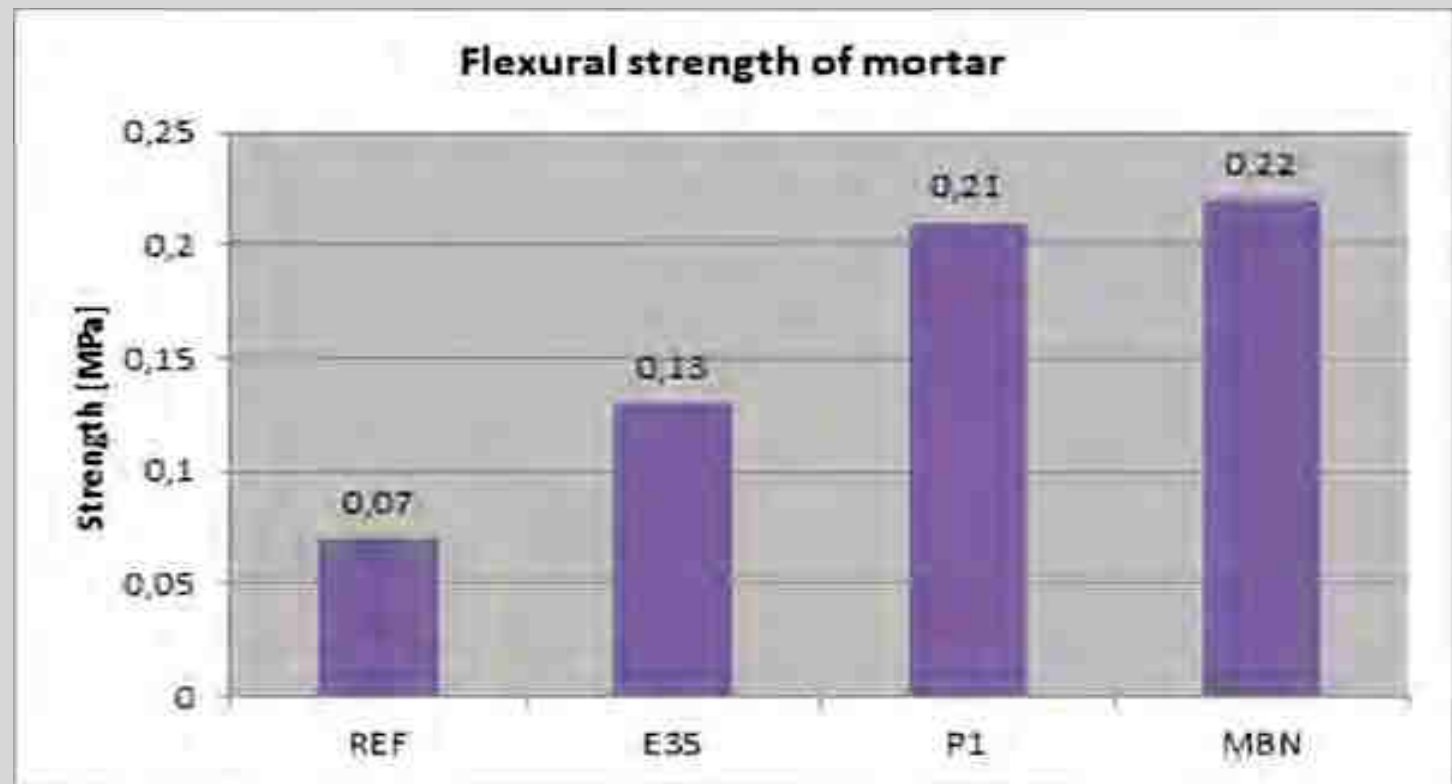
# Flexural strength

Sample	height h [mm]	width b [mm]	Distance b. support s l [mm]	Maximu mstrengt h F [N]	Flexural strength R <sub>t</sub> [MPa]	increase of strength cons./ref.
K_P1_1	30.0	22.4	80	27.18	0.16	300 % rel.
K_P1_2	31.6	21.6	80	46.53	0.26	
K_MBN_1	22.8	33.2	80	40.41	0.28	
K_MBN_3	20.1	26.6	120	9.80	0.16	314% rel.
K_E35_1	16.3	18.2	120	3.63	0.14	186 % rel.
K_E35_2	14.3	21.0	120	2.82	0.12	
K_ref_1	24.6	20.0	120	4.01	0.06	
K_ref_2	27.5	29.2	120	9.88	0.08

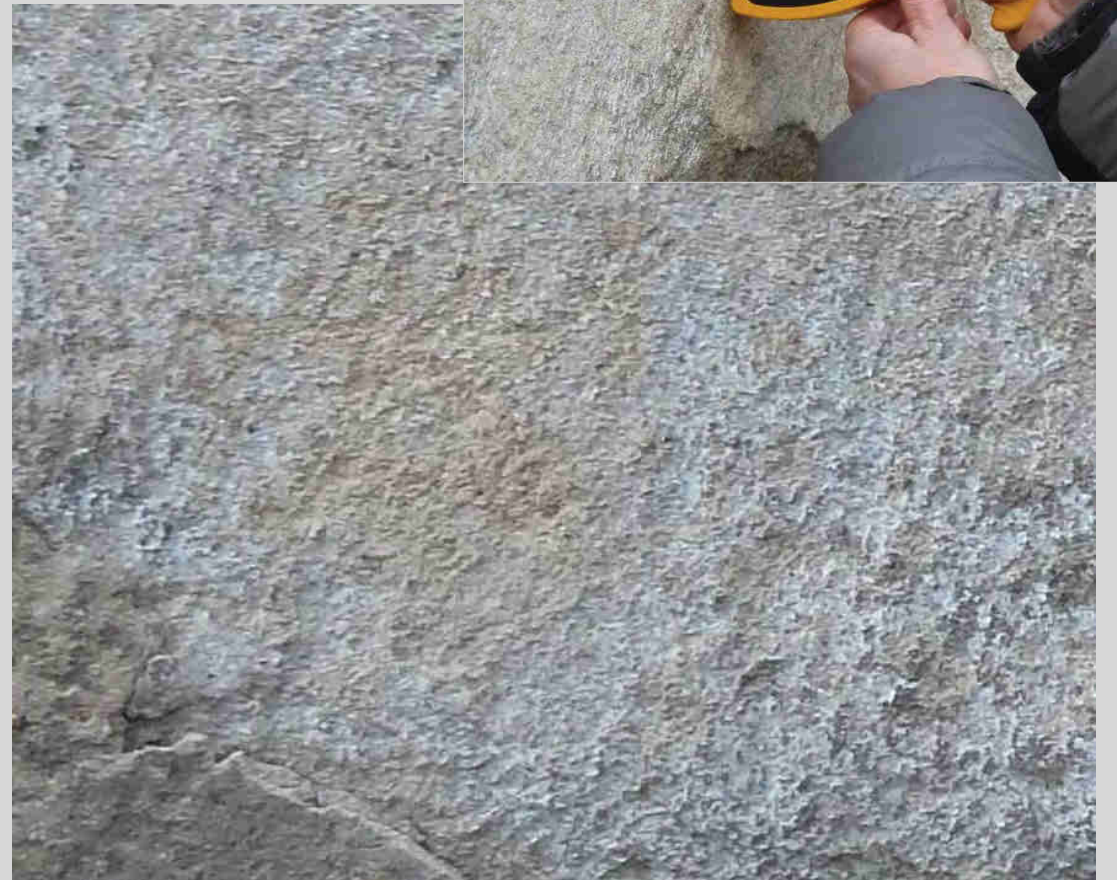
Grinding test confirmed only surface consolidation

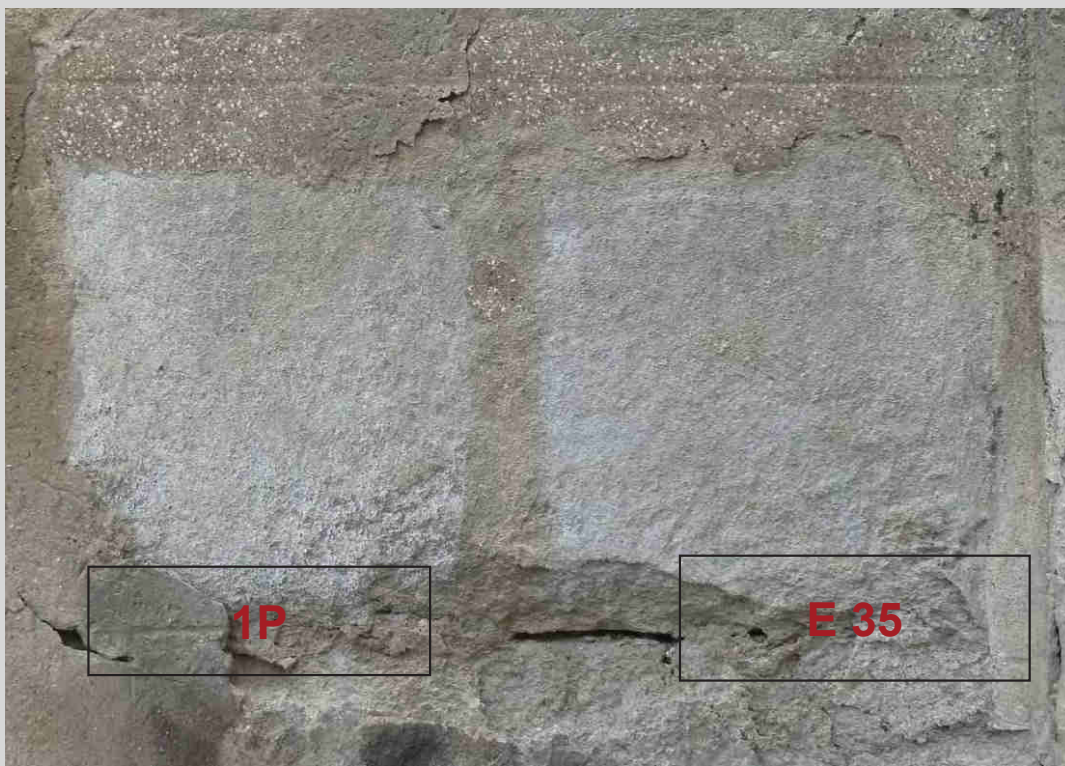
Schmidt hammer test unsuccessful

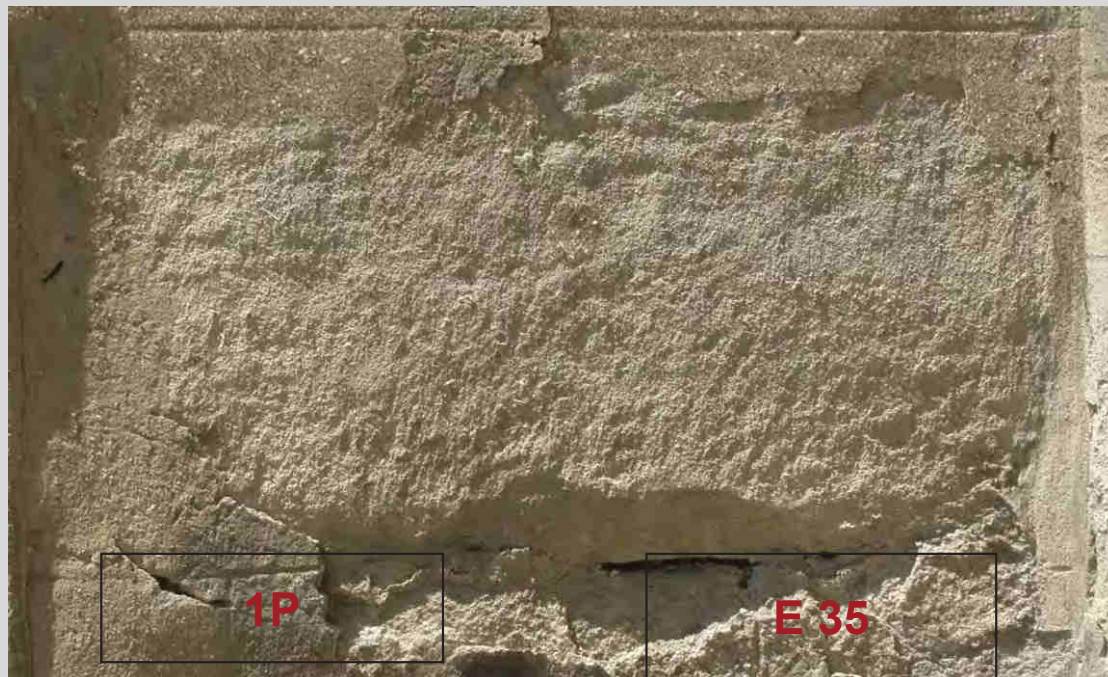
Extent of white haze of both consolidants after 4 applications and complete drying

Photo: December 2013

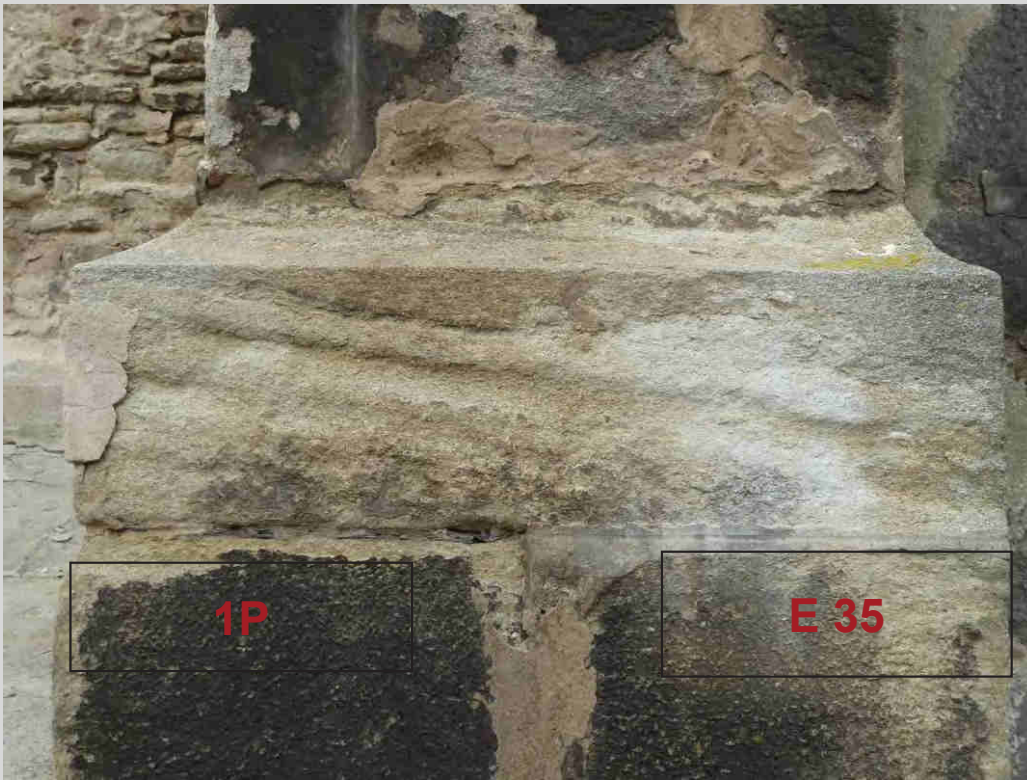
Extent of white haze of both consolidants after 4 applications and complete drying

Photo: December 2013

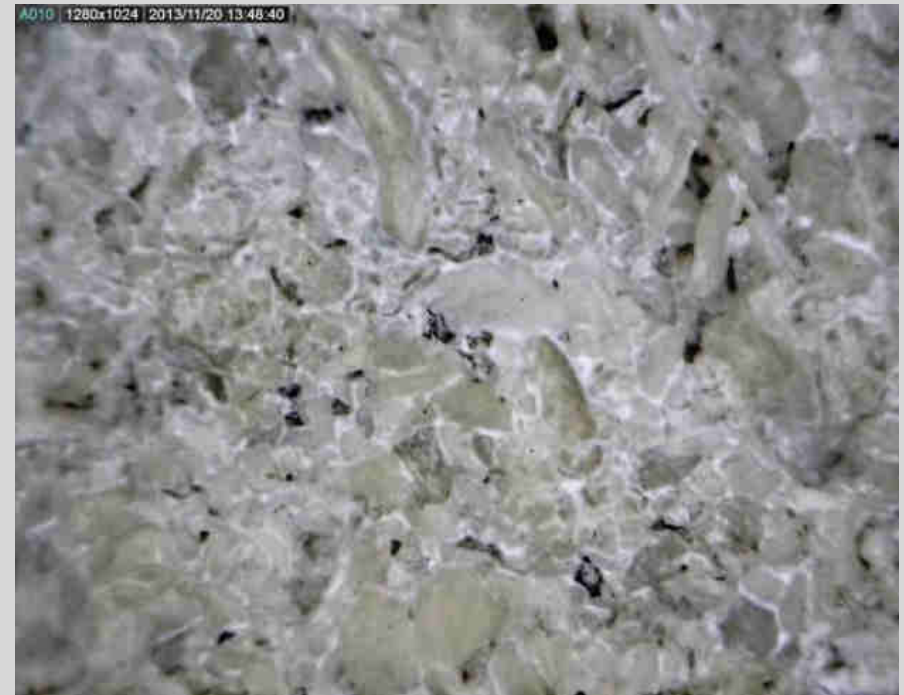
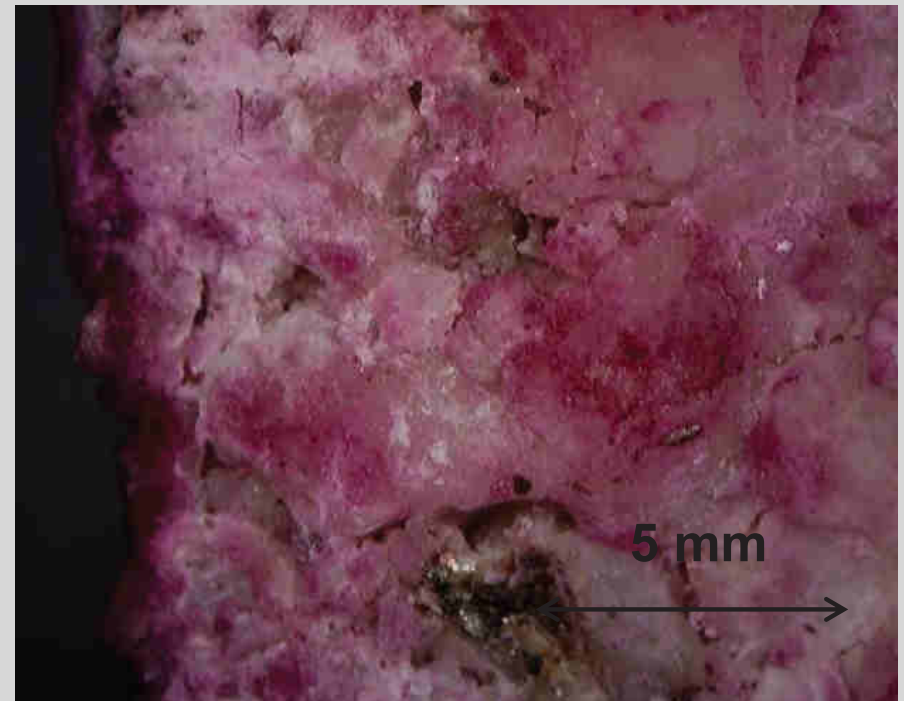
## Limestone Kutná Hora

Surface before treatment ↑

Surface after treatment ↗

Cross-section after treatment →

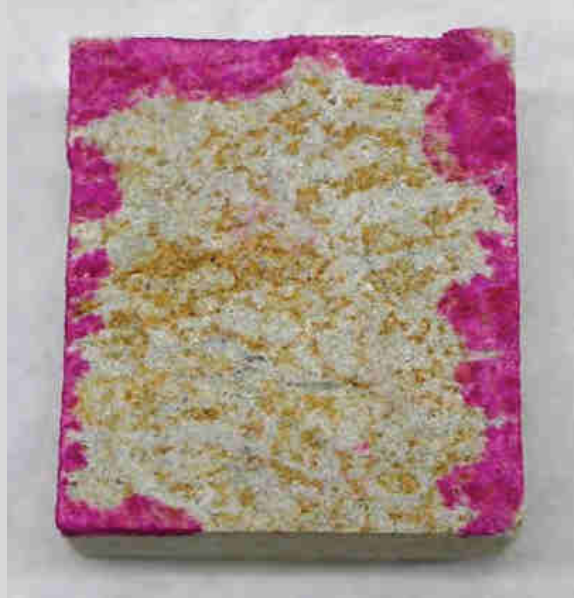
# Depth of penetration in cross-sections staining by phenolphthalein

Nano-suspension	conc. (g/L)	Stone	Depth of penetration [mm]	Surface vailing
E35	10	Kutná Hora	6 to 20	-
		Hořice	Only surface	+
1P	10	Kutná Hora	total cross-section	-
		Hořice	1 to 2	+
MBN	25	Kutná Hora	total cross-section	-
		Hořice	2 to 8	+
MBN-R	10	Kutná Hora	Slight coloration on all cross-section, intensive coloration in depth 3 to 10	-
		Hořice	Only surface	+

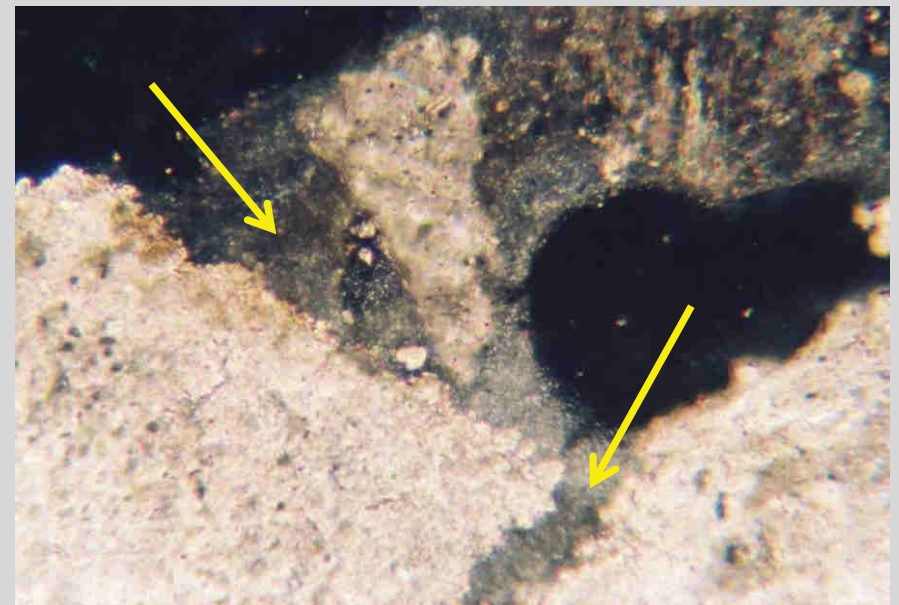
Distribution of „lime“ in porous system

Penetration of nano-suspension  
MBN from surface into narrow  
crack

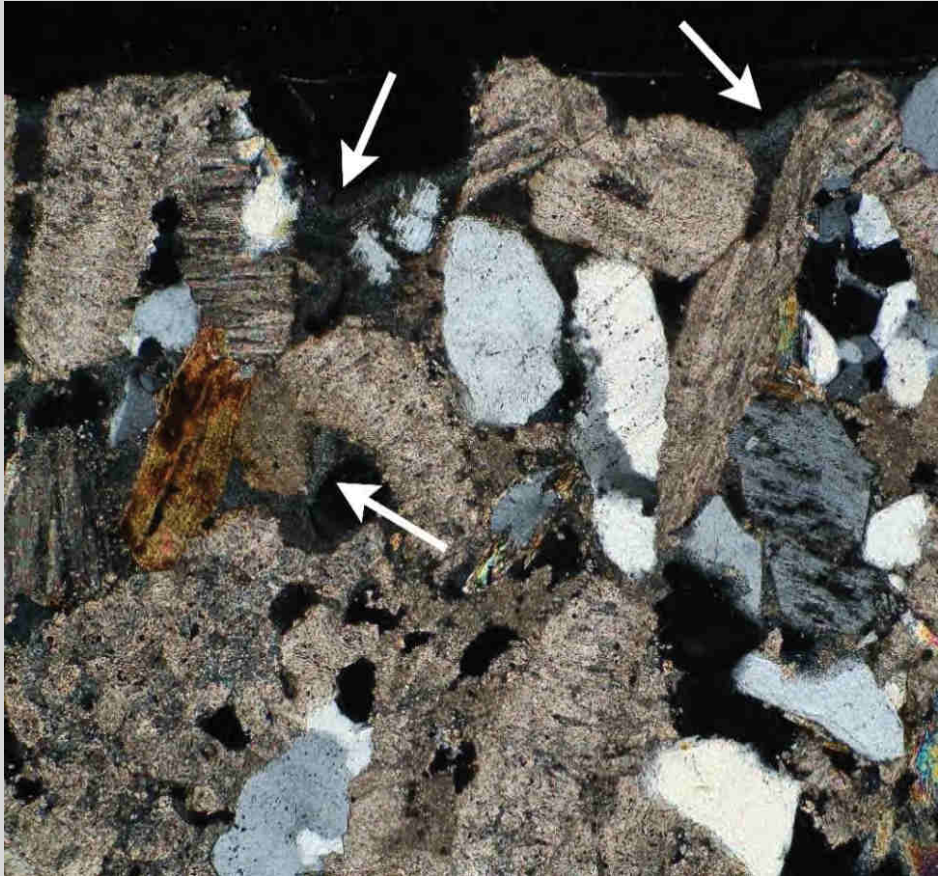
Kutna Hora limestone, MBN, crossed polars, magnification 100x

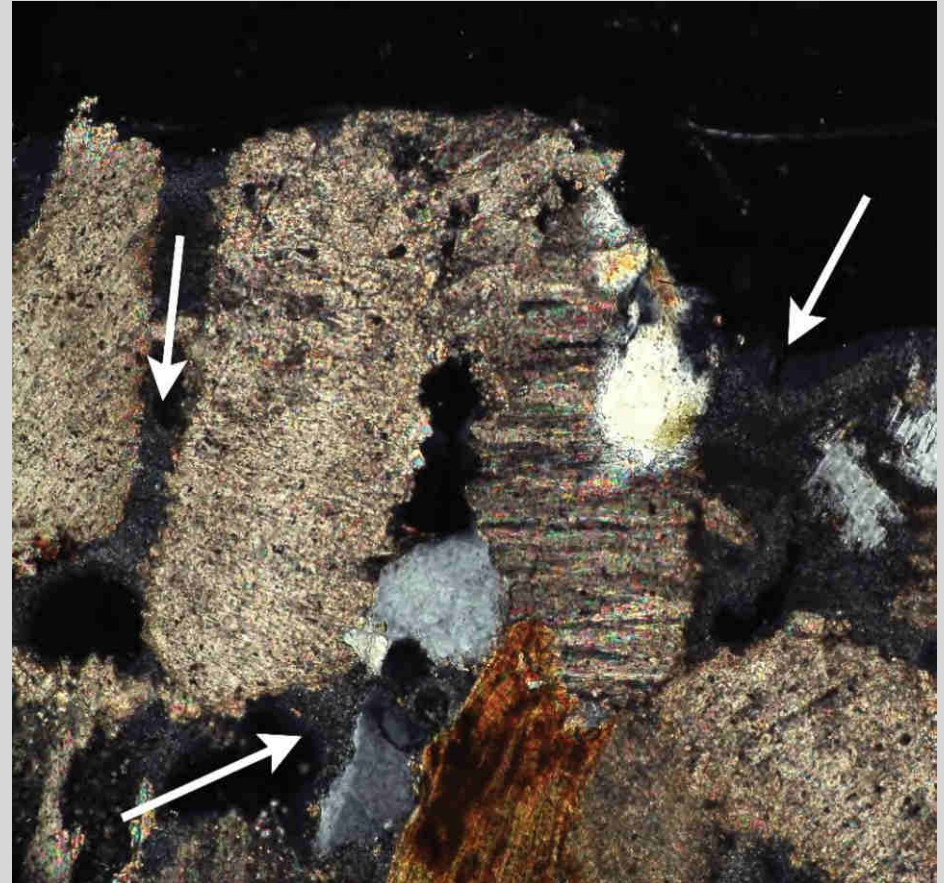
Kutna Hora limestone, MBN, crossed polars, magnification 200x

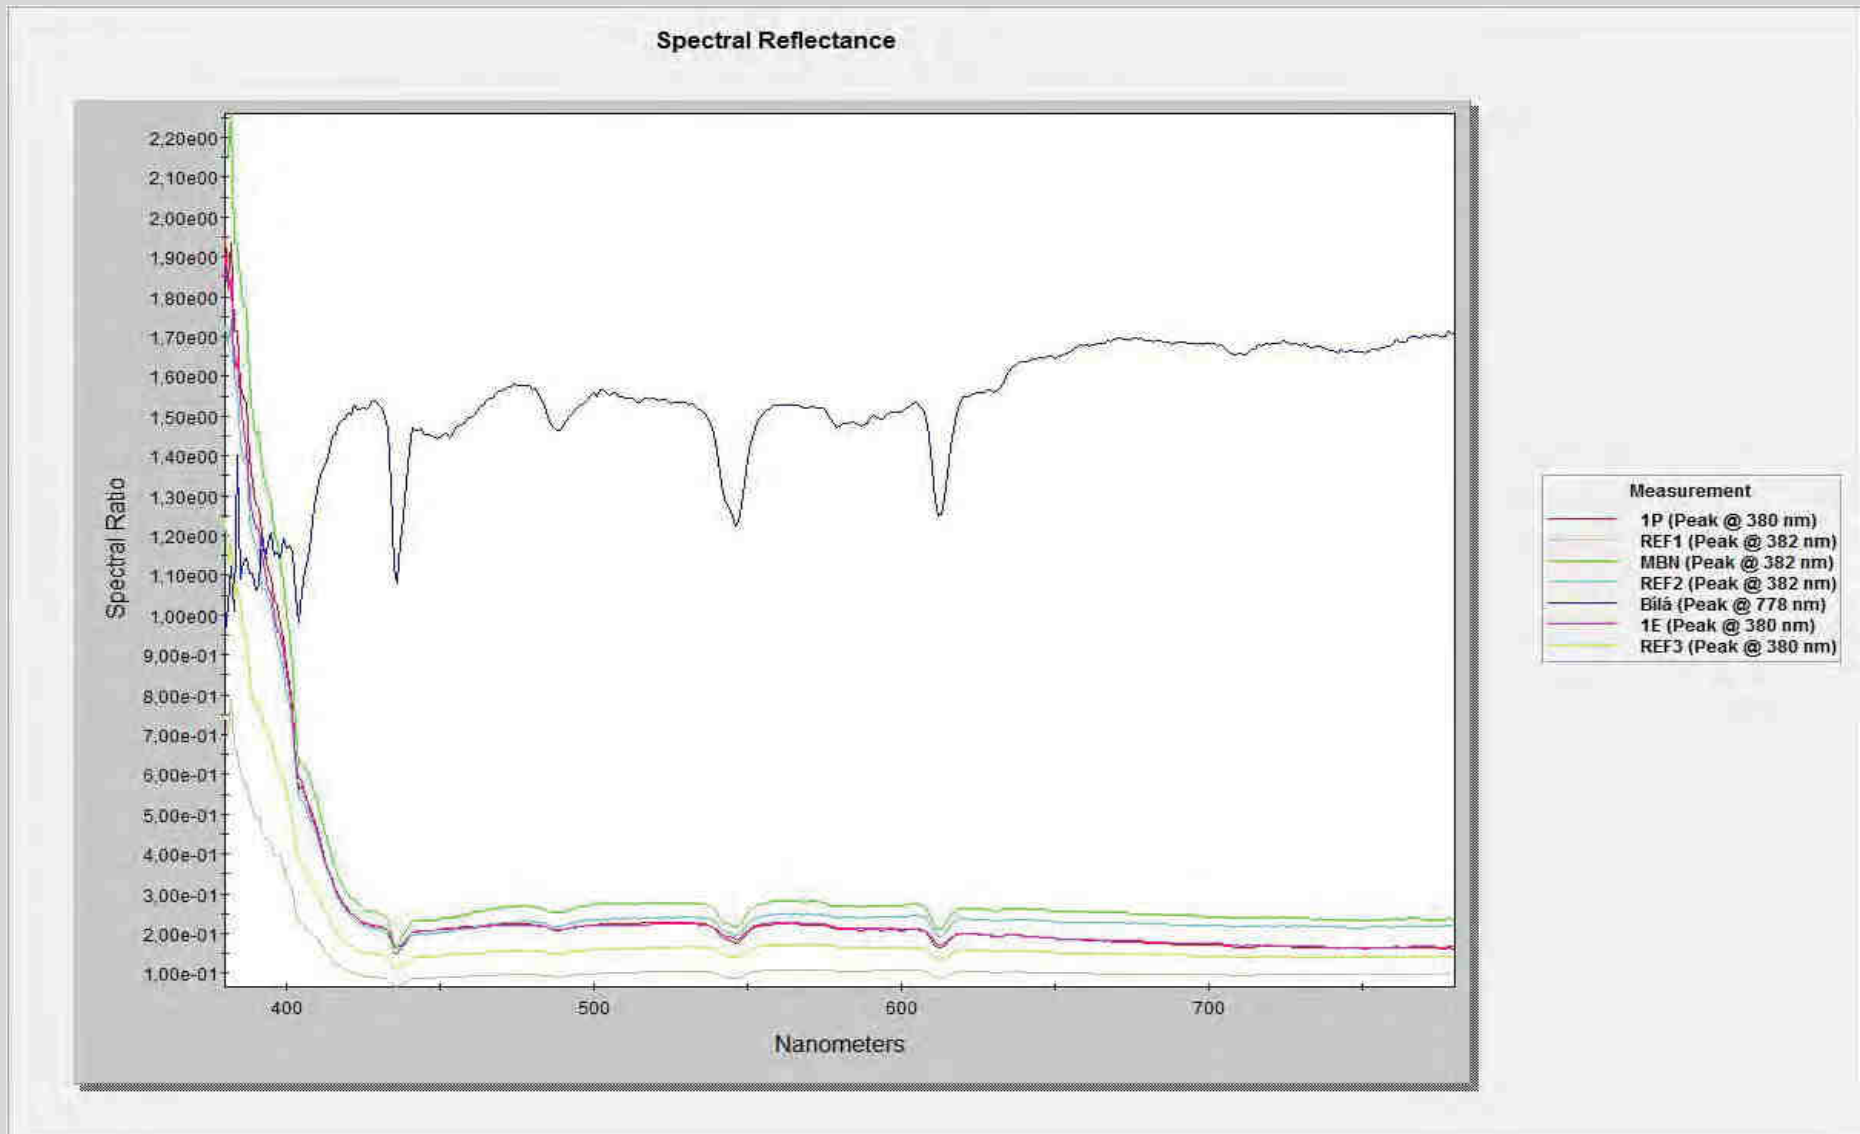
consolidant	wave length interval	average difference
MBN	646-653	0,26
E35	646-653	0,36
1P	646-653	0,88

Results confirmed the restorer's visual results and proved the smallest difference in color in case of treatment by MBN. The highest color shift occurs when using 1P reaching the average number of 0.88, where the slight white haze is visible by naked eye.

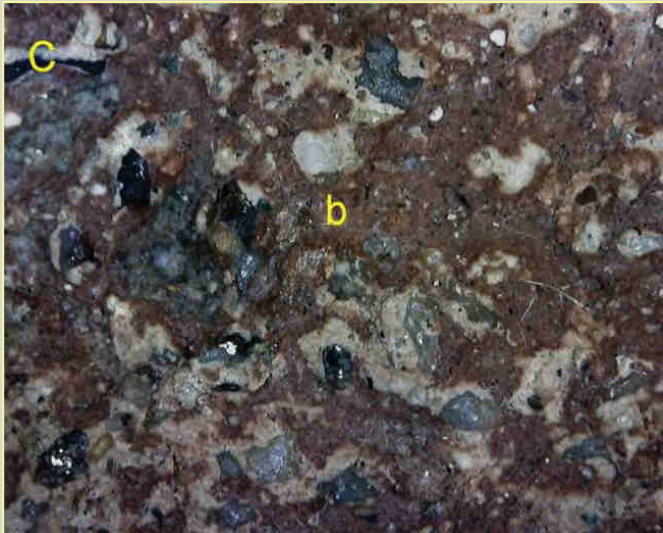
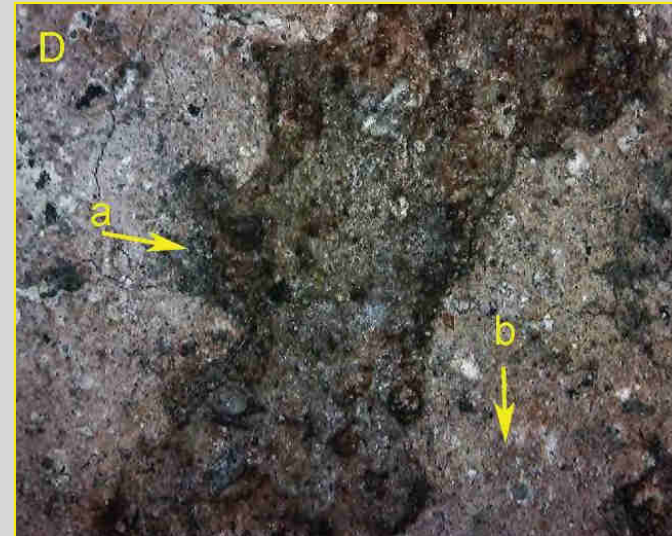
## Surface after dispersion removal by EAPC (C ) and MEB (D)

While in case of using EAPC and MEB there were damages into the paint layer.

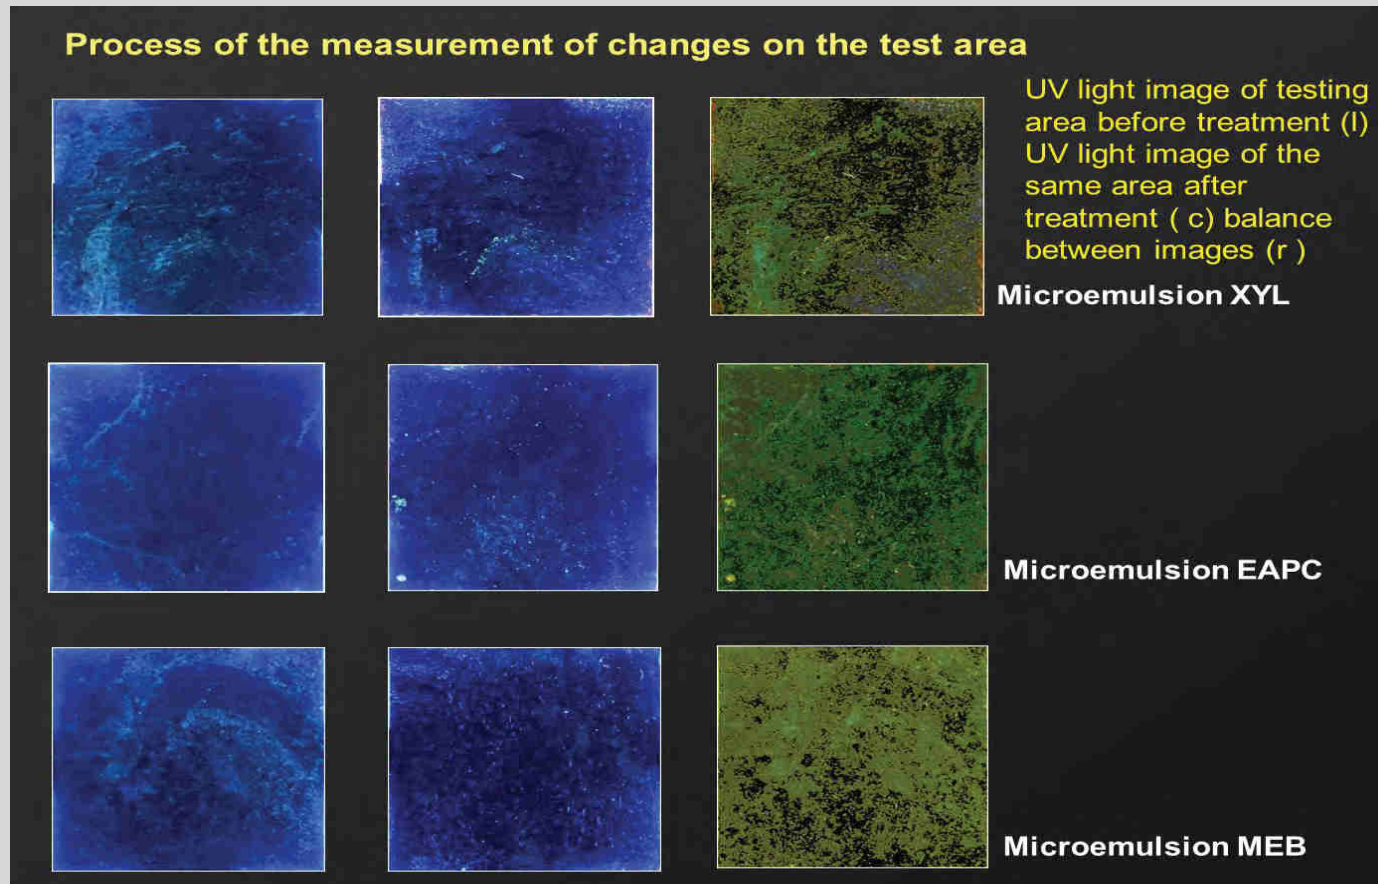
The measurement method of changes between the reference image and the image of area treated by microemulsions consists in overlapping of pictures and subtraction of their differences

Far right images show the balance after marking changes in the area.  
Mathematical calculation declared the removal of acrylic coating in the extent of

**57 % by XYL**

**68 % by MEB**

**63 % by EAPC**

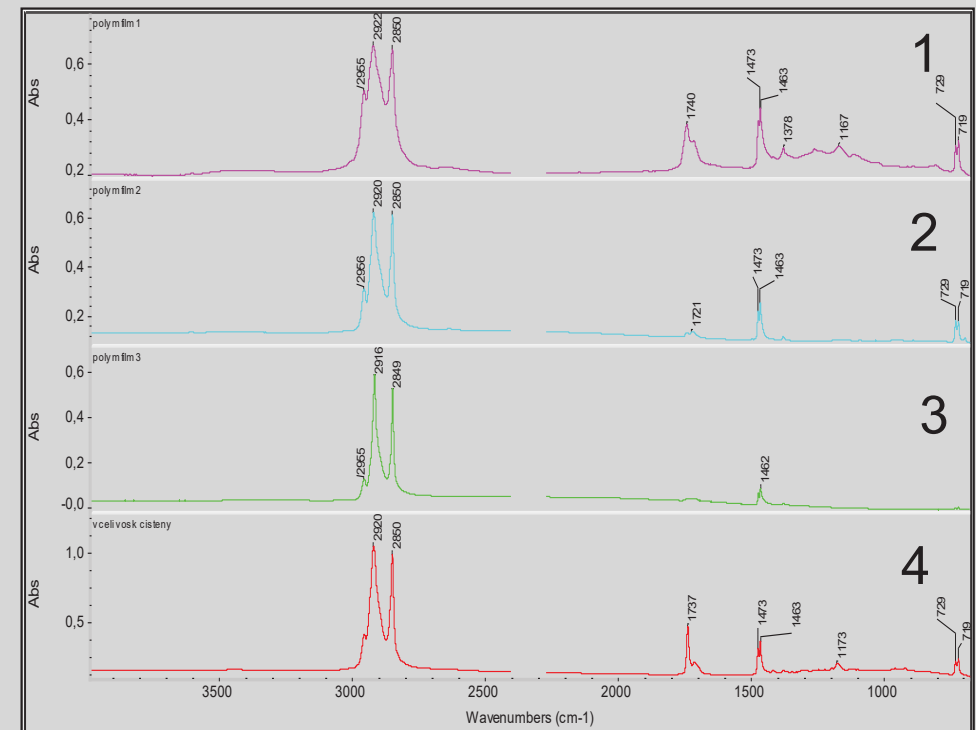
FTIR

1, 2, 3 – surface layers

4 - beeswax
