# THE REHABILITATION OF THE OLD WASTEWATER TREATMENT PLANT PRAGUE, CZECH REPUBLIC INDUSTRIAL HERITAGE AND MANAGEMENT

Šárka Jiroušková  
Petr Justa

# OLD WASTEWATER TREATMENT PLANT

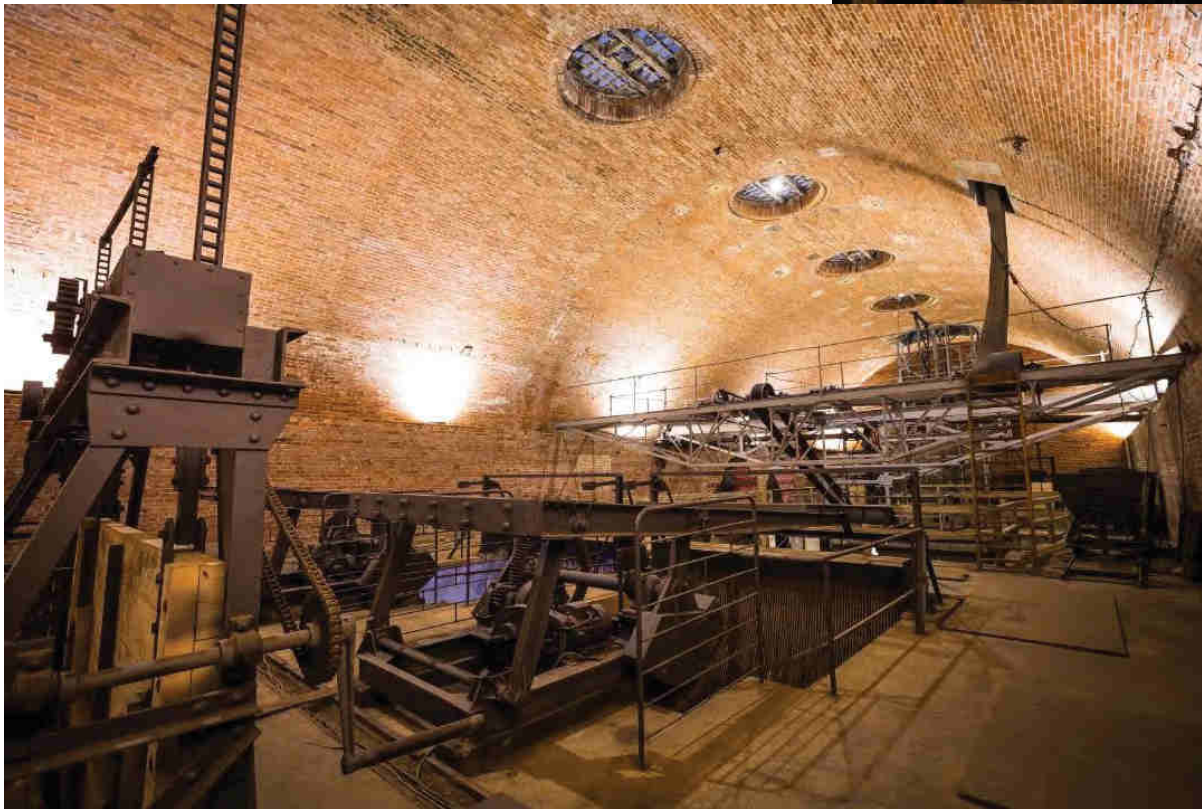
Sand trap

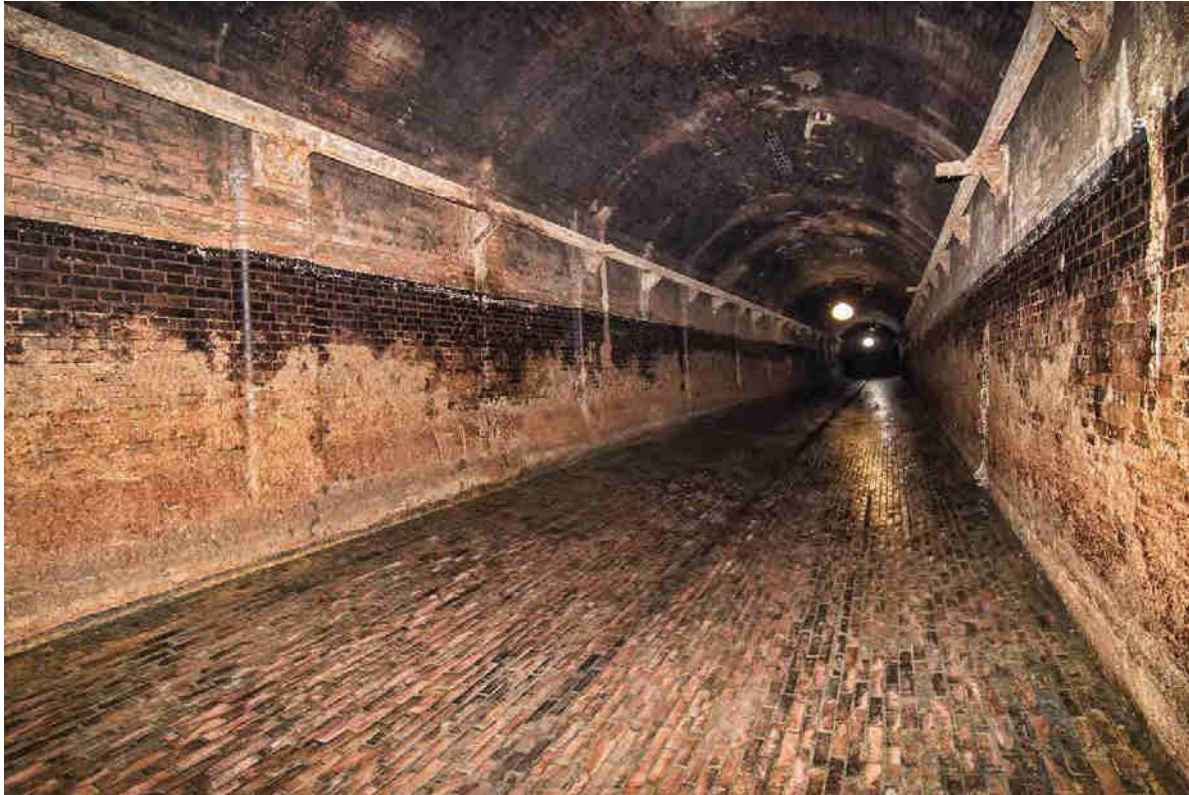
## Settling tanks

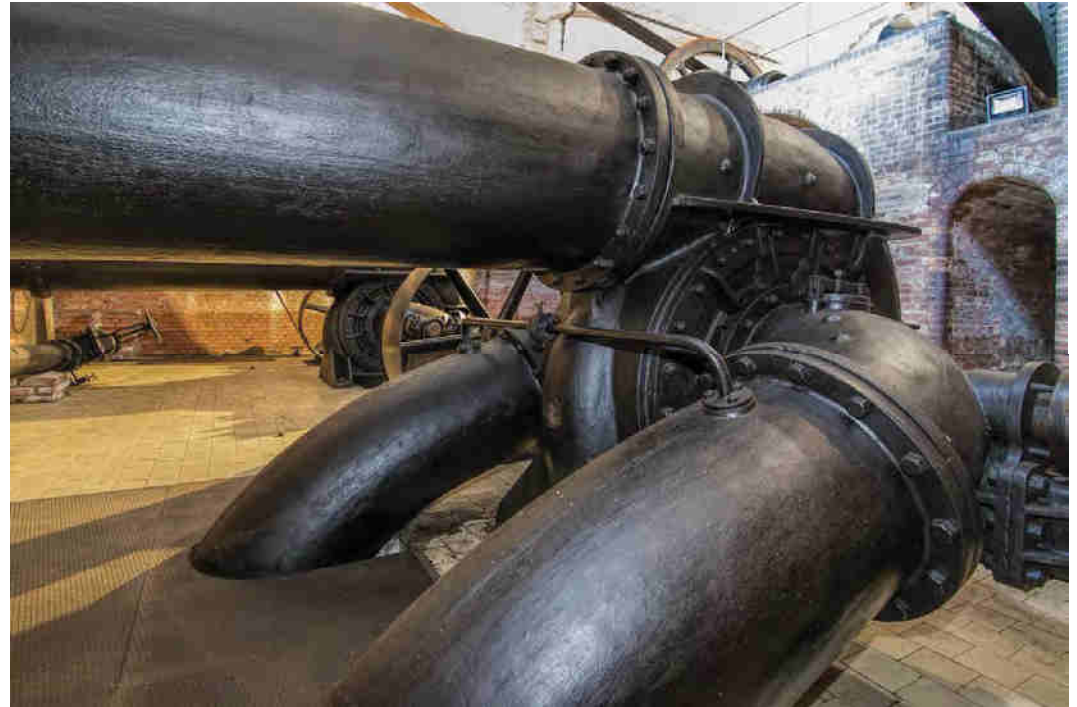
Engine room  
Flood pumps

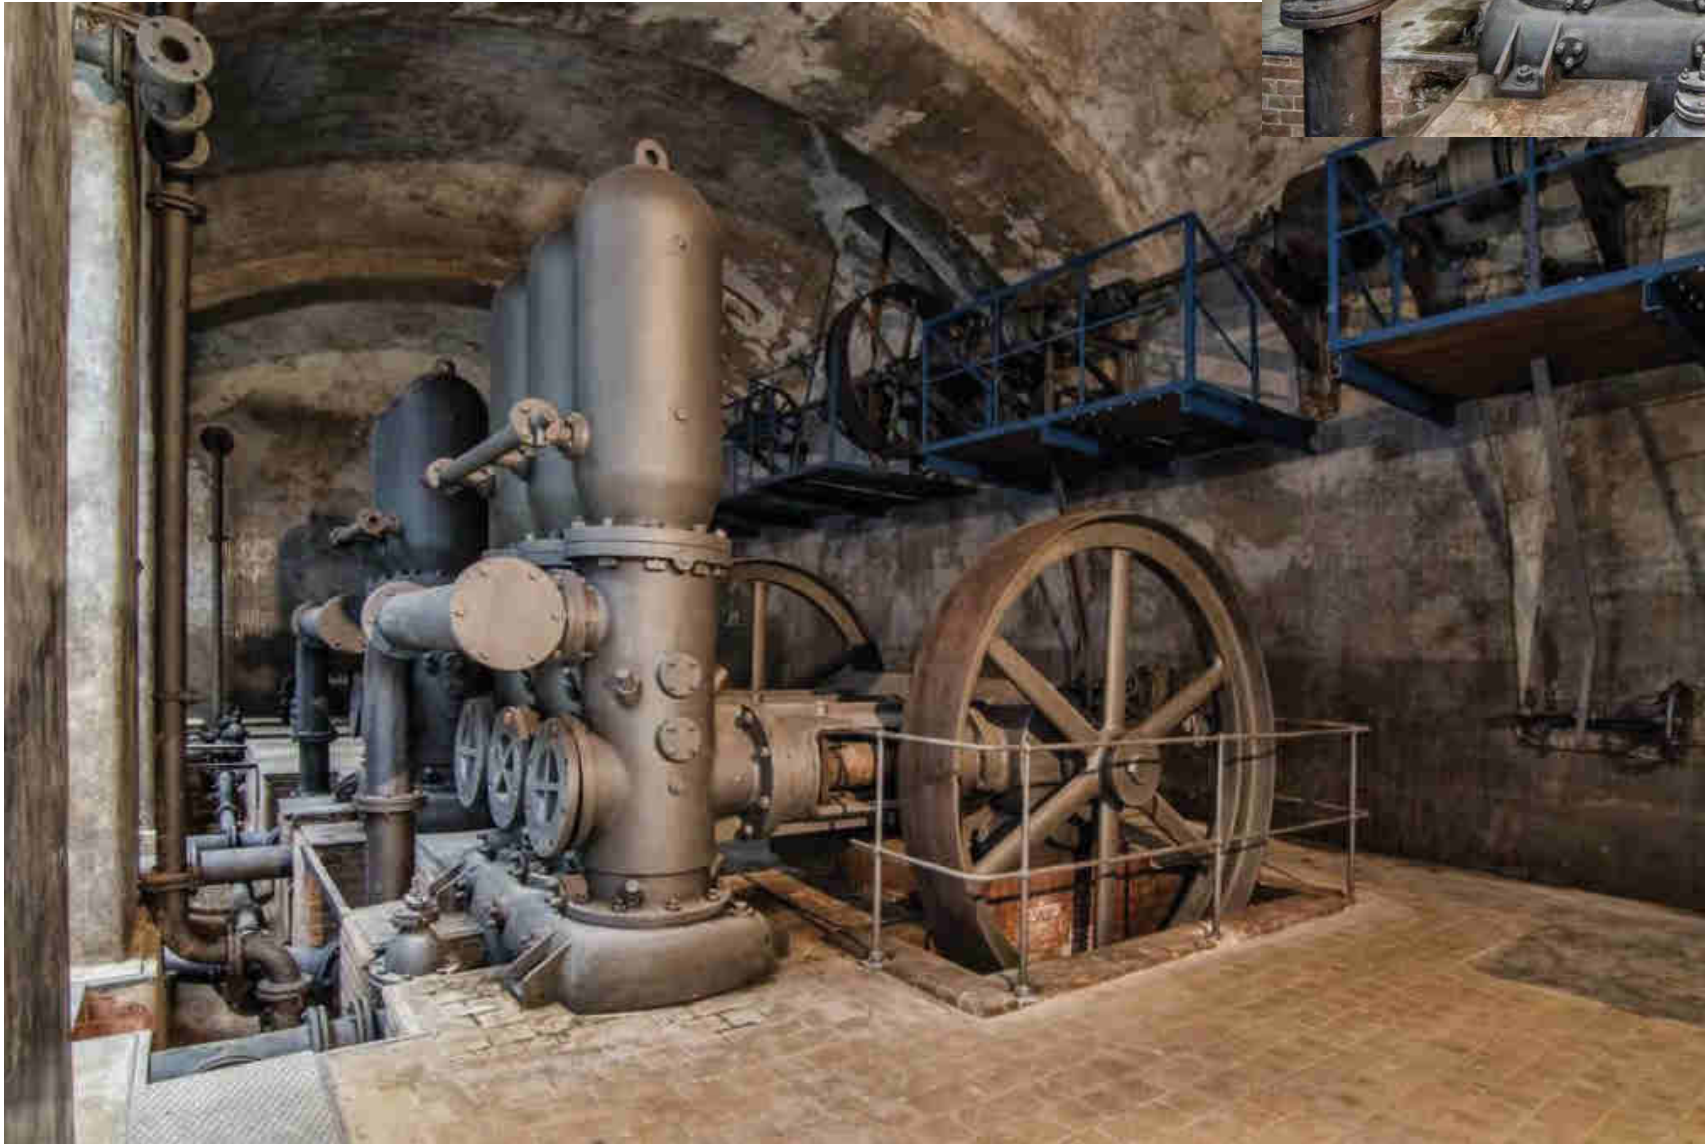
Sludge pumps

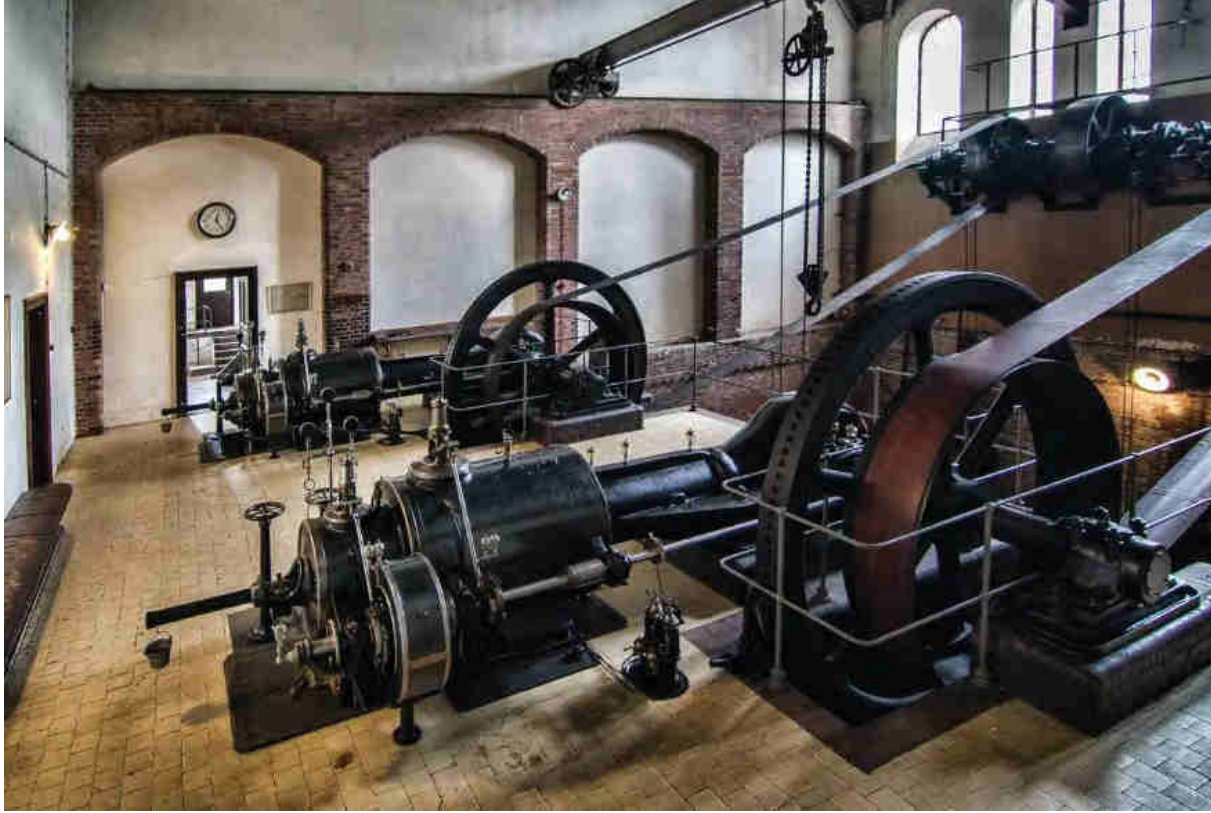
Engine room  
Steam engines

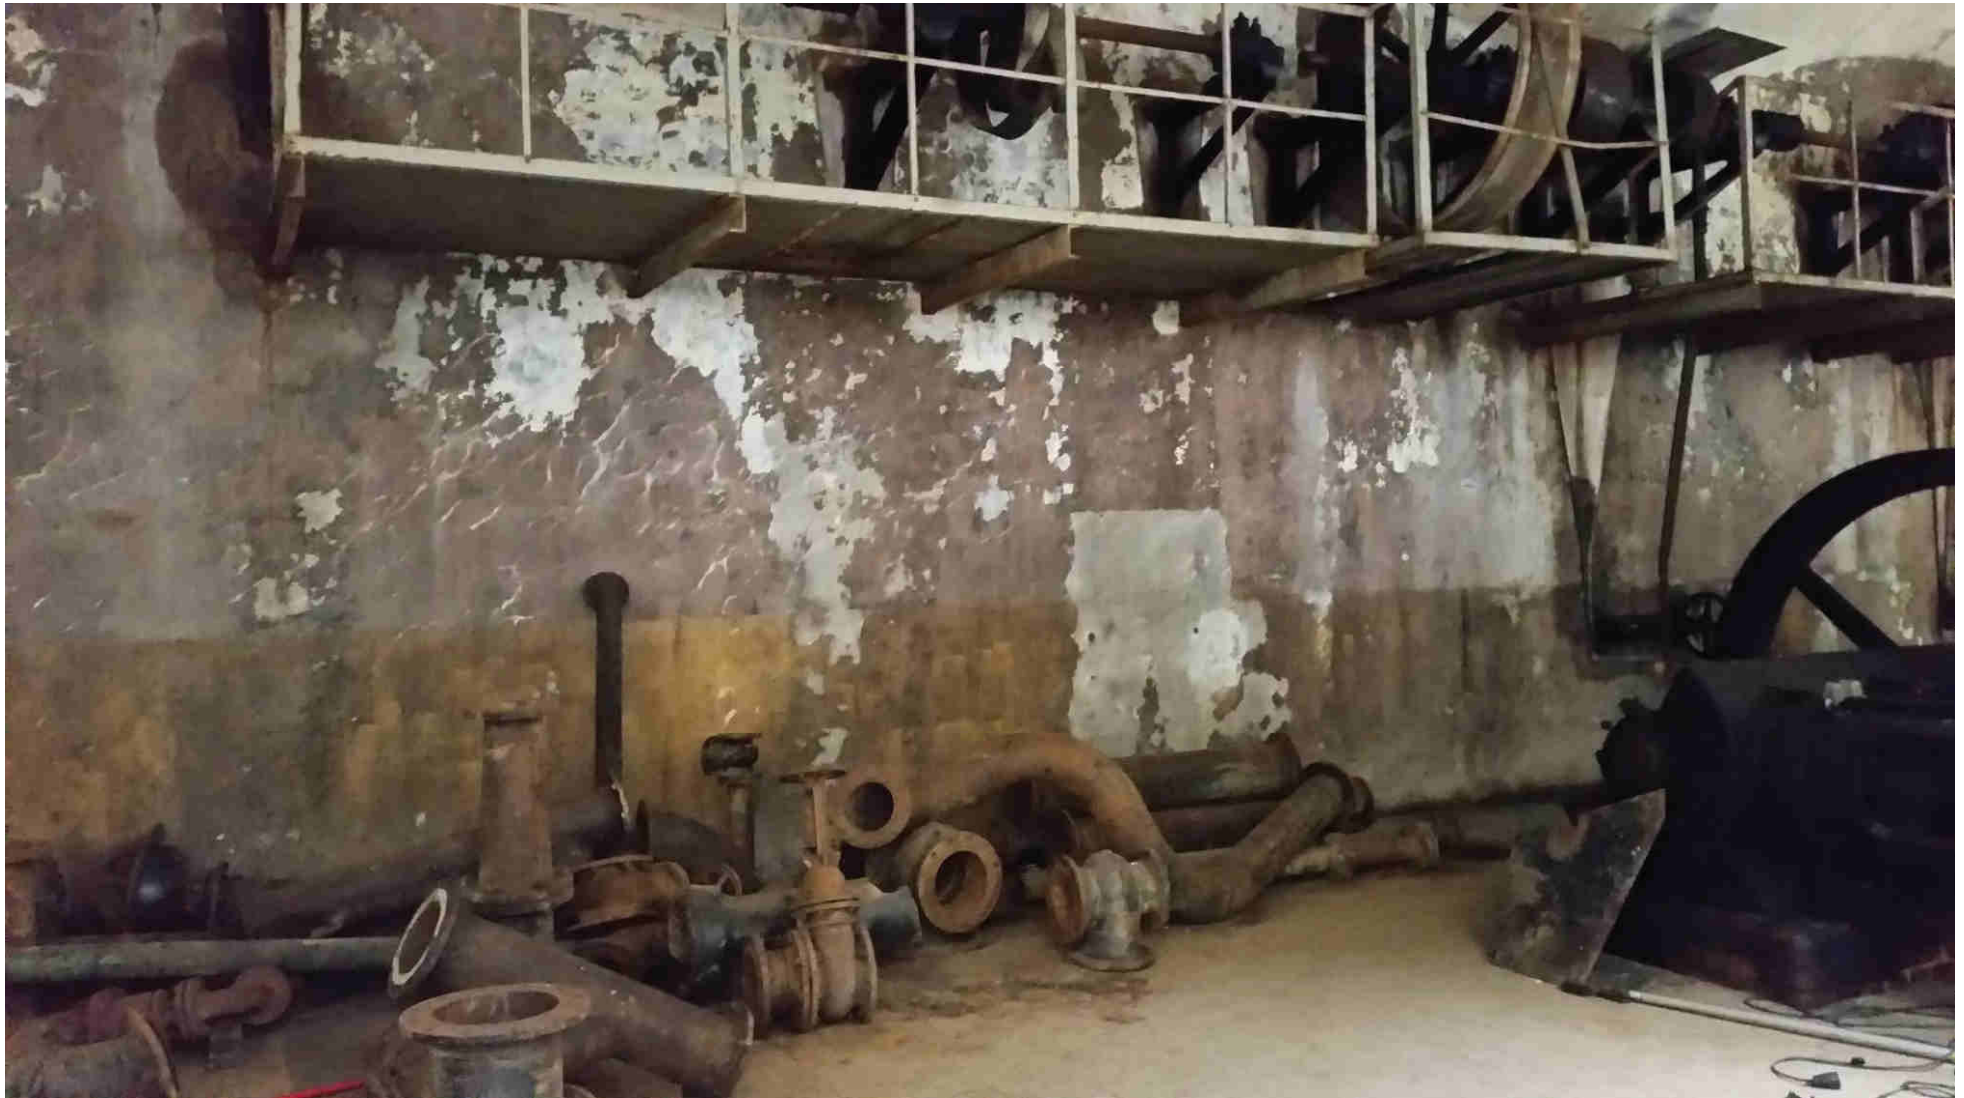
## Underground Sludge pump room

- number of layers to be removed
- old wiring and electrical units were checked and all recent additions were removed
- intensive biological attack of algae
- recent interventions within walls and columns

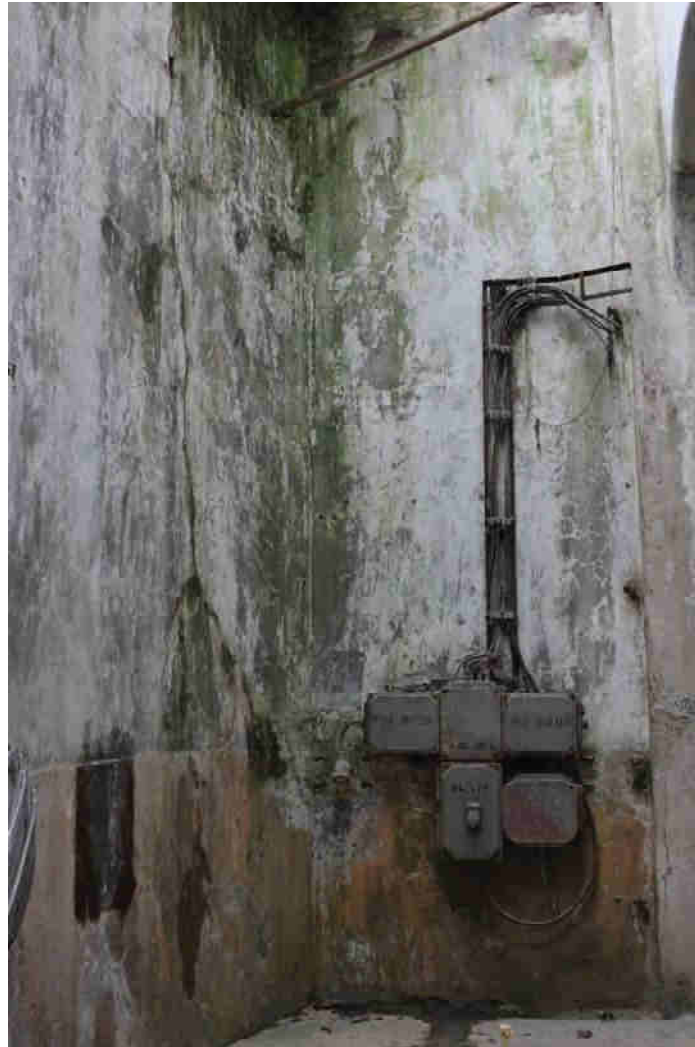
# Walls before intervention

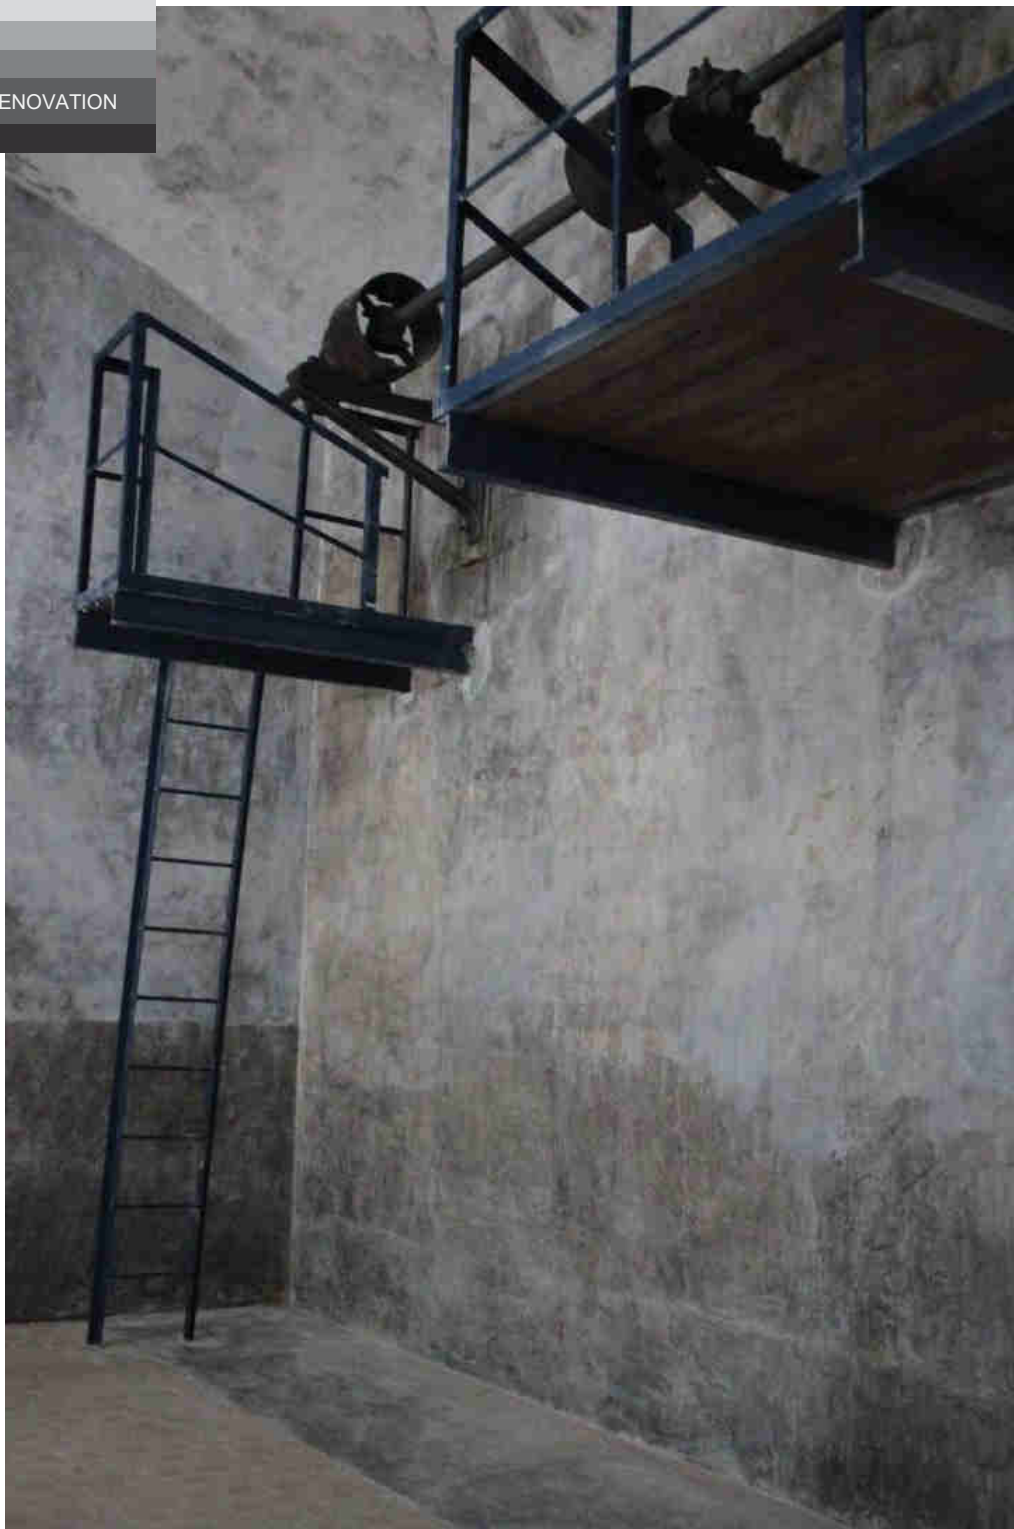
Preserved condition after repair  
of walls and plasters

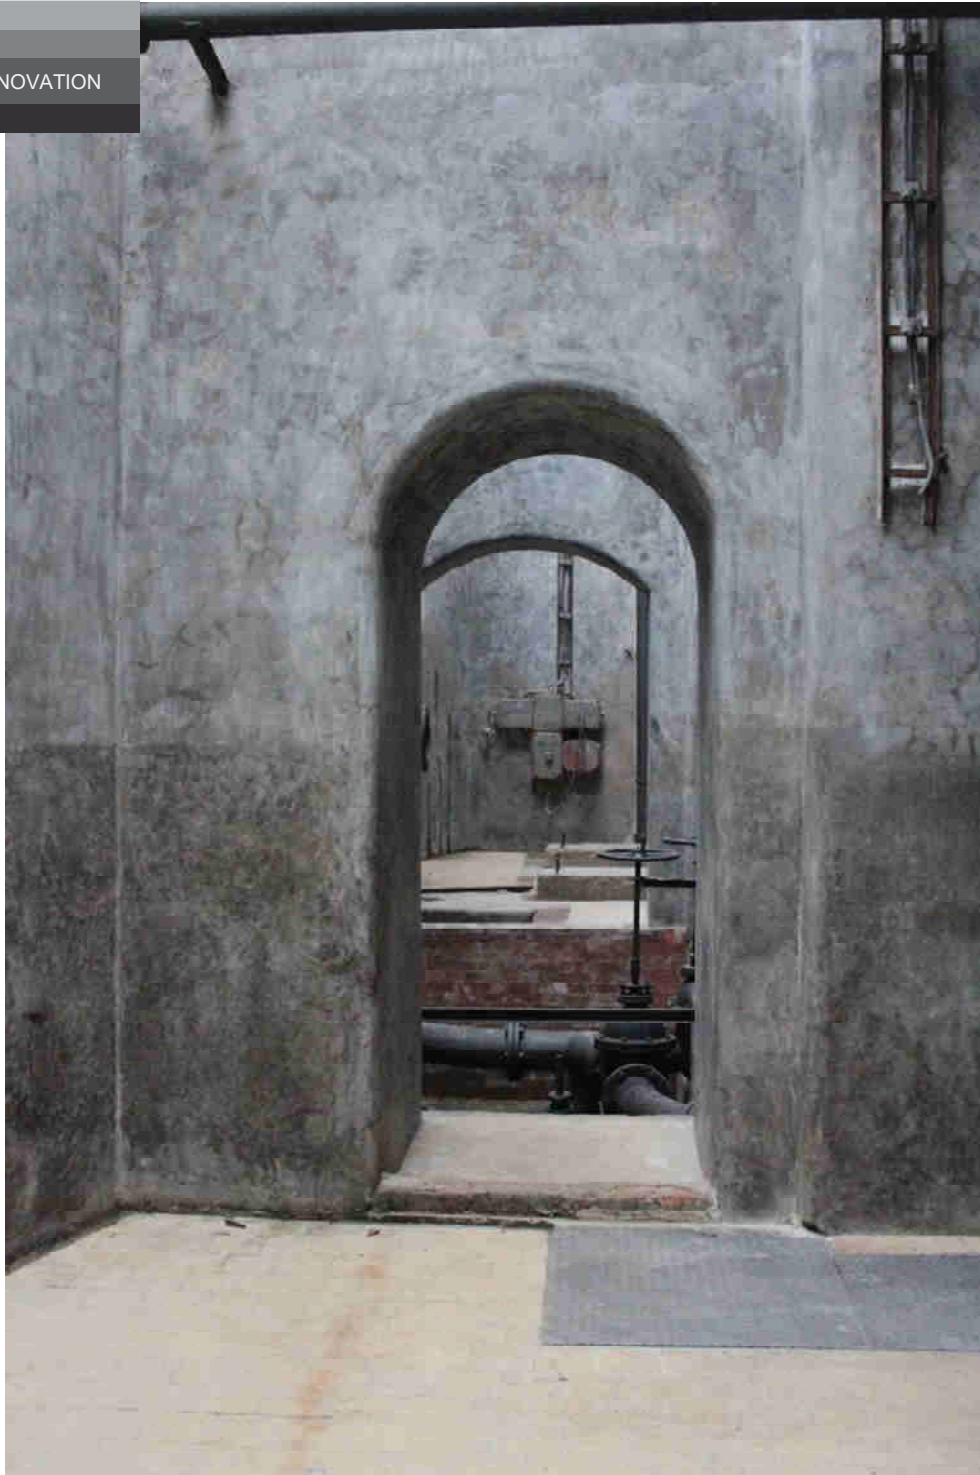
Final appearance after retouching
