Stabilization and Conservation of Minaret Choli in Erbil, Iraq

**presented by Petr Justa
Gema Art Group, Prague, Czech Republic**

- The minaret is situated 900 m west of the southern gate of the Erbil citadel.
- Construction ascribed to the atabeg al-Mudhaffar Din Kokburi (ca. 1190 AD),
- only remaining relic of a large mosque, the earliest phase might be of late Umayyad or early Abbasid period

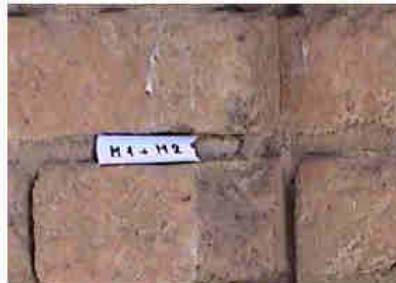
Sampling place

Joint mortar from deeper part of the joint; same place as M1

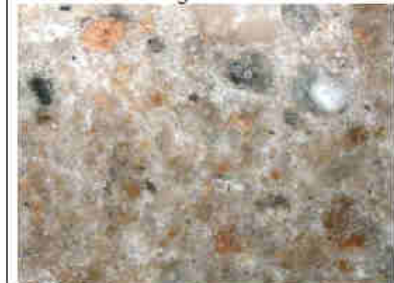
Microphotograph of cross-section in white reflected light

The matrix is composed mainly by calcium sulphate. It has a very high porosity with quite large pores (up to 300-400 µm), which are often typical for gypsum based mortars. Matrix contains a very low amount of calcium carbonate (max. 2-3 %). Single grains of calcium sulphate are also present in the mortar. Similarly to sample M1 are the edges of a part these grains again well interconnected with the matrix and a reaction rim is visible.

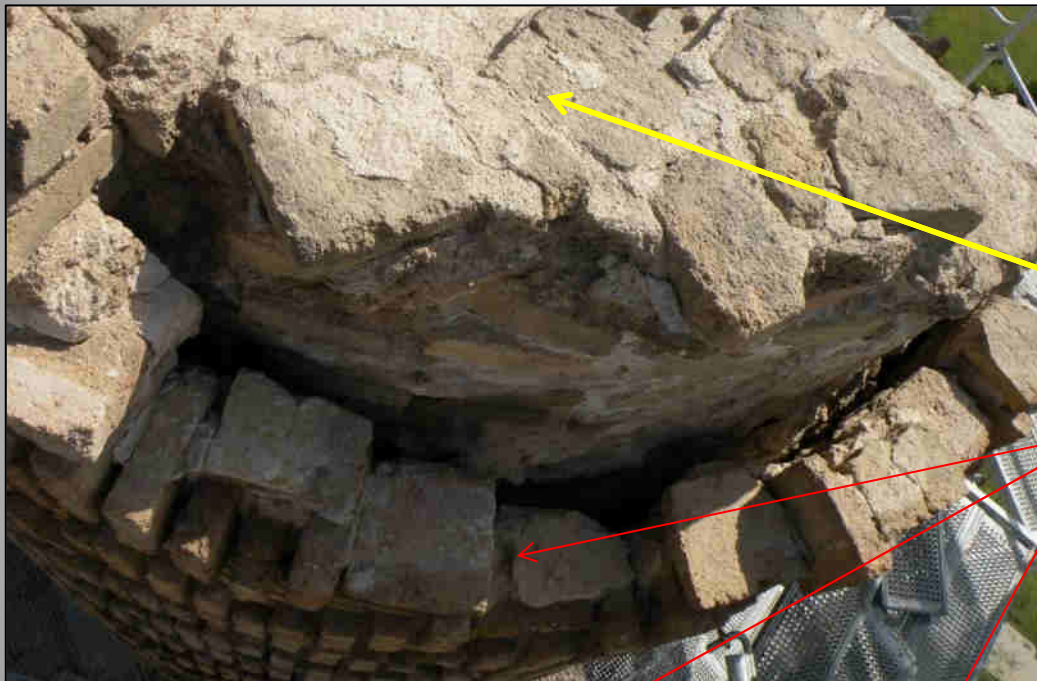
Detachment of the outer wall from the core

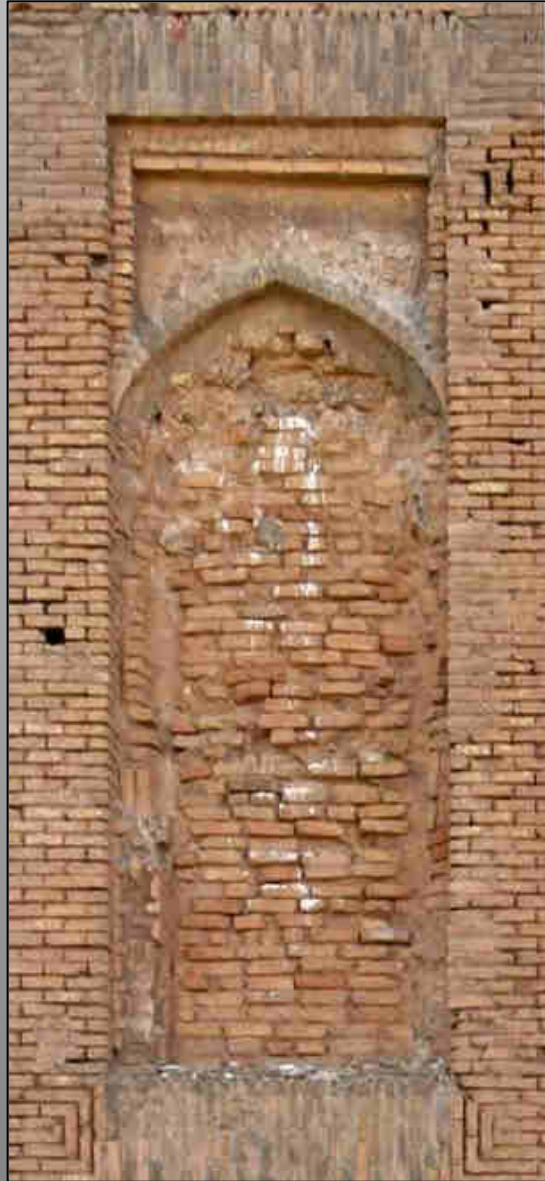
Lower large niches before treatment

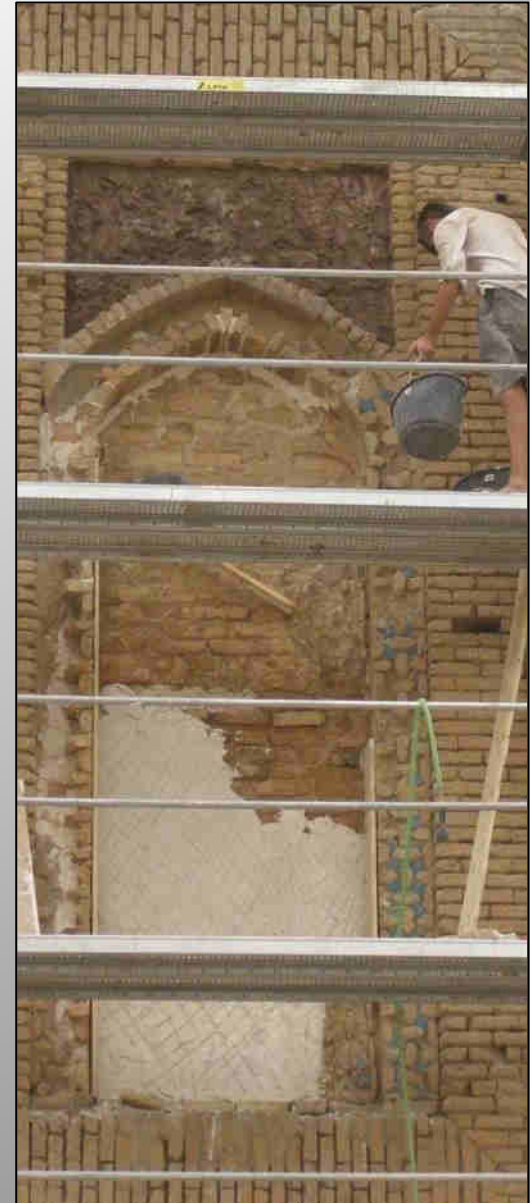
SW large niche in course of treatment

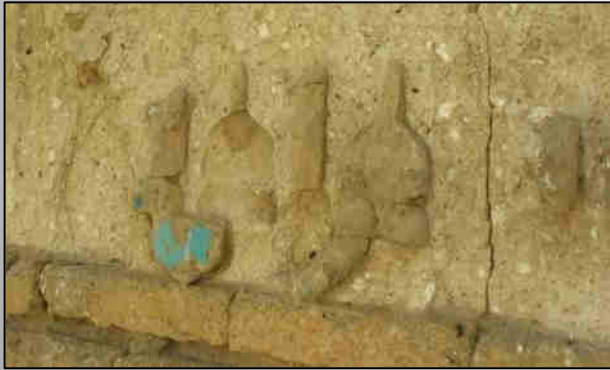
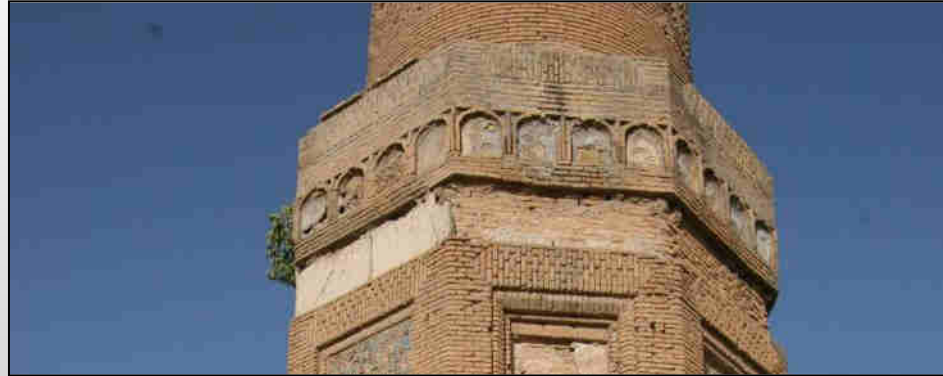
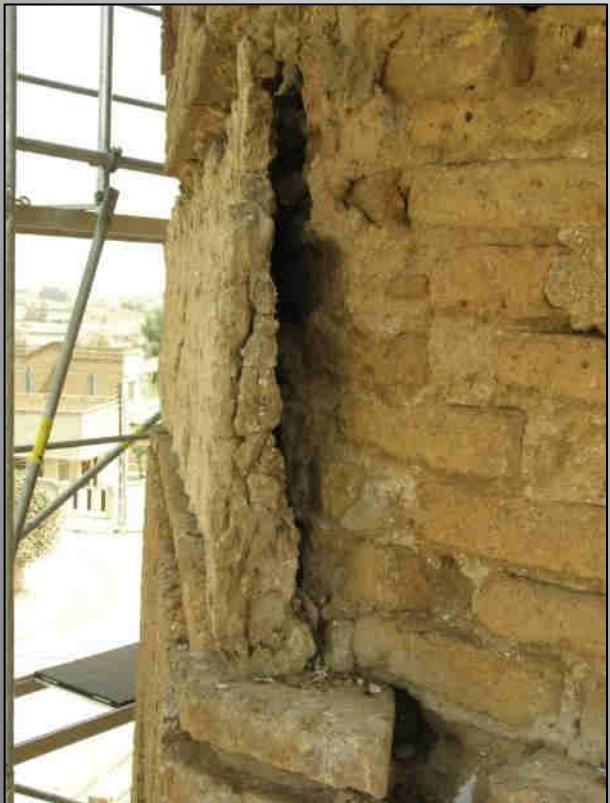
Running **gypsum belt** under small niches – before treatment

Stabilization and reconstruction of the gypsum belt

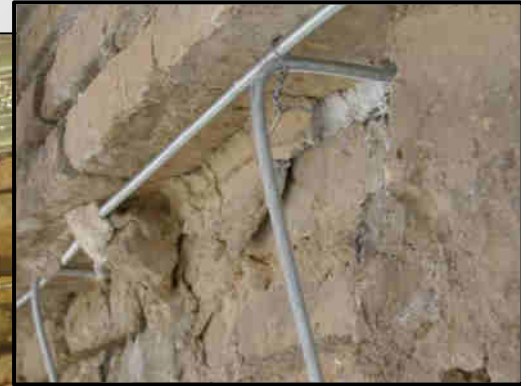
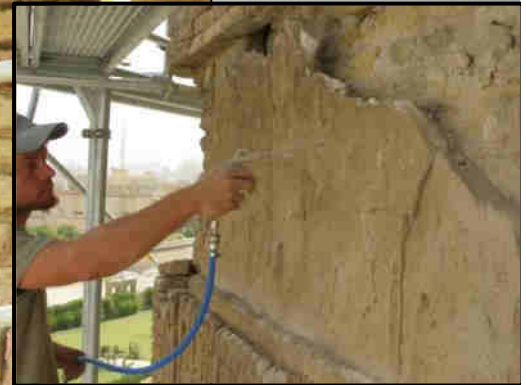
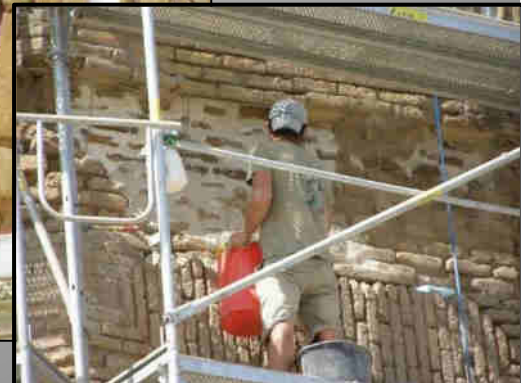
**Gypsum running belt after conservation
and partly reconstruction (right)**

Arrows locate original fragments

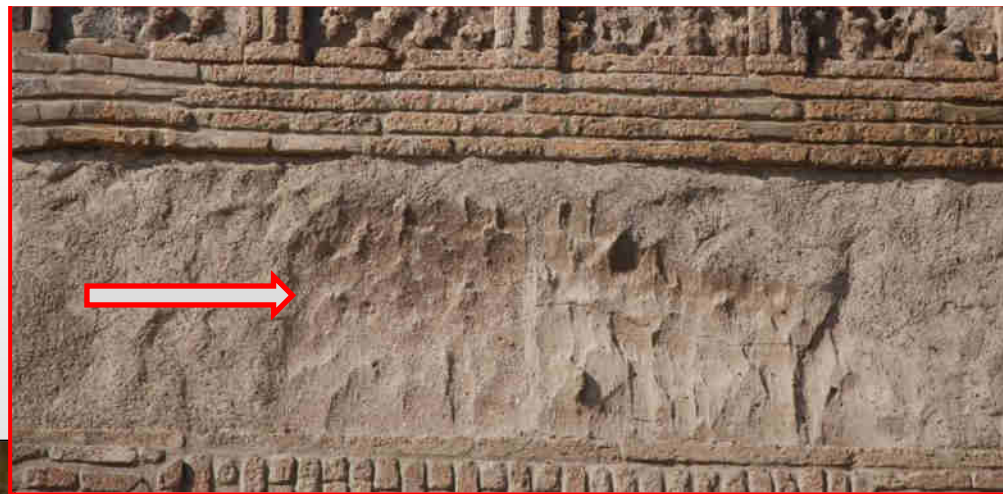
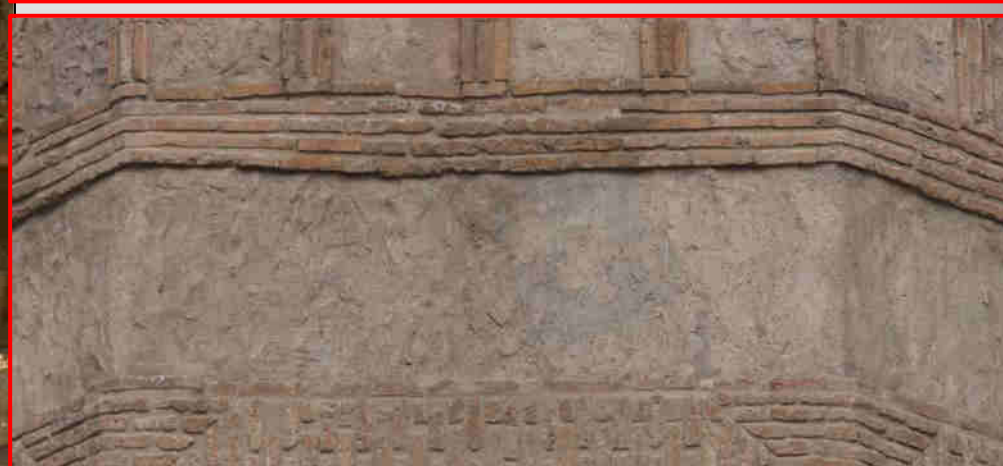
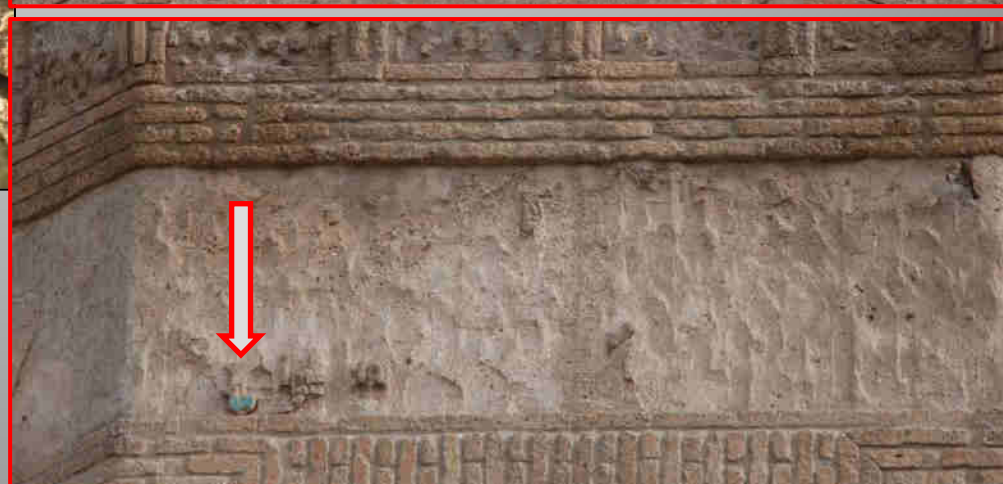
**Gypsum running belt during
reconstruction (above)**

NE part of the minaret, **small niches**
and **gypsum belt** after treatment

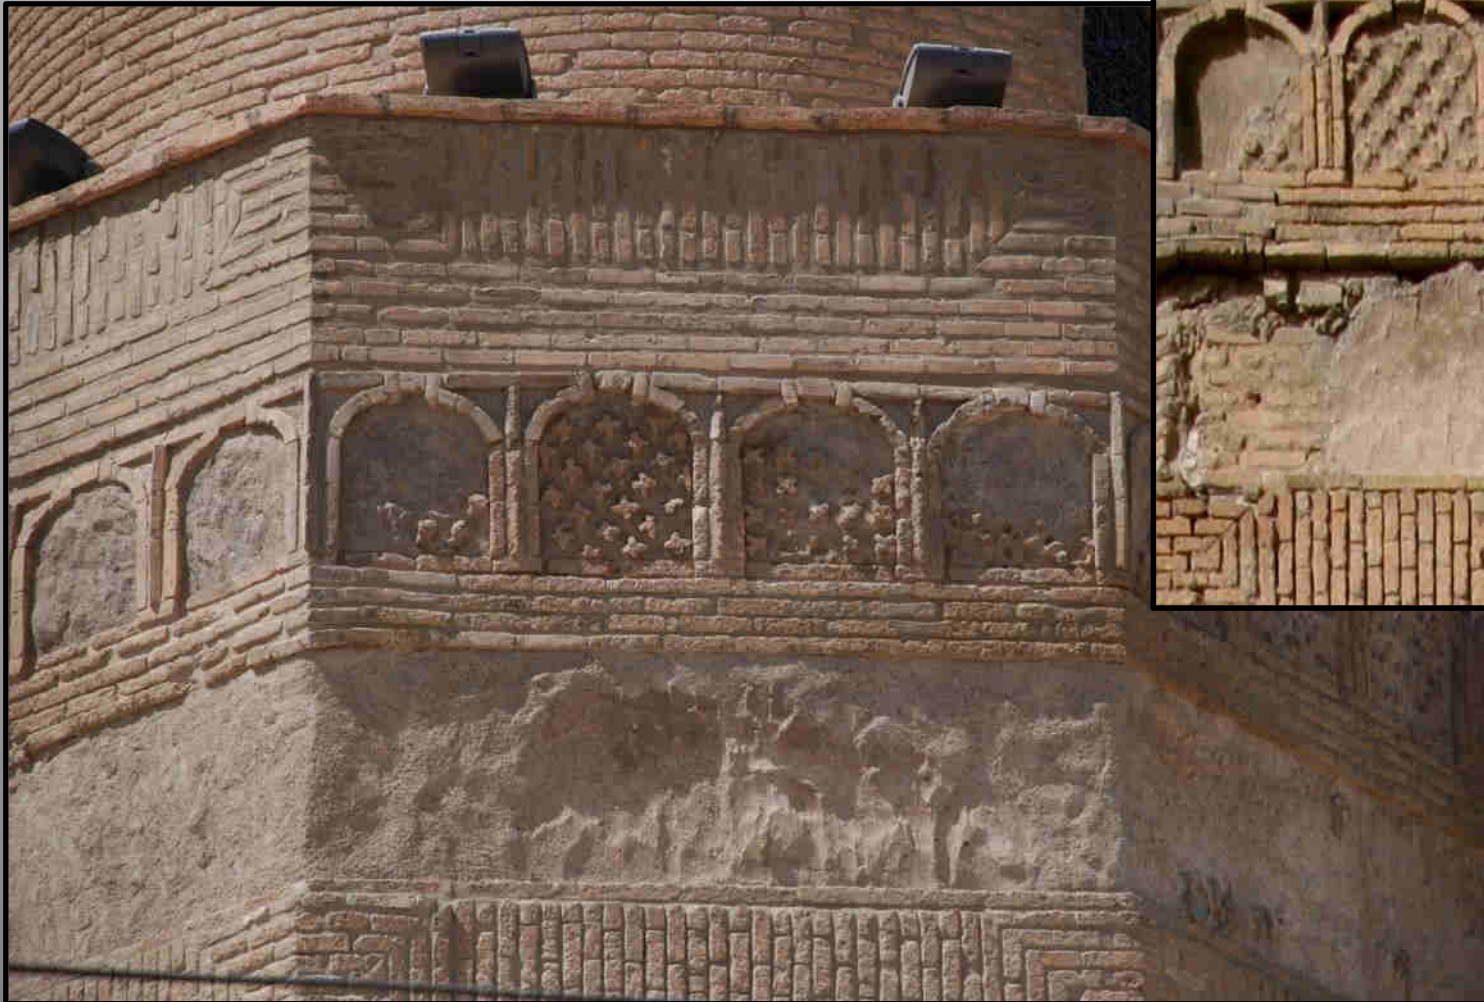
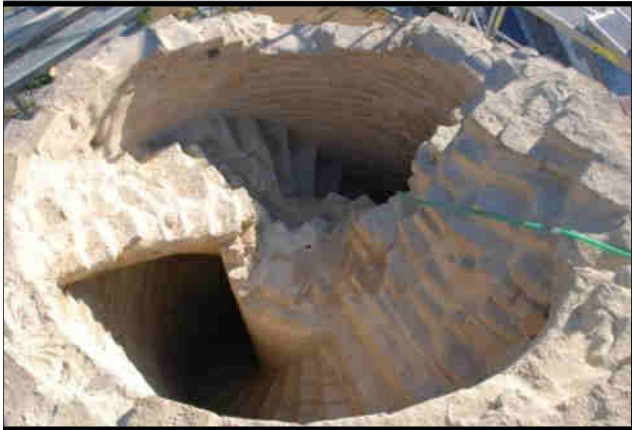
**The summit after conservation, before roofing (below)
reconstruction of northern window (left, see the arrow)**

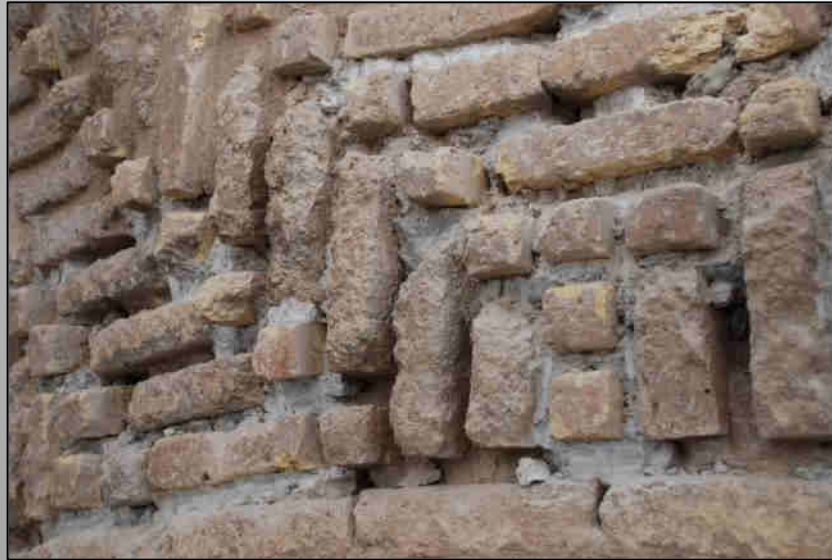
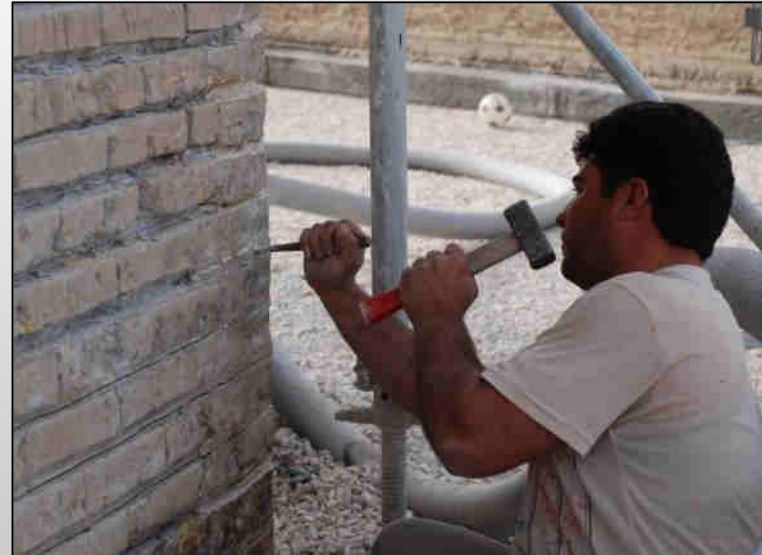
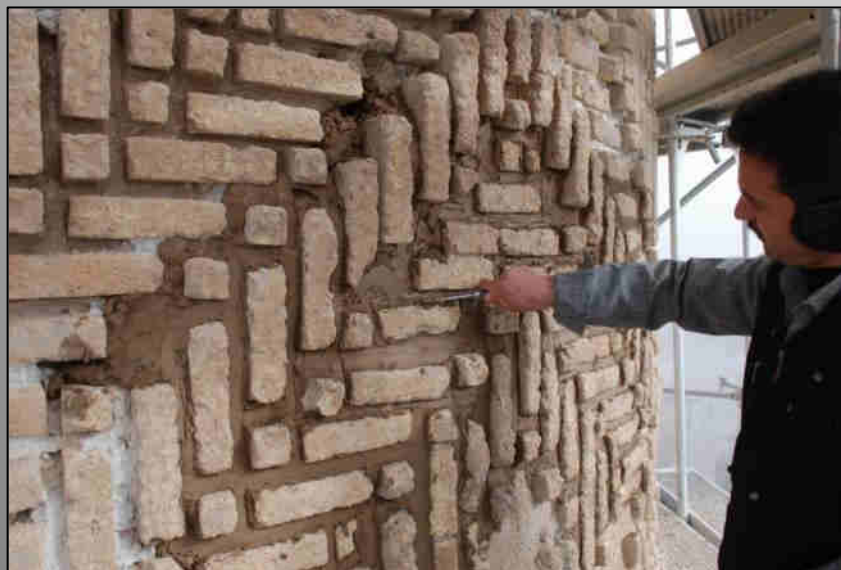
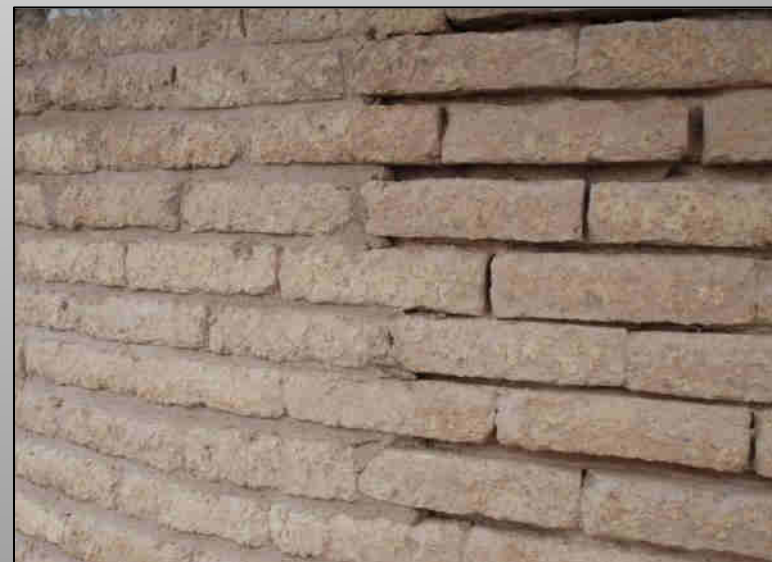
The procedure of **repointing** of joints

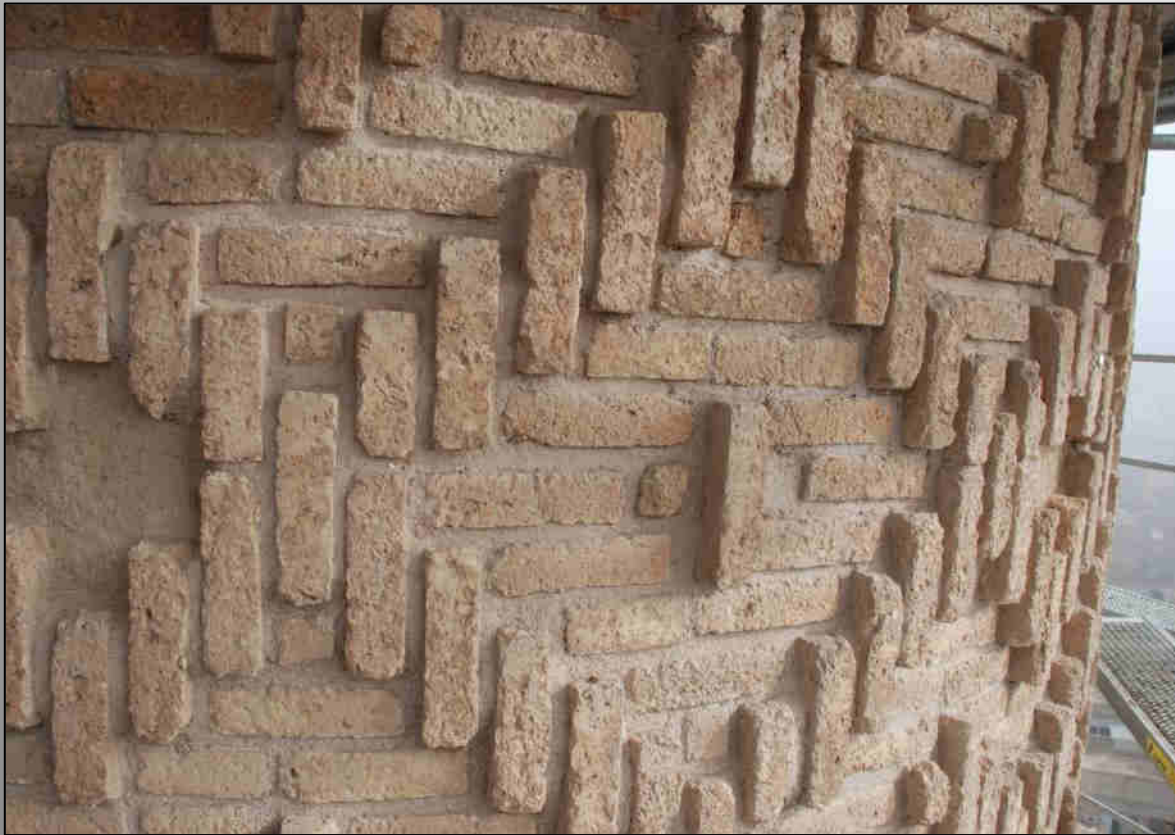
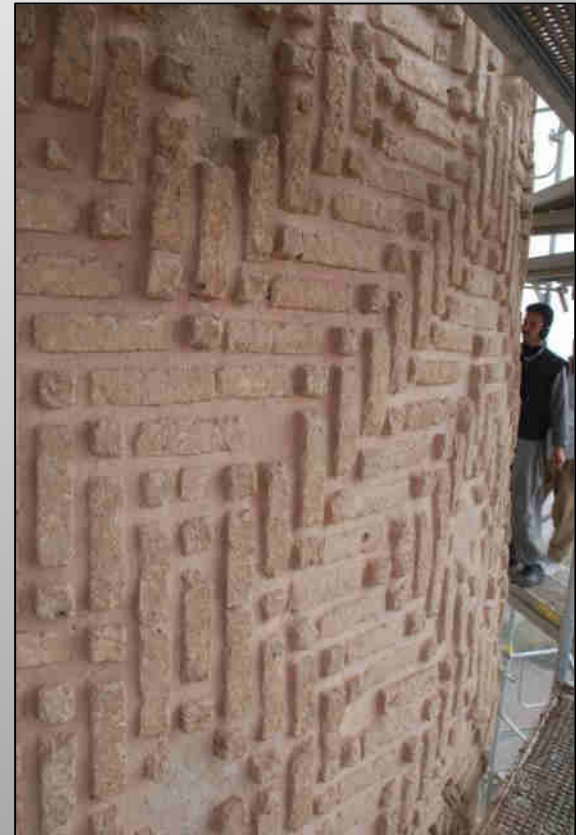
Repointing of joints after completion

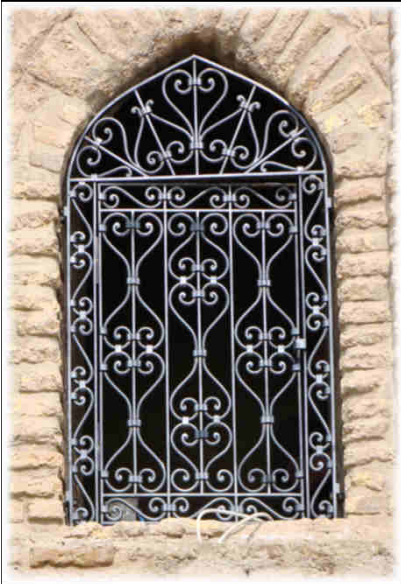
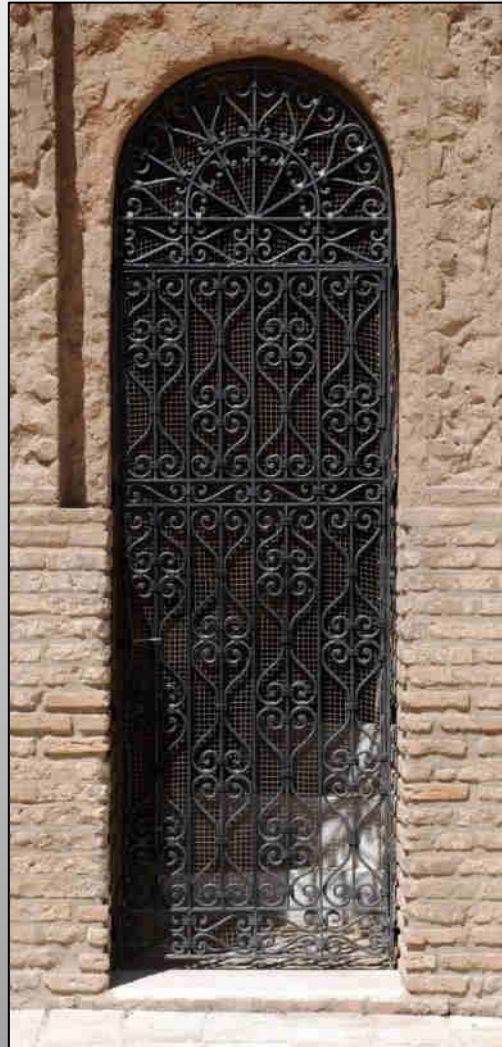
New design for window and door grills

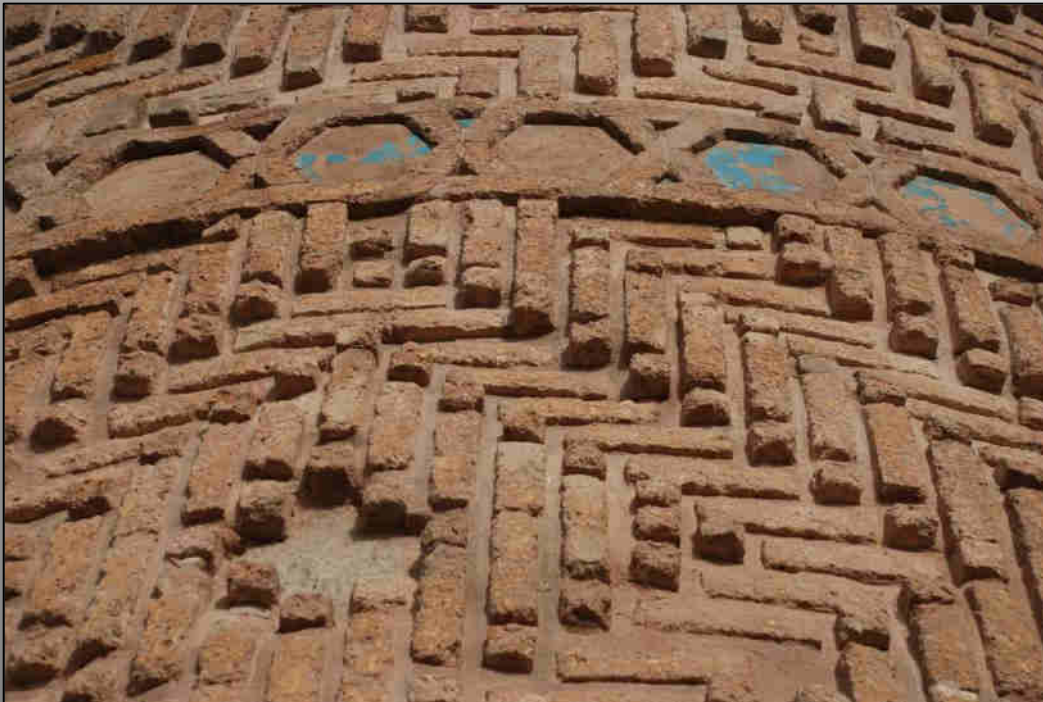
Minaret Choli after conservation

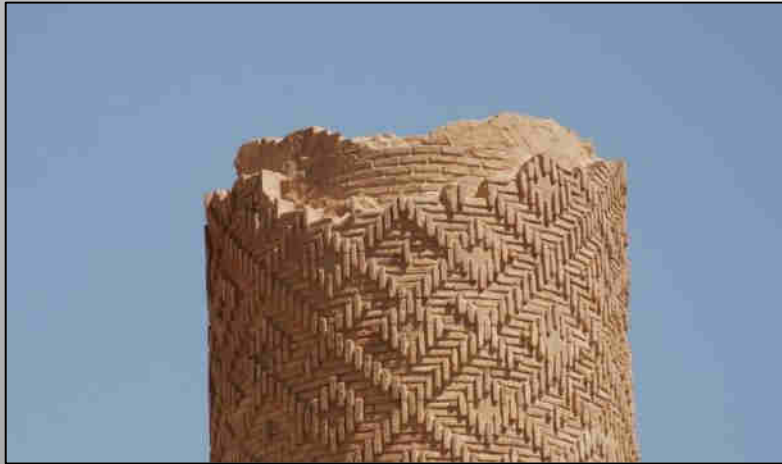
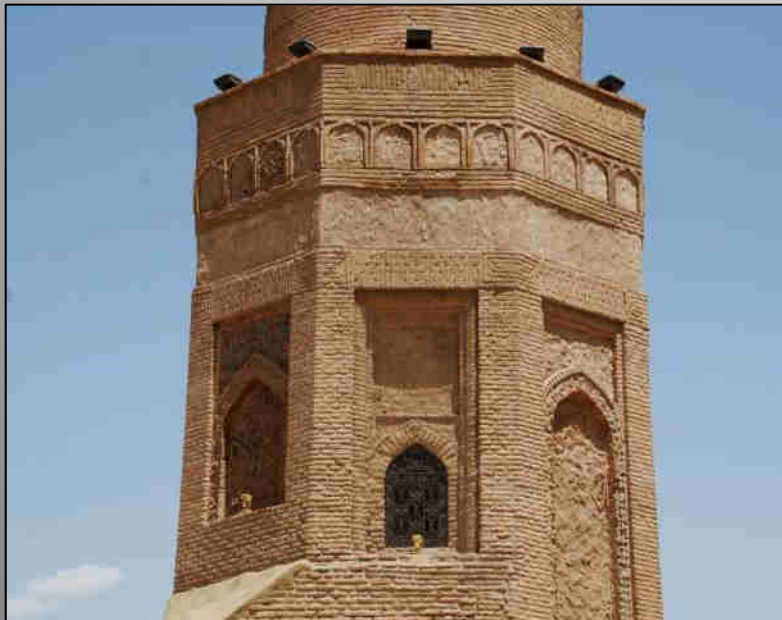
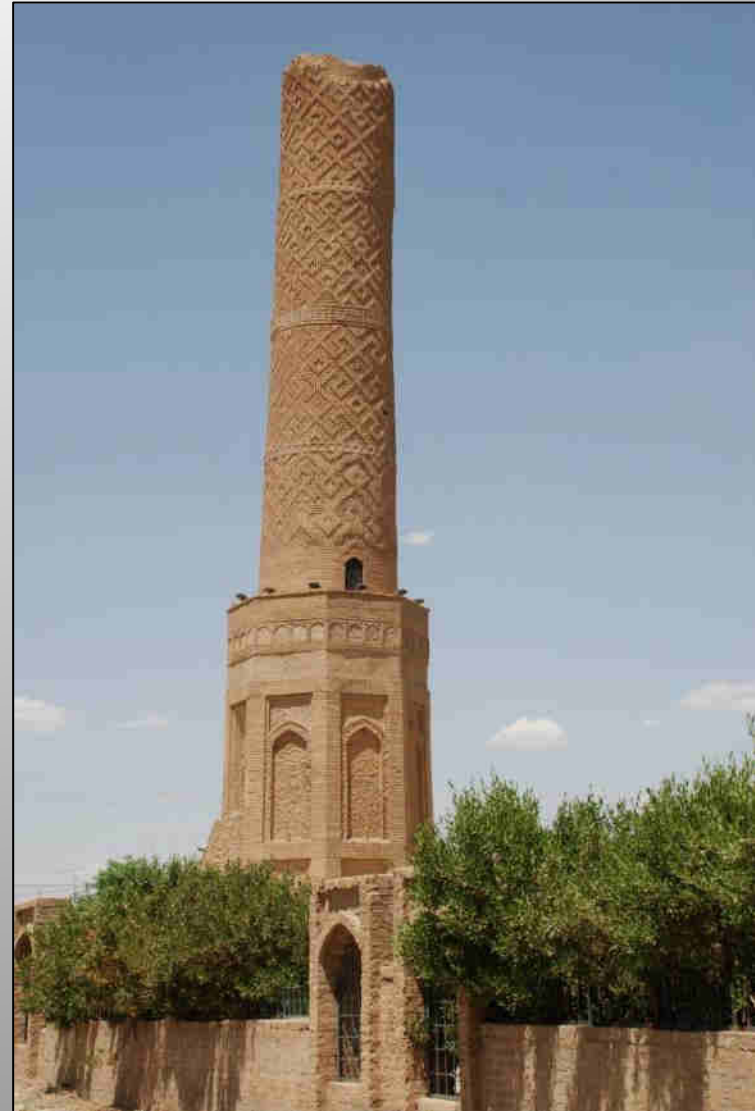
Minaret Choli after conservation

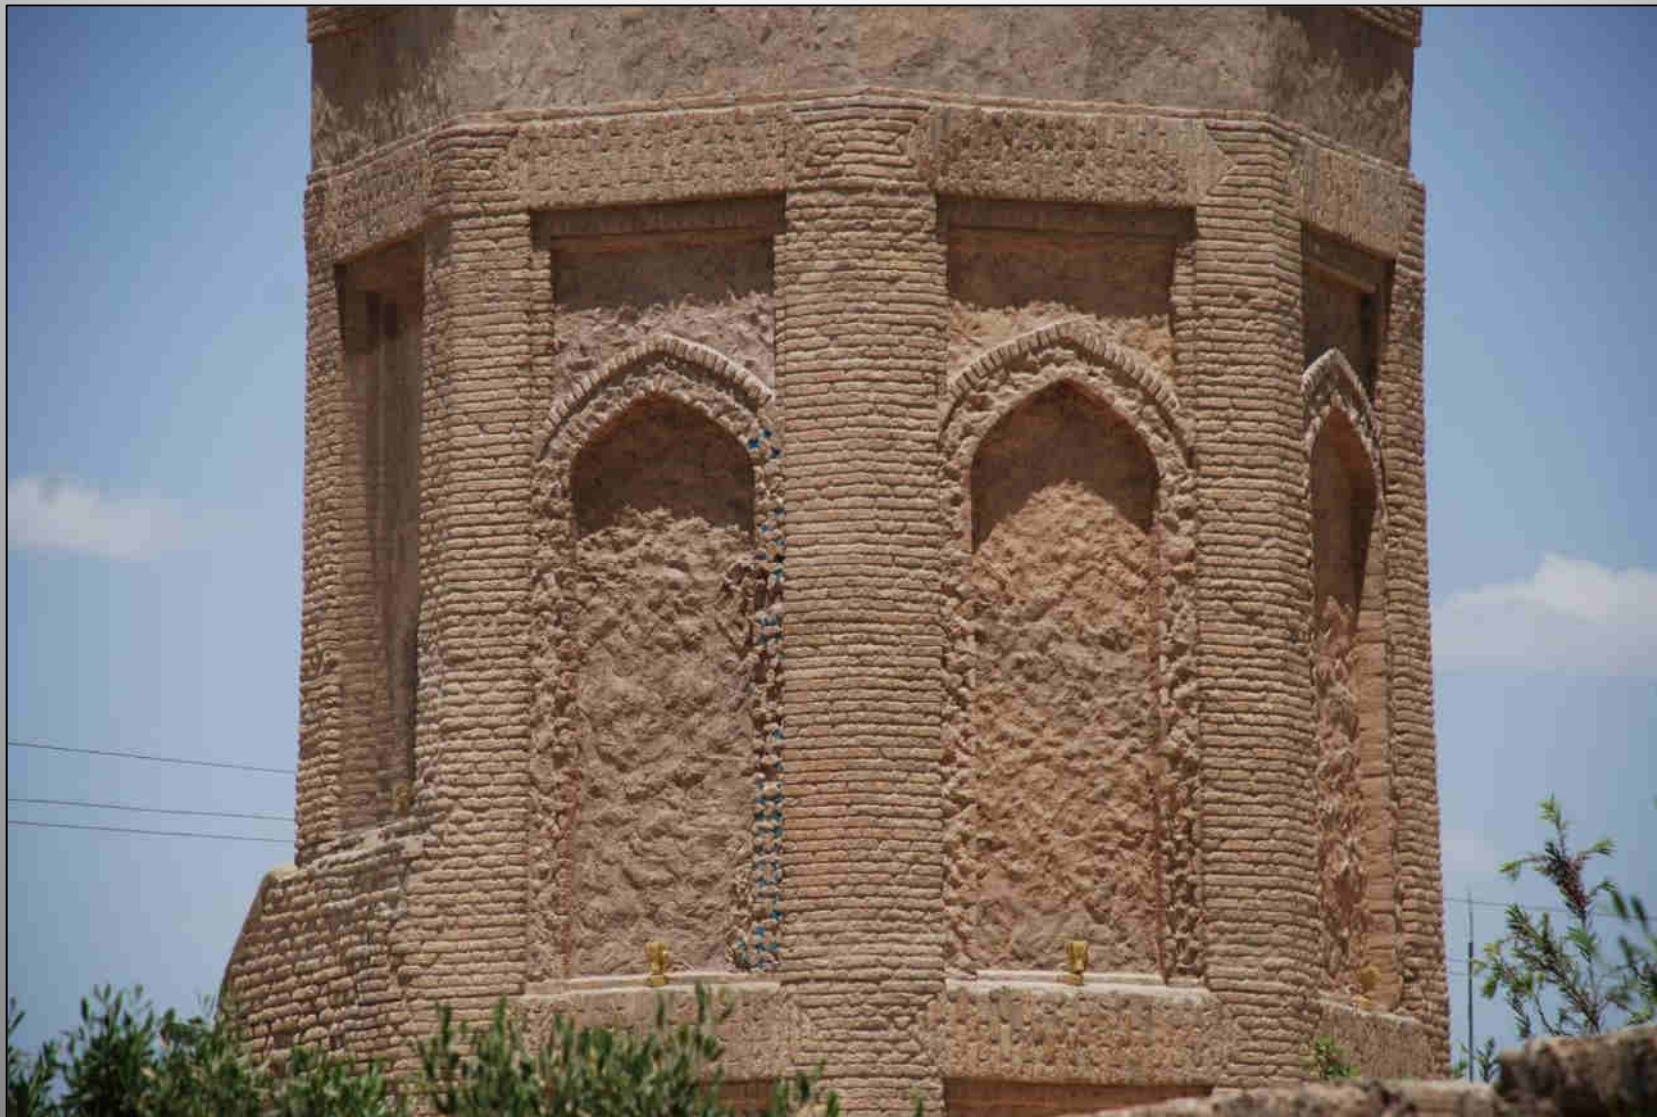
Southern upper niches after conservation
